TECHNICAL REPORT

MFL Tank Floor Inspection

DEI, Lavrio
Tank T-7
Report No. FTR-4443 Rev. 0

Test Dates: 11-15/7/2022
Report Date: 22/7/2022

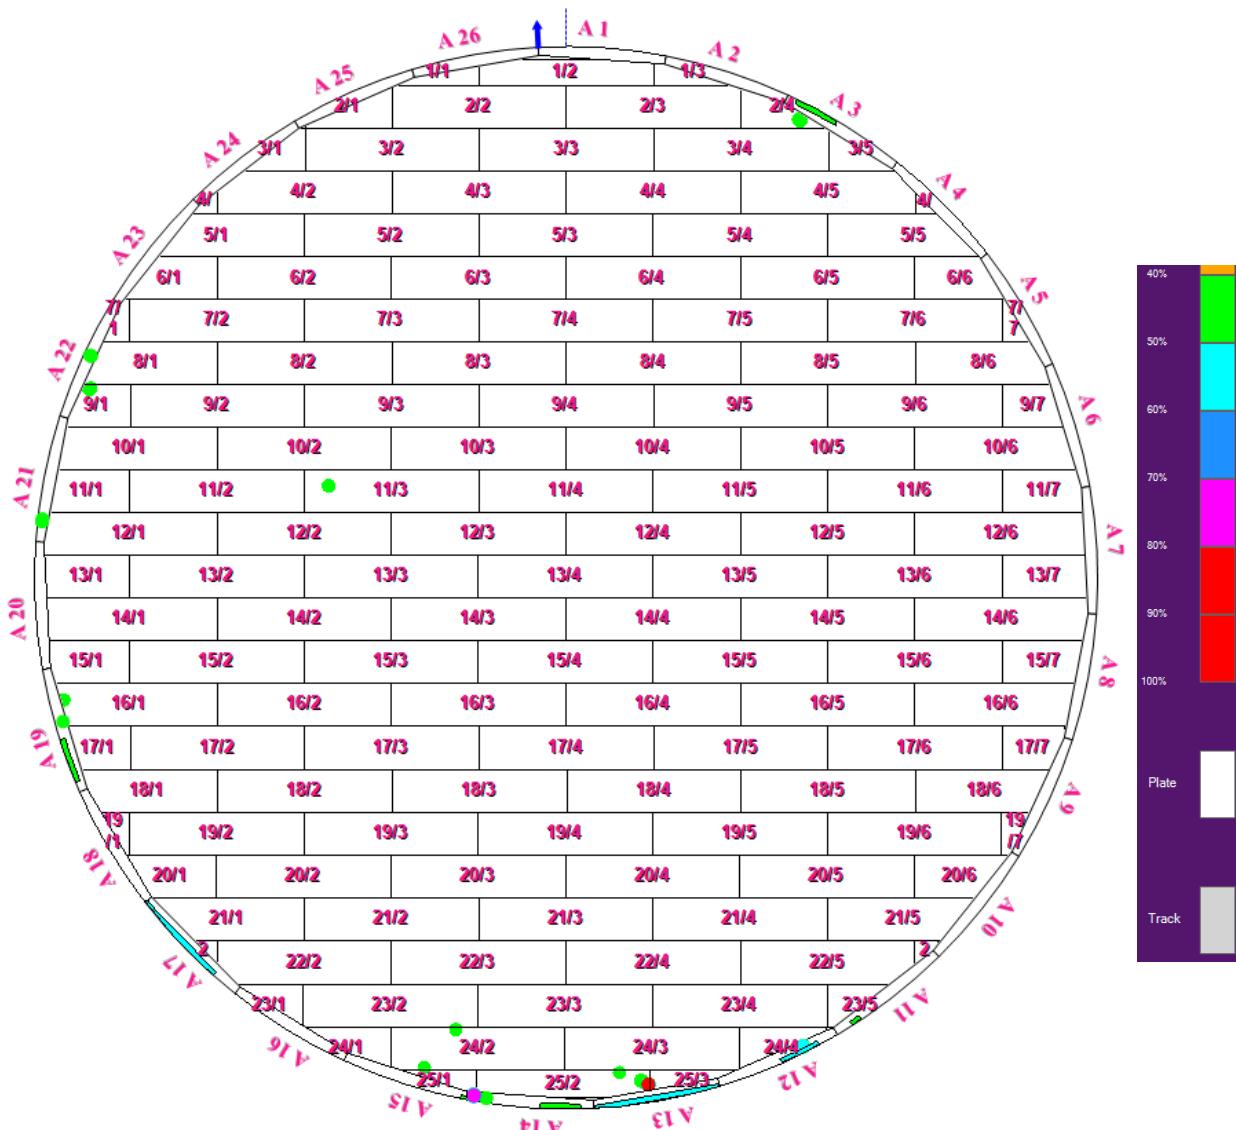
Six main plates were detected with top and bottom side thickness loss above 40%. Bottom side corrosion was found in plates 2.4, 9.1, 24.2 and 25.2 and top side pitting on plates 11.3 and 16. Furthermore, a hole was found in plate 25.2.

Figure 1 – Tank layout showing plate numbering system and MFL results with thickness loss above 40%.
(Displayed discontinuities are not in scale, have been enhanced for viewing purposes)

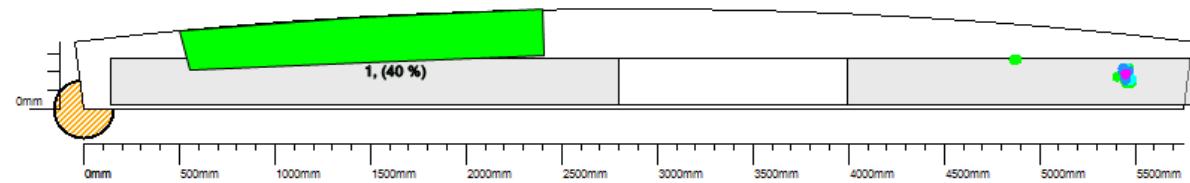
Annular 14

M - 1: Loss: 40%

Bottom side corrosion

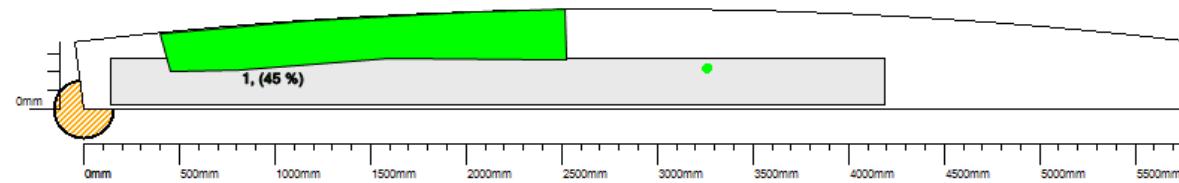
Annular 19

M - 1: Loss: 45%

Bottom side corrosion

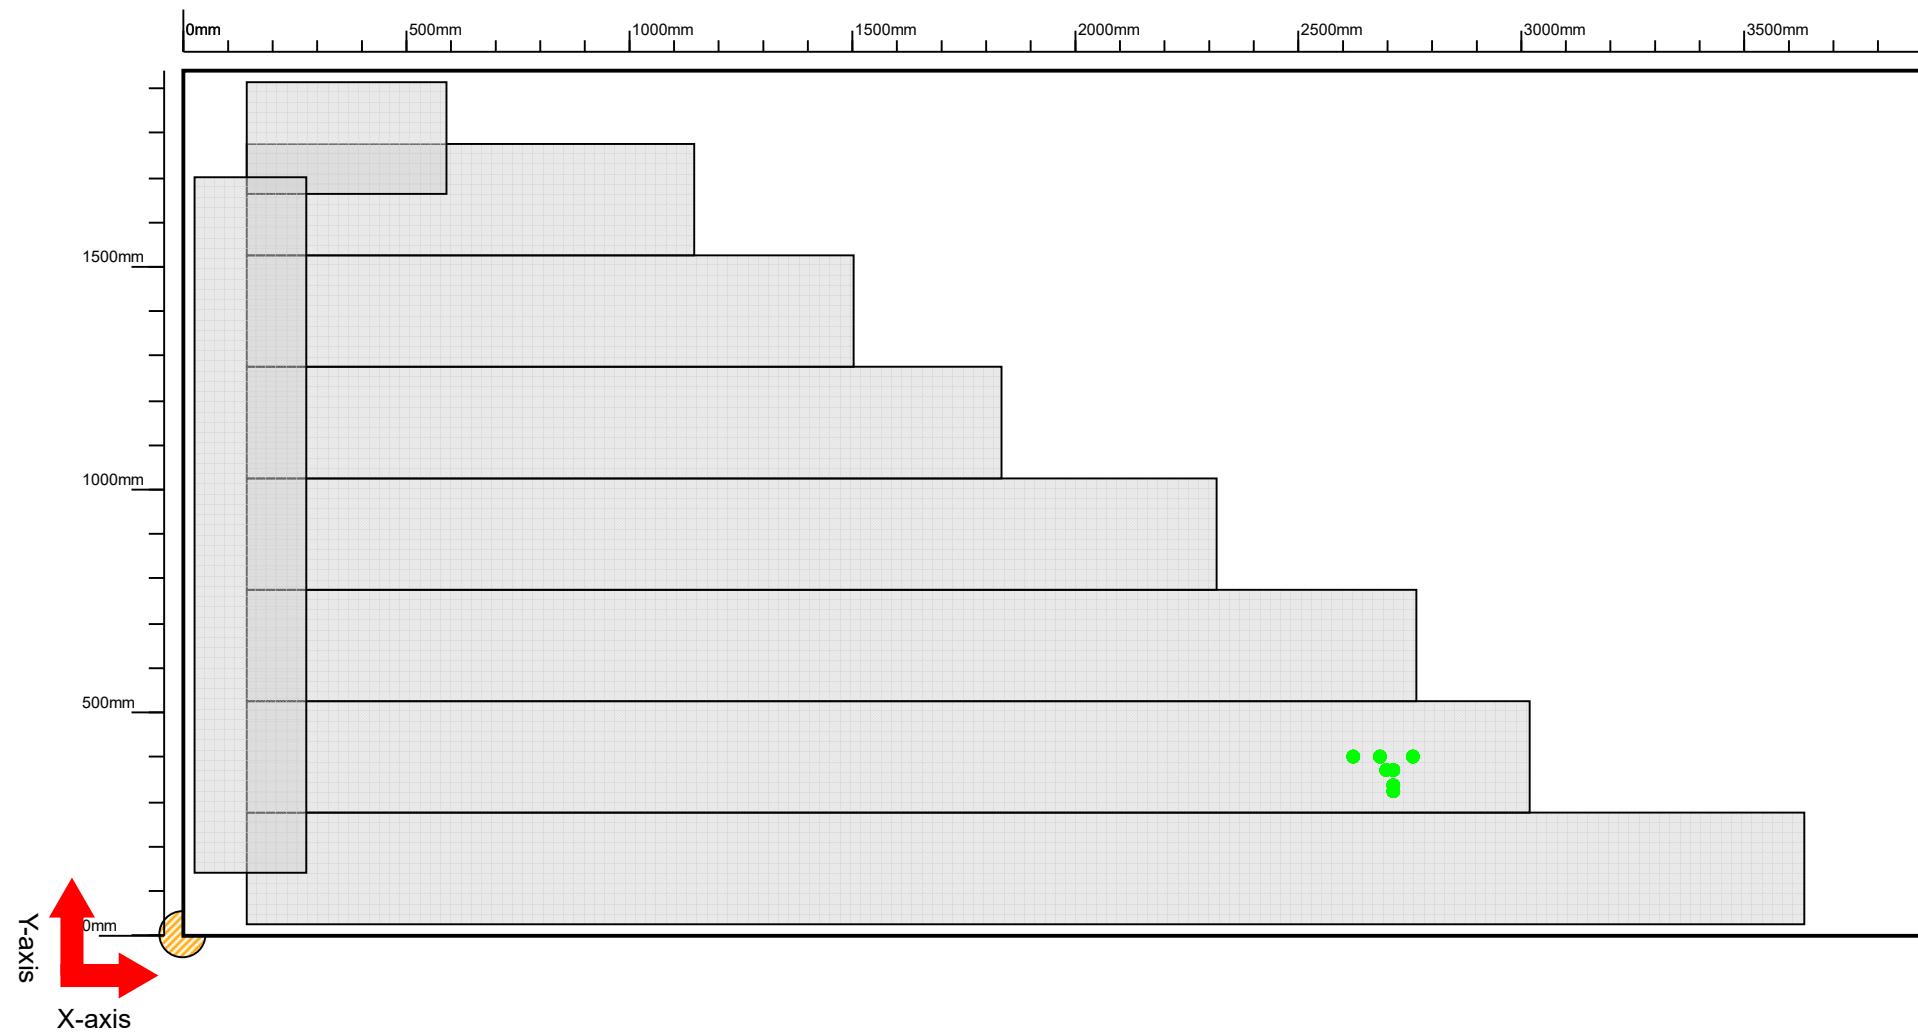
Row: 2
Plate Length (mm): 3900
Orientation: Horizontal
Max discontinuity: 42
Lower Threshold: 40%
Defect enhancement setting: 7

Plate: 4
Plate Width (mm): 1940
Scan Method: Parallel
Showing defects from: **TOP & BOTTOM**
Upper Threshold: 100% (**Import Threshold:** 20%)

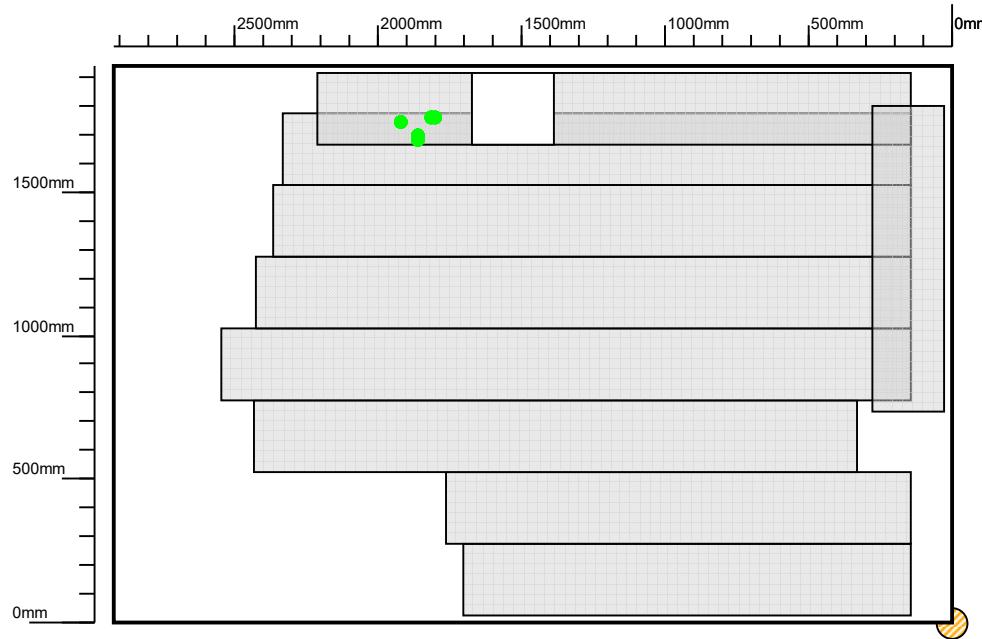
Discontinuity Colour Scheme		Symbols		Row: 9 Plate: 1 Plate Length (mm): 2920 Plate Width (mm): 1940 Orientation: Horizontal Scan Method: Parallel Max discontinuity: 45 Showing defects from: TOP & BOTTOM Lower Threshold: 40% Upper Threshold: 100% (Import Threshold: 20%) Defect enhancement setting: 7			
40% - 49%	50% - 59%	Tank	No7	Operator:	JDA		
60% - 69%	70% - 79%	Non-Scanned Area		Equipment Serial:	2861013		
80% - 89%	90% - 99%	Plate Reference	LAVRIO				
90% - 100%	Weld Discontinuity	Tank Reference	MISTRAS				
			Client:				
			DEH

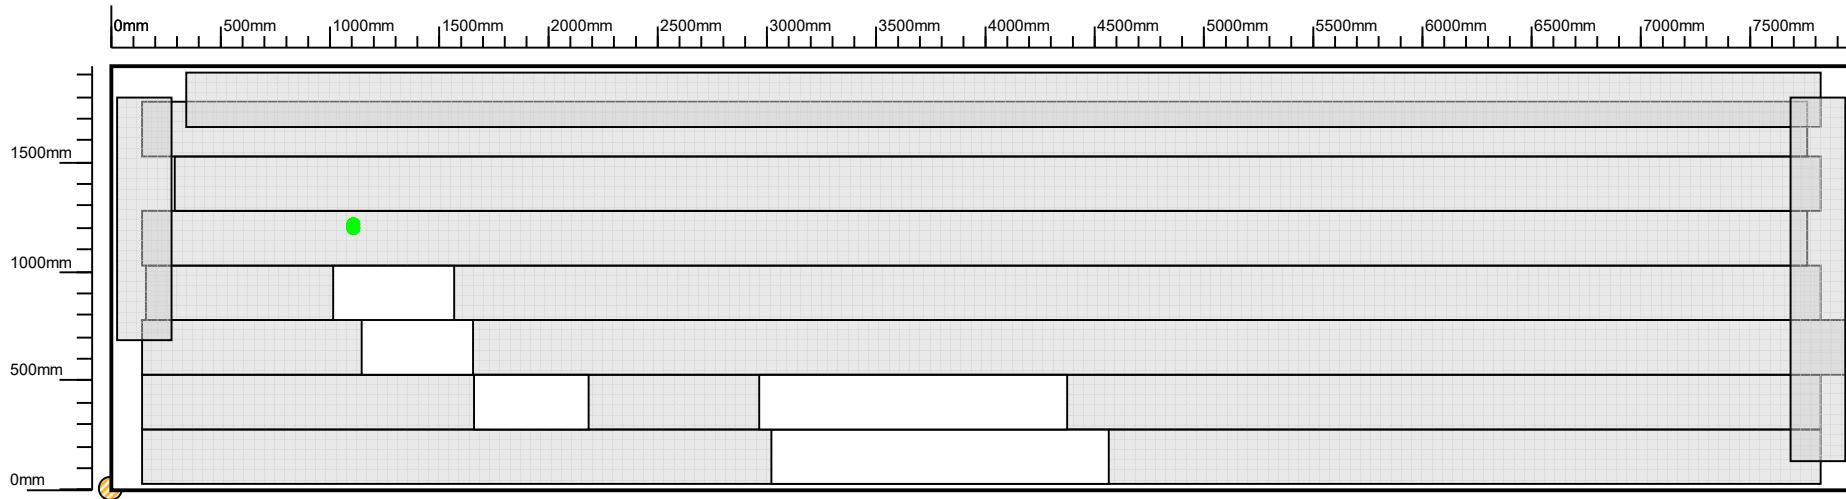
Row:	11	Plate:	3	
Plate Length (mm):	7960	Plate Width (mm):	1940	
Orientation:	Horizontal	Scan Method:	Raster	
Max discontinuity:	43	Showing defects from: TOP & BOTTOM		
Lower Threshold:	40%	Upper Threshold:	100% (Import Threshold: 20%)	
Defect enhancement setting:	7			
Tank:	No7	Operator:	JDA	
Date:		Equipment Serial:	2861013	
Location:	LAVRIO			
Company:	MISTRAS			
Client:	DEH

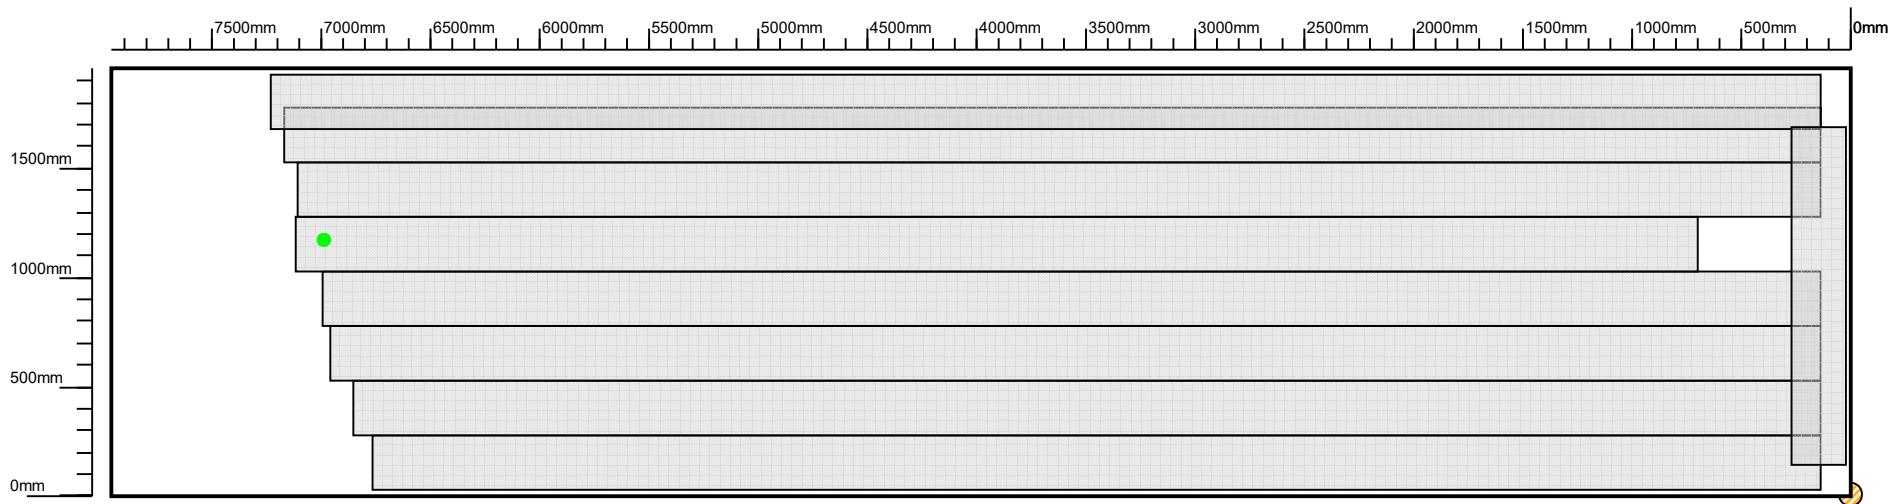
Discontinuity Colour Scheme		Symbols		Row: 16 Plate Length (mm): 7960 Orientation: Horizontal Max discontinuity: 42 Lower Threshold: 40% Defect enhancement setting: 7 Tank: No7 Date: Location: LAVRIO Company: MISTRAS Client: DEH			
40% - 49% 50% - 59% 60% - 69% 70% - 79% 80% - 89% 90% - 100% Weld Discontinuity		Track Non-Scanned Area Plate Reference Tank Reference		Eddyfi Technologies

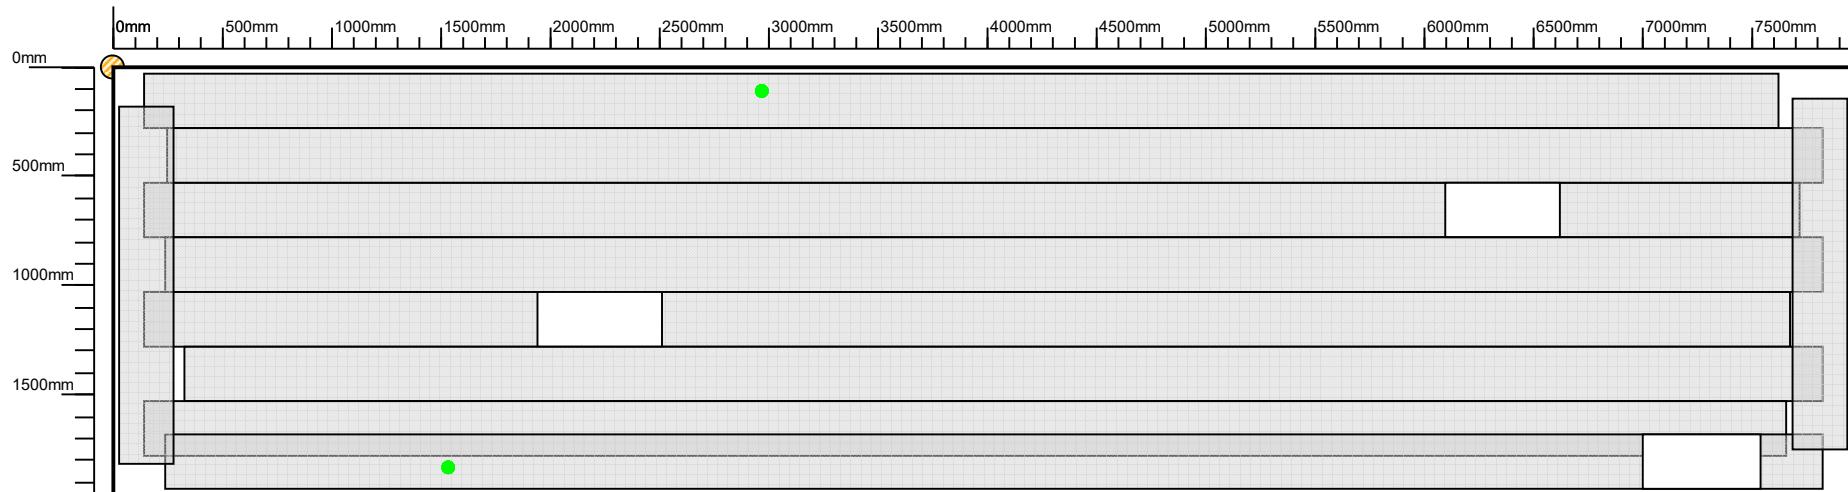
Row:	24	Plate:	2
Plate Length (mm):	7960	Plate Width (mm):	1960
Orientation:	Horizontal	Scan Method:	Raster
Max discontinuity:	41	Showing defects from:	TOP & BOTTOM
Lower Threshold:	40%	Upper Threshold:	100% (Import Threshold: 20%)
Defect enhancement setting:	7		
Tank:	No7	Operator:	JDA
Date:		Equipment Serial:	2861013
Location:	LAVRIO		
Company:	MISTRAS		
Client:	DEH

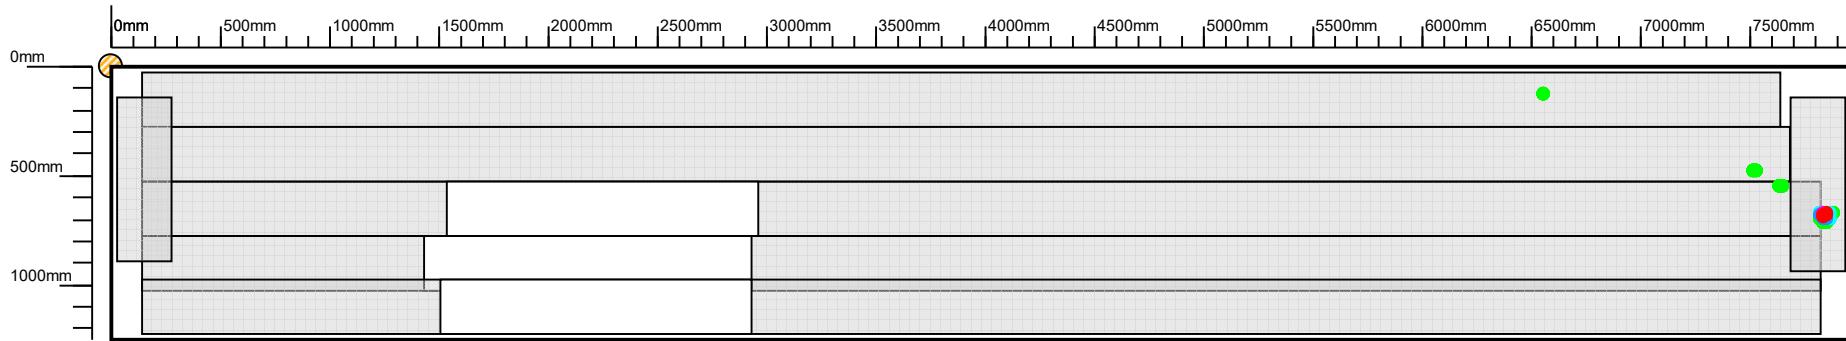
Row: 25
Plate Length (mm): 7960
Orientation: Horizontal
Max discontinuity: 100
Lower Threshold: 40%
Defect enhancement setting: 7

Plate: 2
Plate Width (mm): 1250
Scan Method: Parallel
Showing defects from: TOP & BOTTOM
Upper Threshold: 100% (Import Threshold: 20%)

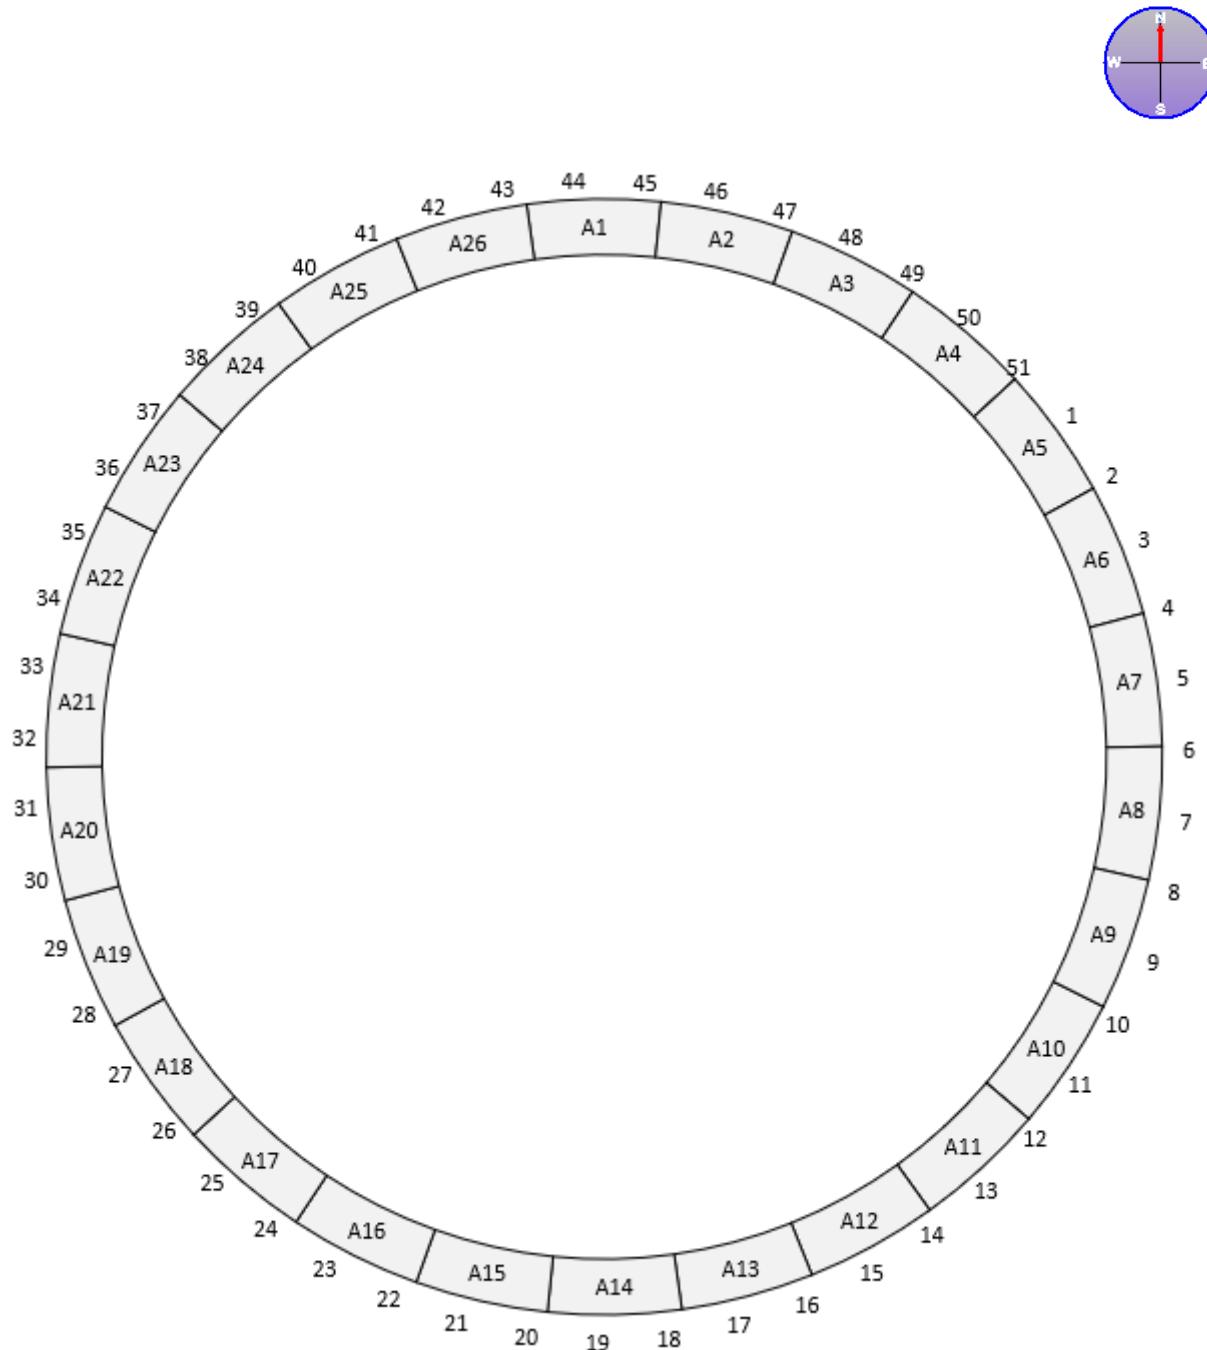
Figure 4 - The position numbers for the external UT thickness measurements are counted clockwise starting from the datum point 1, which start at the center of the north-east manway.

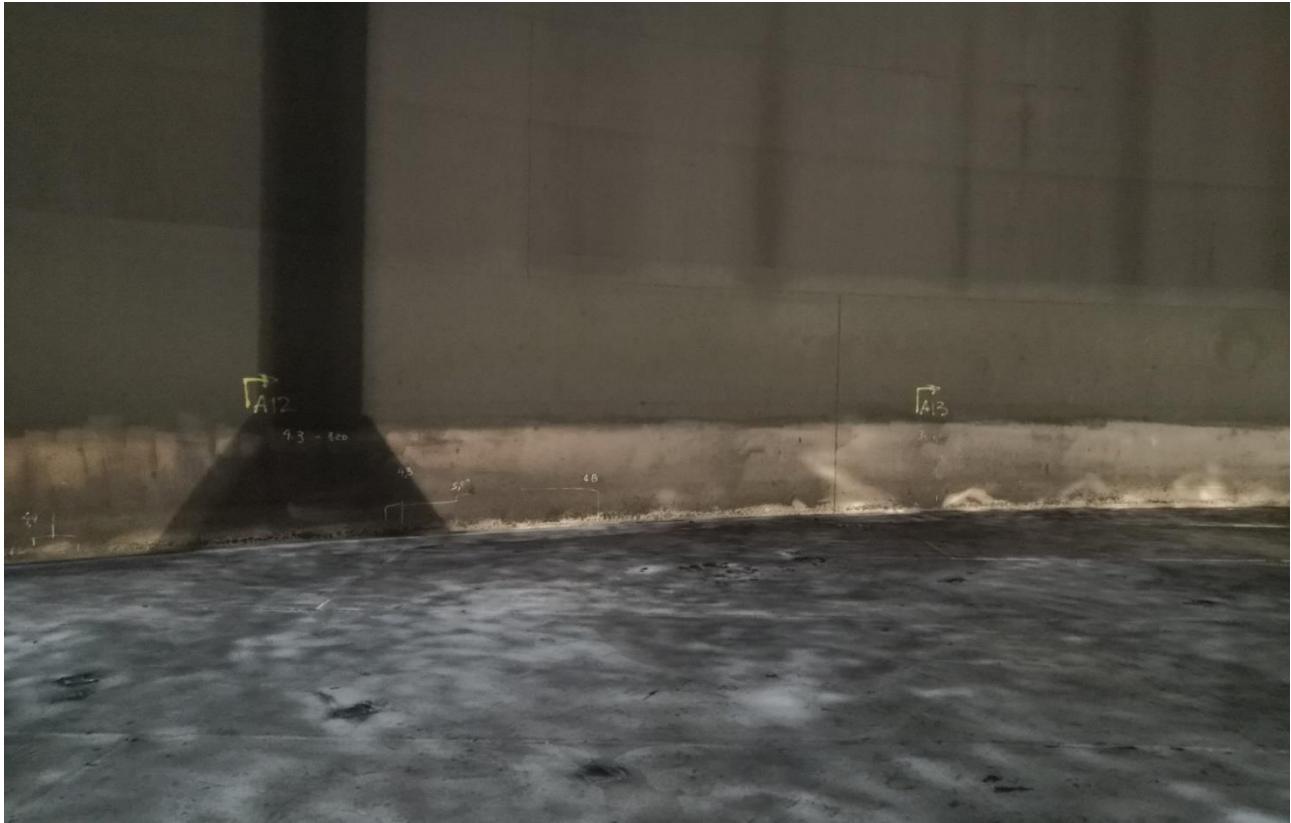
Figure 5 – Bottom side pitting on annular plates A12 and A13.

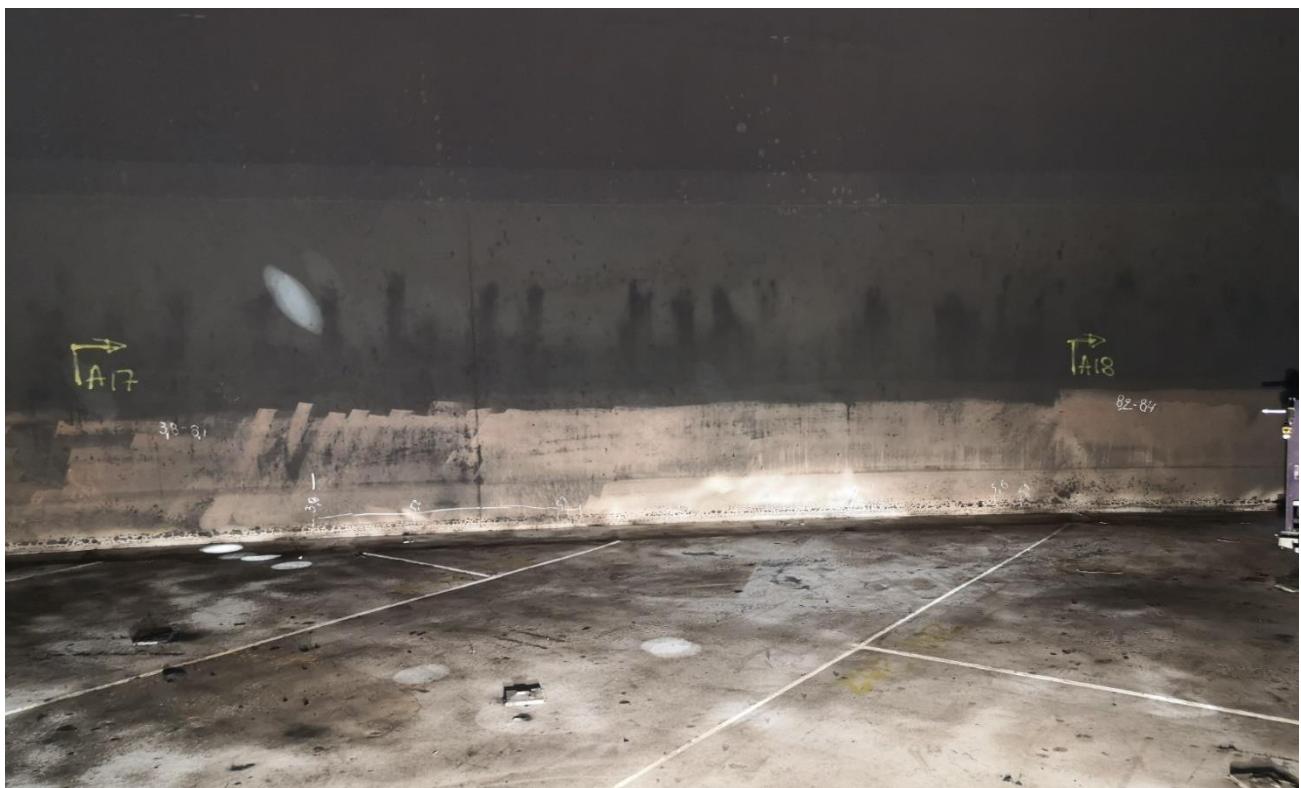
Figure 6 – Bottom side pitting on annular plate A17.

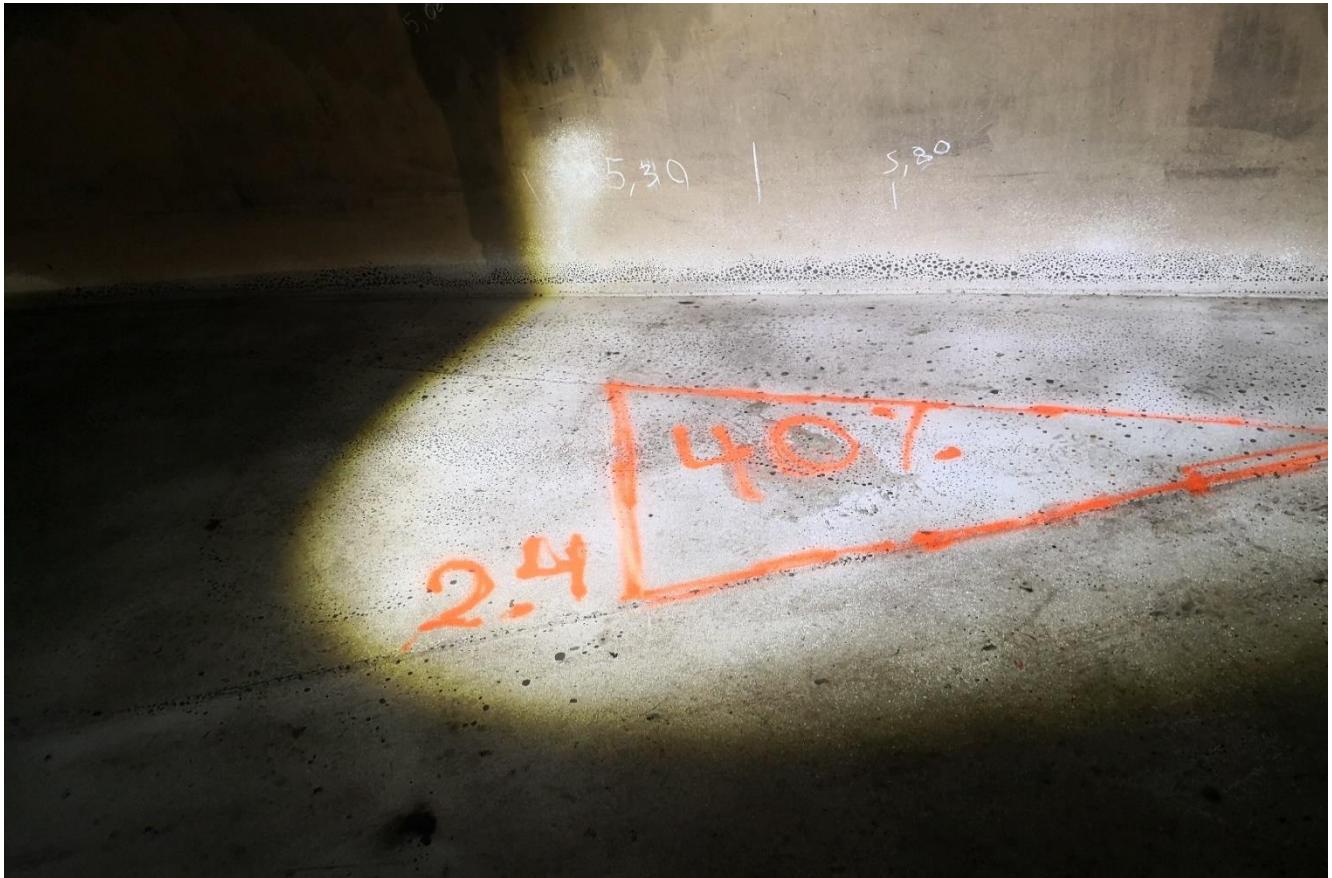
Figure 7 – Bottom side pitting on main floor plate 2.4

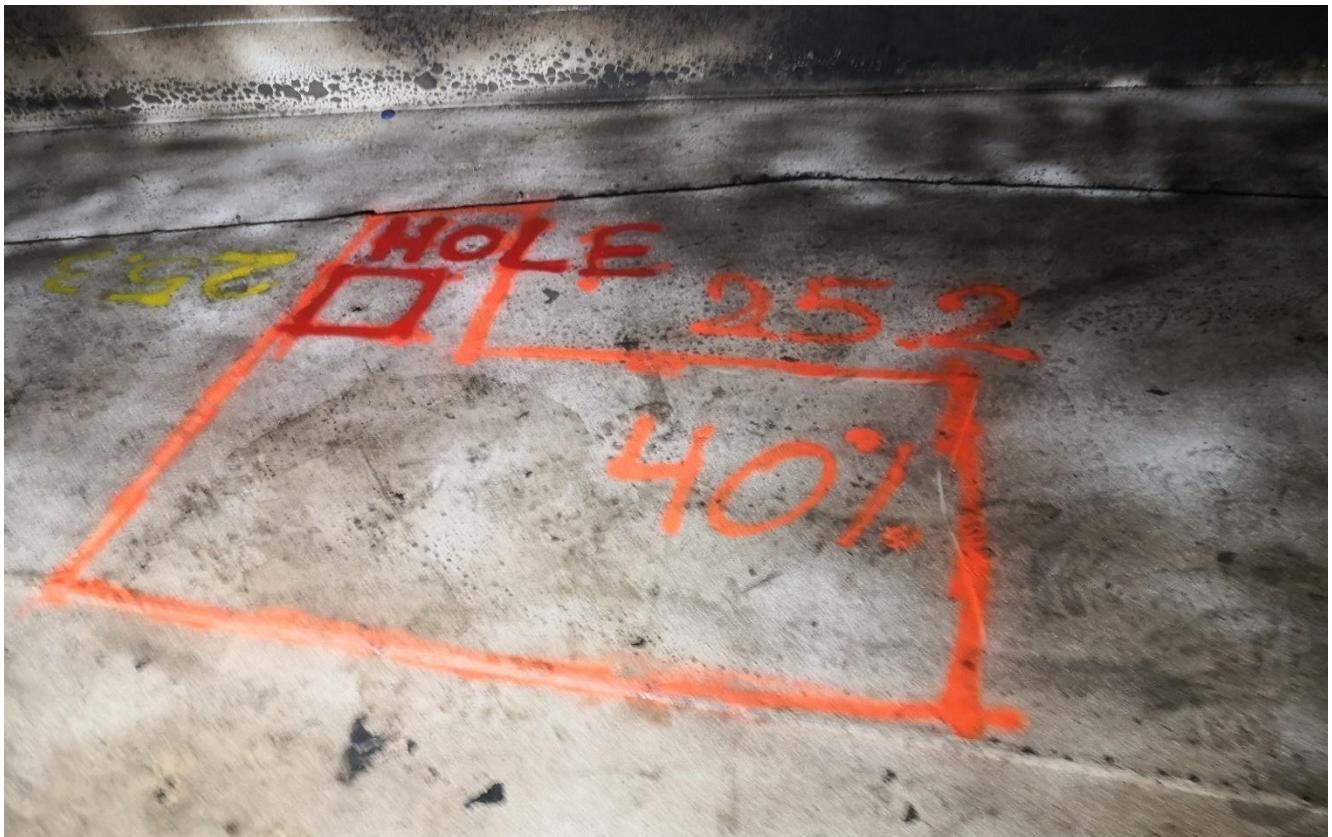
Figure 8 – Bottom side pitting and one hole on main floor plate 25.2

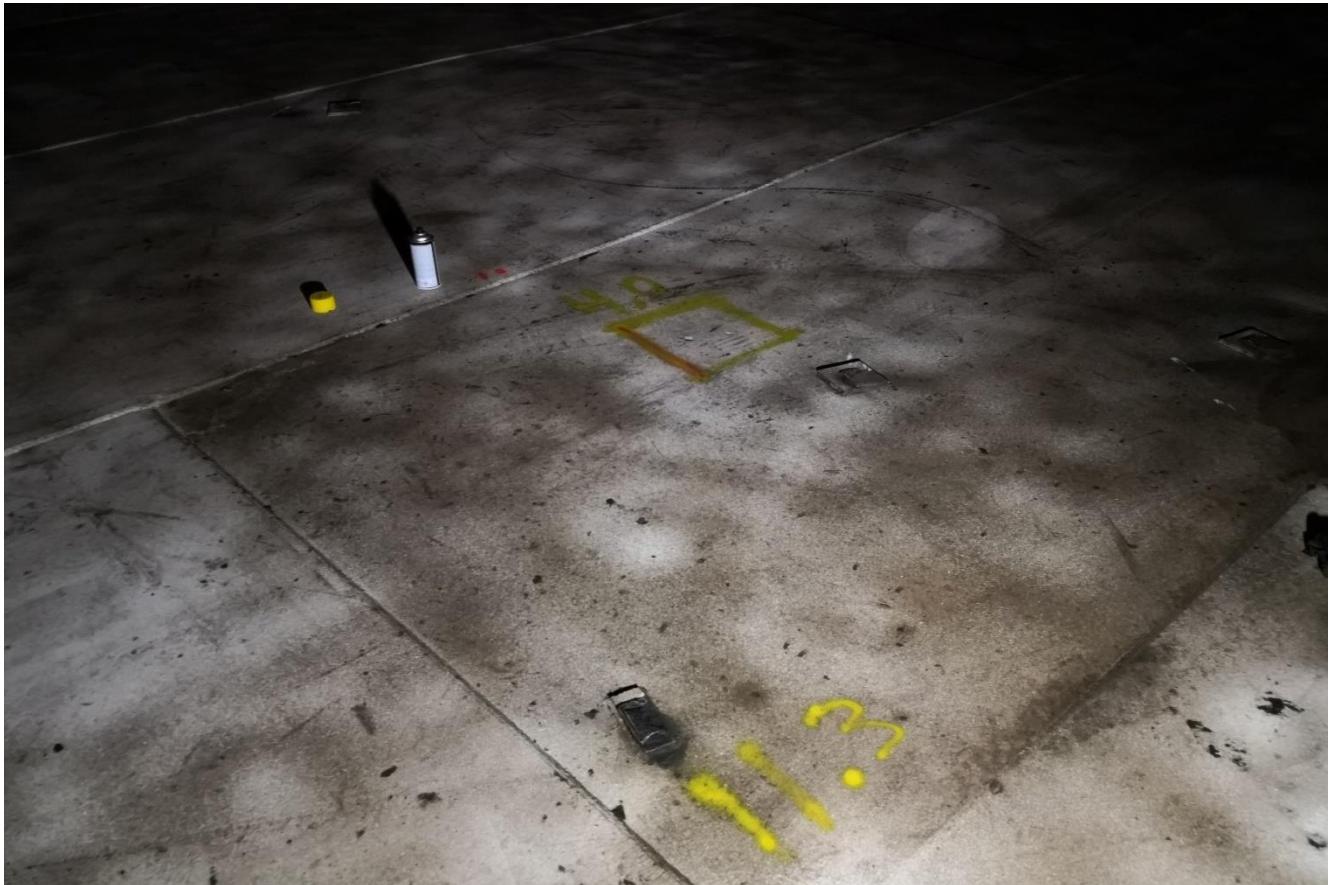
Figure 9 – Top side pit on main plate 11.3

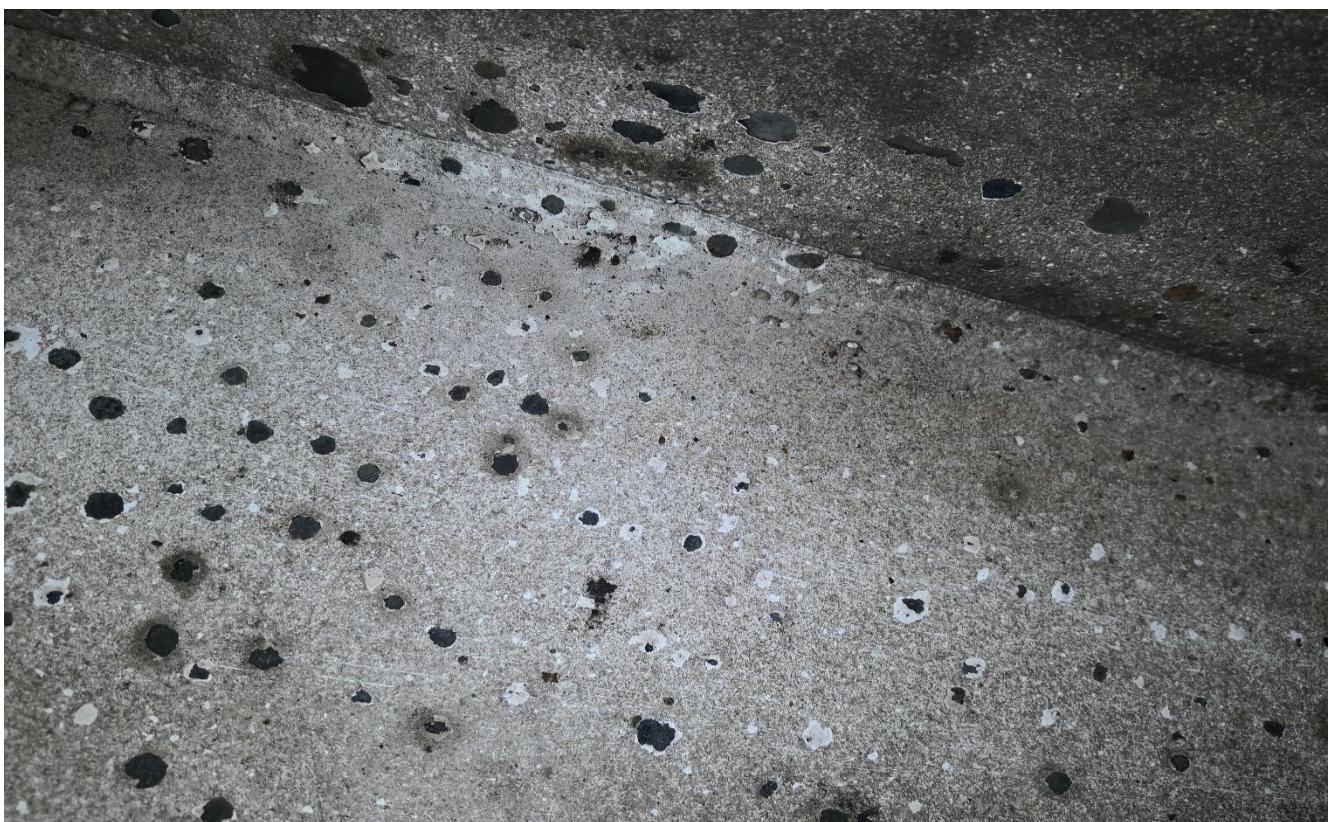
Thickness measurements were between 4.8mm and 8.6mm with the minimum located on A22 annular plate. Moreover, all over the critical zone areas with weld spatter were present which prevented examination of the full area with manual UT inspection.

Figure 10 – Representative picture of bad surface on critical zone due to spatters.

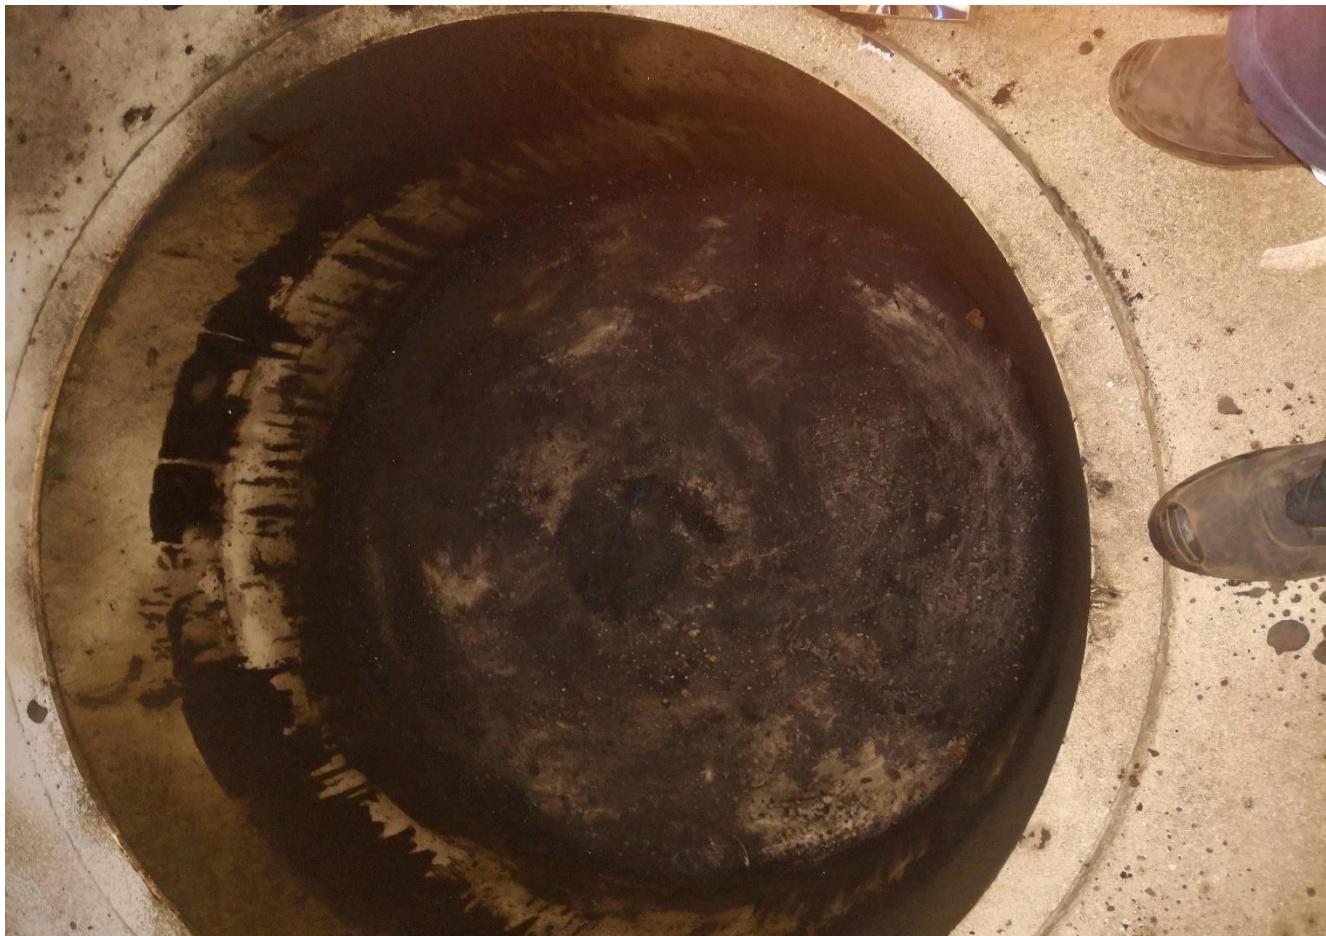
Neither of the sumps was inspected due to thick layer of remaining sandblast. Client was informed and cleaning was requested but no actions were made as replacement of sumps was scheduled.

Figure 11 – Top view of sump full of sandblast leftovers.
