Αντικείμενο: «Καθαίρεση του κύριου κτιρίου του ΑΗΣ ΛΙΠΤΟΛ, που περιλαμβάνει το λεβητοστάσιο, το μηχανοστάσιο, το κτίριο αφαλάτωσης και το Control Room, το Σύστημα Αποκομιδής τέφρας με την καμινάδα και τον Πύργο ψύξης»

ΣΥΜΠΛΗΡΩΜΑ Νο2

ΠΑΡΑΡΤΗΜΑ Ι

Πίνακας ΠΙ-1: Εξοπλισμός από τον οποίο πραγματοποιήθηκε δειγματοληψία πιθανών αμιαντούχων υλικών

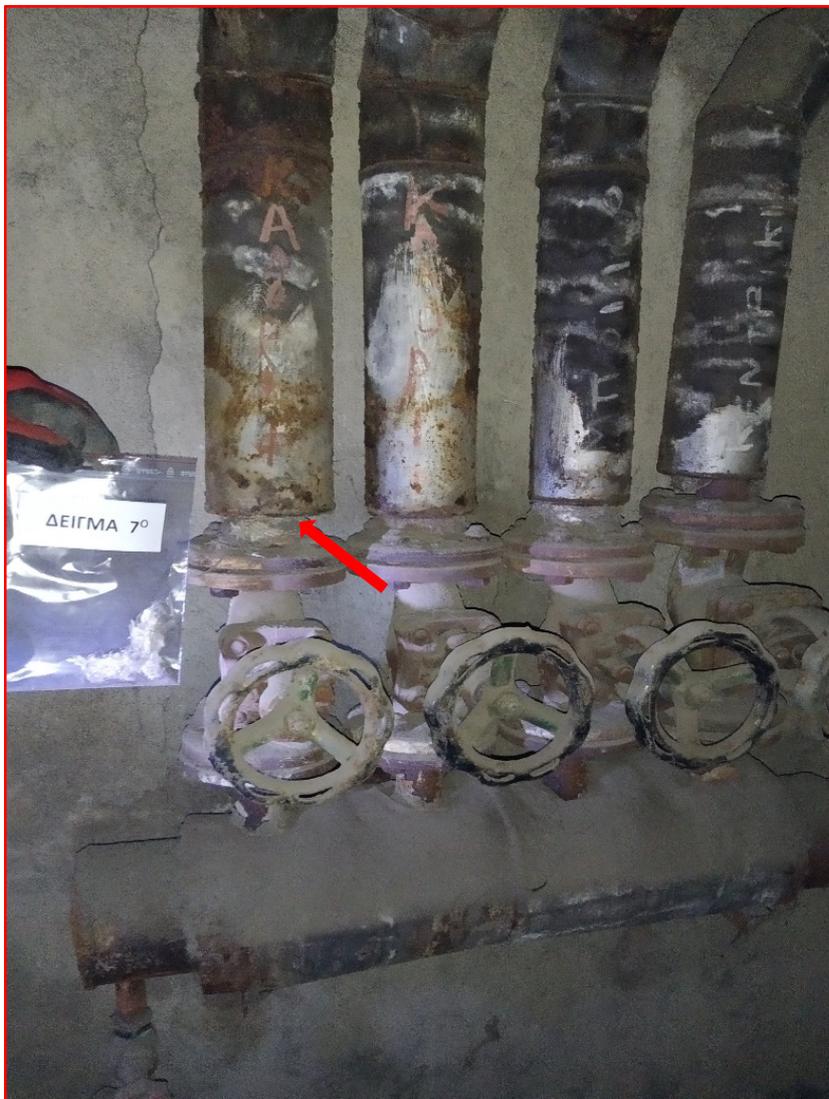
Ποσότητα:	4 σωληνώσεις που έχουν συνολικά 16μ μήκος
Παρατηρήσεις:	Παρατηρήθηκε χύδην μόνωση όμοια με αυτή του δείγματος διάσπαρτη στο πάτωμα του χώρου. Συστήνεται η διαχείριση της τέφρας του δωματίου ως αμιαντούχο απόβλητο.
Κατάσταση υλικού:	Καλή. Το μονωτικό υλικό έχει μορφή υφάσματος με αποτέλεσμα να είναι συνεκτικό.
Εκτίμηση Επικινδυνότητας:	Όταν το υλικό δεν υφίσταται μηχανική διαταραχή, ο κίνδυνος είναι χαμηλός. Σε αντίθετη περίπτωση ο κίνδυνος είναι υψηλός

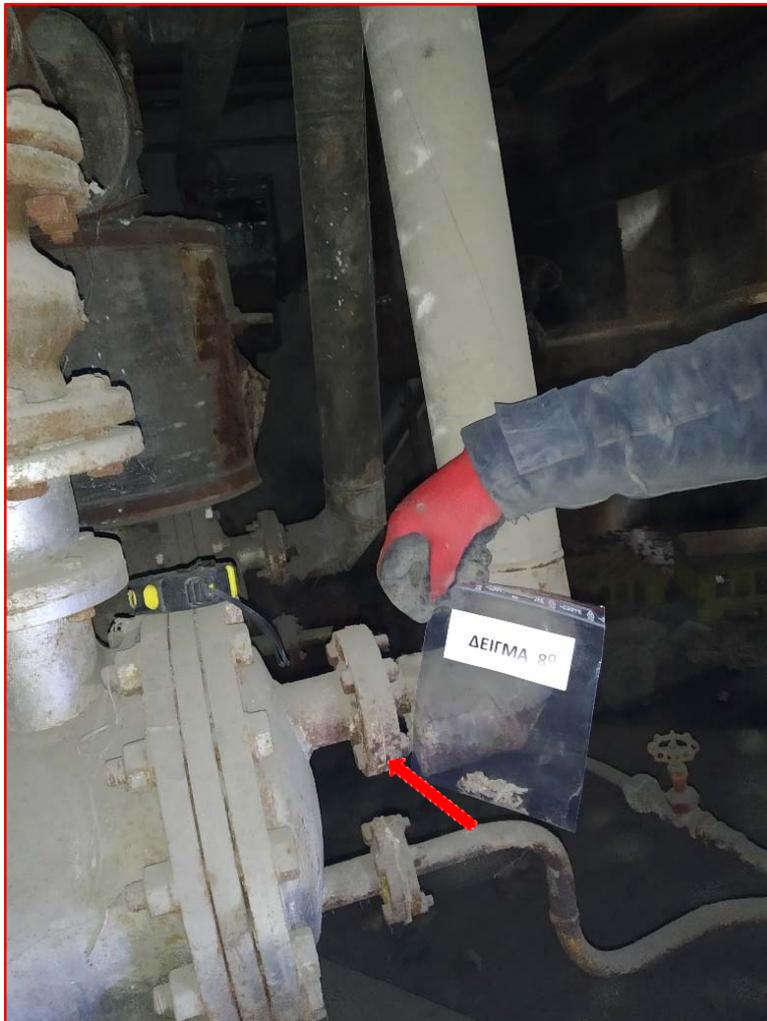
Ποσότητα:	30 τεμ
Παρατηρήσεις:	Σε όλο το χώρο του μικρού λεβητοστασίου υπάρχουν περίπου 30 συνδέσεις σωληνώσεων διαφόρων διαμέτρων (Φ150,Φ250,Φ400) που περιέχουν φλάντζες. Παρατηρήθηκε οπτικά ότι οι φλάντζες είναι όμοιες με αυτή του δείγματος Ν ^ο 8. Συστήνεται η διαχείριση όλων των φλαντζών του δωματίου ως αμιαντούχες.
Κατάσταση υλικού:	Καλή. Το στεγανωτικό υλικό είναι σε καλή κατάσταση και ο αμιάντος δεν είναι εκτεθειμένος.
Εκτίμηση Επικινδυνότητας:	Όταν το υλικό δεν υφίστανται μηχανική διαταραχή, ο κίνδυνος είναι χαμηλός. Σε αντίθετη περίπτωση ο κίνδυνος είναι υψηλός.

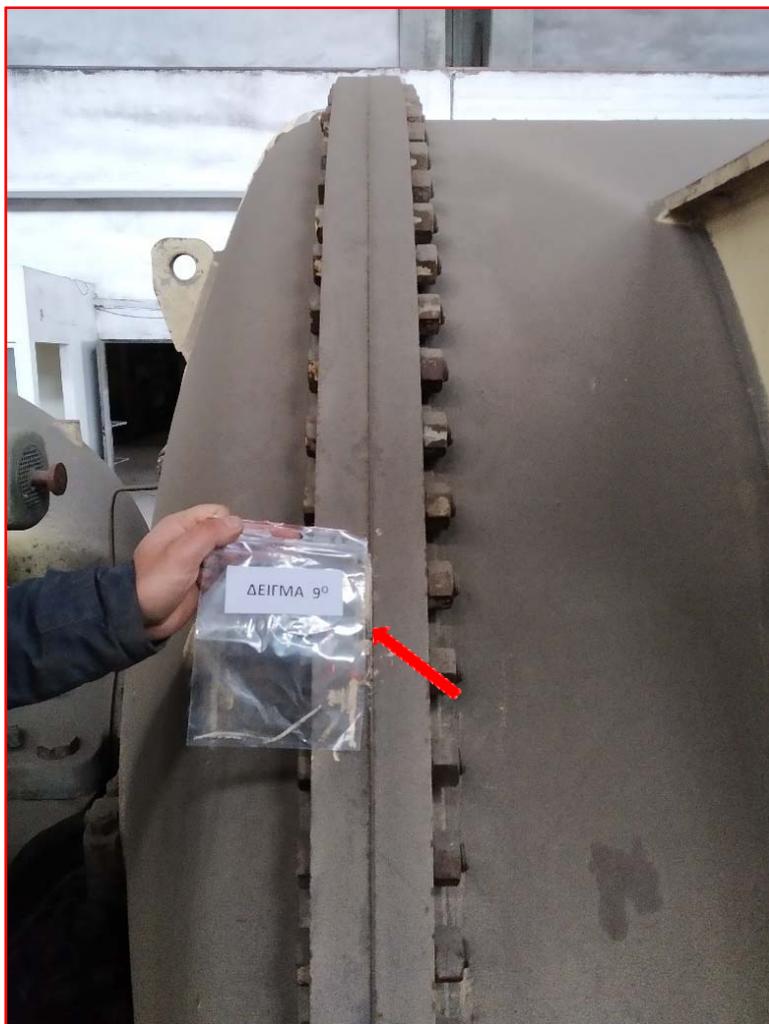
Ποσότητα:	2 τεμ
Παρατηρήσεις:	Η δειγματοληψία των στεγανωτικών υλικών πραγματοποιήθηκε στην στροβιλογεννήτρια εξωτερικά, ενδέχεται να υπάρχουν στεγανωτικά υλικά στο εσωτερικό του μηχανήματος που πιθανόν να είναι αμιαντούχα.
Κατάσταση υλικού:	Καλή. Το στεγανωτικό υλικό είναι σε καλή κατάσταση και ο αμίαντος δεν είναι εκτεθειμένος.
Εκτίμηση Επικινδυνότητας:	Όταν το υλικό δεν υφίστανται μηχανική διαταραχή, ο κίνδυνος είναι χαμηλός. Σε αντίθετη περίπτωση ο κίνδυνος είναι υψηλός

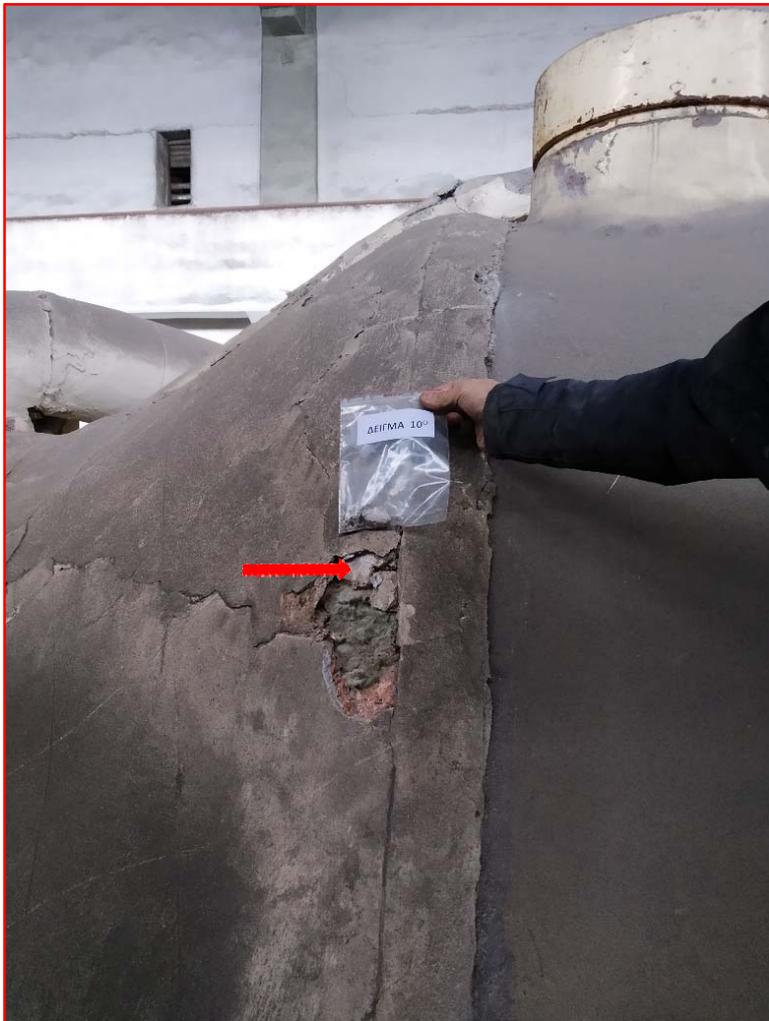
Ποσότητα:	3 m ³
Παρατηρήσεις:	Στο περίβλημα του κυρίως σώματος της στροβιλογεννήτριας εντοπίστηκαν τρία διαφορετικά είδη μόνωσης (τρεις χρωματισμοί). Τα δύο περιέχουν ίνες αμιάντου (δείγμα N° 10 – 11) και το τρίτο (δείγμα N° 12) είναι μόνωση από ορυκτές ίνες. Το γεγονός ότι αυτό το μη αμιαντούχο υλικό είναι σε επαφή με τα άλλα δύο υλικά που είναι αμιαντούχα δεν καθιστά εφικτό τον διαχωρισμό του με ασφάλεια κατά συνέπεια κρίνεται σκόπιμο να γίνει διαχείριση του συνόλου της μόνωσης ως αμιαντούχο απόβλητο.
Κατάσταση υλικού:	Καλή. Η μόνωση έχει συνεκτική και σκληρή υφή.
Εκτίμηση Επικινδυνότητας:	Όταν το υλικό δεν υφίστανται μηχανική διαταραχή, ο κίνδυνος είναι χαμηλός. Σε αντίθετη περίπτωση ο κίνδυνος είναι υψηλός

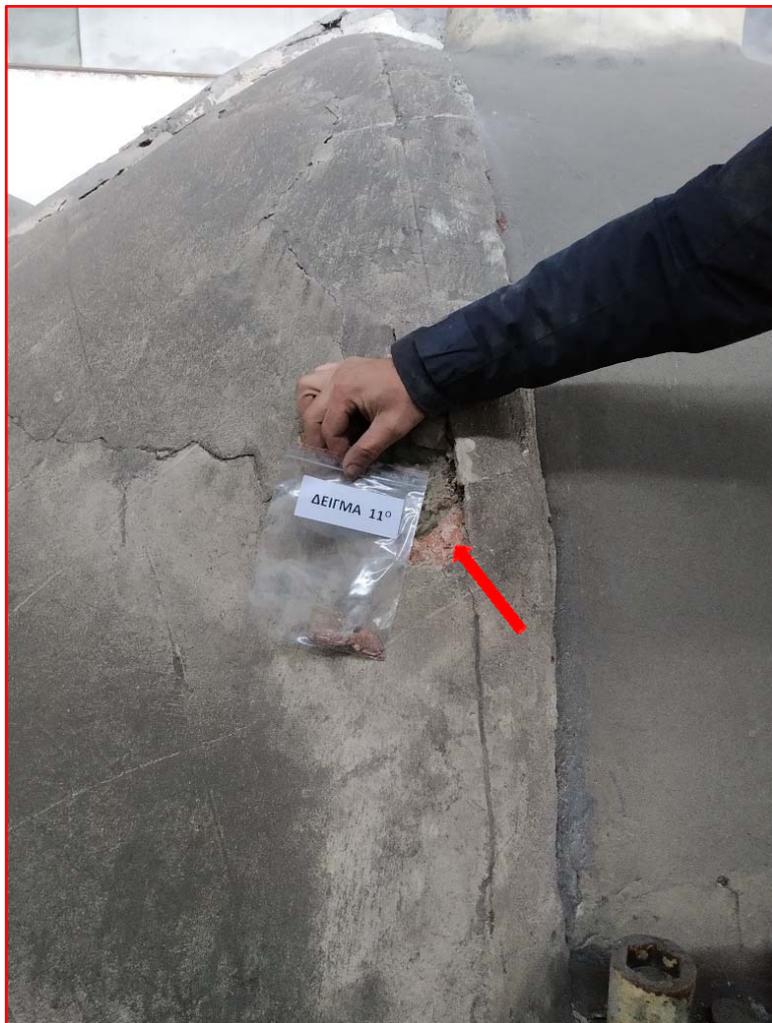
Ποσότητα:	3 m ³
Παρατηρήσεις:	Στο περίβλημα του κυρίως σώματος της στροβιλογεννήτριας εντοπίστηκαν τρία διαφορετικά είδη μόνωσης (τρεις χρωματισμοί). Τα δύο περιέχουν ίνες αμιάντου (δείγμα N ^ο 10 – 11) και το τρίτο (δείγμα N ^ο 12) είναι μόνωση από ορυκτές ίνες. Το γεγονός ότι αυτό το μη αμιαντούχο υλικό είναι σε επαφή με τα άλλα δύο υλικά που είναι αμιαντούχα δεν καθιστά εφικτό τον διαχωρισμό του με ασφάλεια κατά συνέπεια κρίνεται σκόπιμο να γίνει διαχείριση του συνόλου της μόνωσης ως αμιαντούχο απόβλητο.
Κατάσταση υλικού:	Καλή. Η μόνωση έχει συνεκτική και σκληρή υφή.
Εκτίμηση Επικινδυνότητας:	Όταν το υλικό δεν υφίστανται μηχανική διαταραχή, ο κίνδυνος είναι χαμηλός. Σε αντίθετη περίπτωση ο κίνδυνος είναι υψηλός

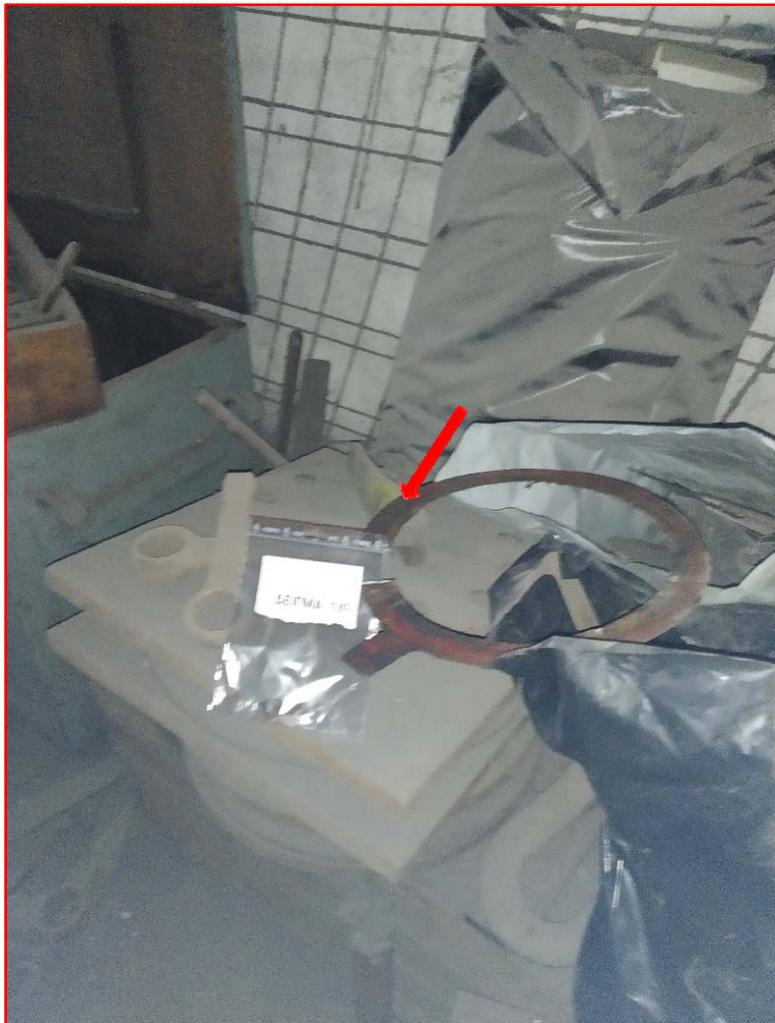
Ποσότητα:	Μη μετρήσιμη
Παρατηρήσεις:	Στο χώρο εντοπίστηκαν χύδην στεγανωτικά υλικά (φλάντζες), που ενδέχεται να περιέχουν ίνες αμιάντου. Η τέφρα που έχει επικαλύψει τα υλικά δημιούργησε προβλήματα στον διαχωρισμό με βάση το χρώμα. Δείγμα από τον ίδιο χώρο είναι και το Ν° 72. Συστήνεται η διαχείριση όλων των στεγανωτικών υλικών του χώρου ως αμιαντούχα.
Κατάσταση υλικού:	Καλή. Το στεγανωτικό υλικό είναι σε καλή κατάσταση και ο αμιάντος δεν είναι εκτεθειμένος.
Εκτίμηση Επικινδυνότητας:	Όταν το υλικό δεν υφίστανται μηχανική διαταραχή, ο κίνδυνος είναι χαμηλός. Σε αντίθετη περίπτωση ο κίνδυνος είναι υψηλός

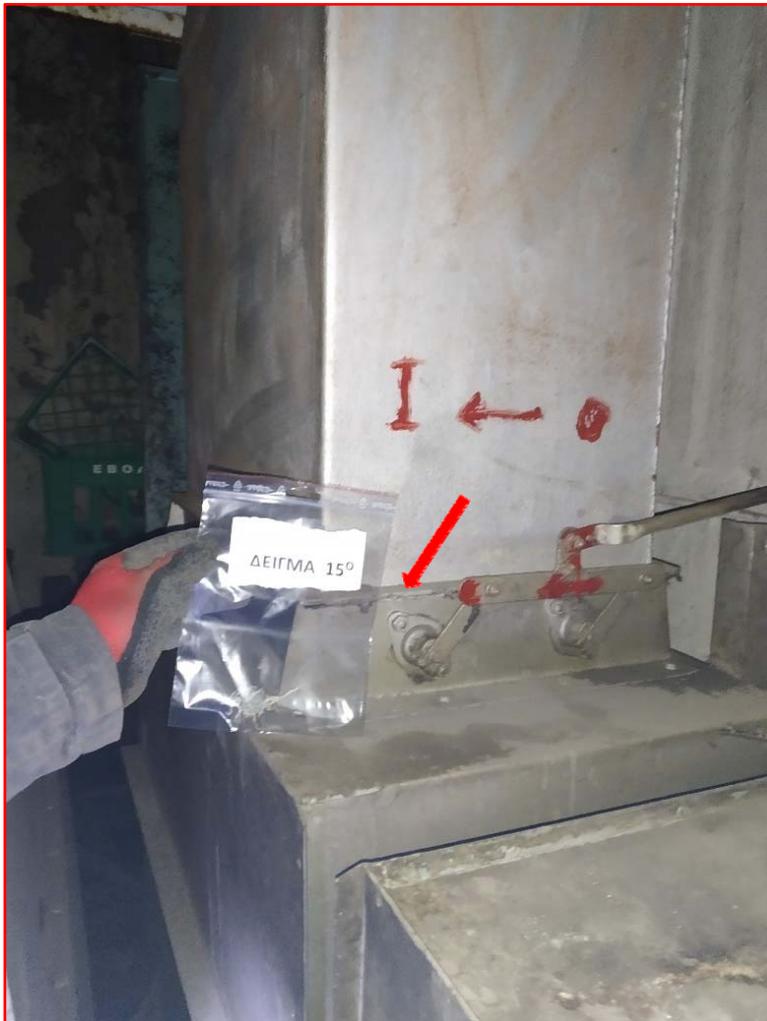
Ποσότητα:	20μ μήκος
Παρατηρήσεις:	Ο χώρος βρίσκεται πίσω από τον ηλεκτρικό πίνακα ελέγχου εναλλακτήρα. (δωμάτιο κλιματισμού)
Κατάσταση υλικού:	Καλή. Το στεγανωτικό υλικό είναι σε καλή κατάσταση και ο αμίαντος δεν είναι εκτεθειμένος.
Εκτίμηση Επικινδυνότητας:	Όταν το υλικό δεν υφίστανται μηχανική διαταραχή, ο κίνδυνος είναι χαμηλός. Σε αντίθετη περίπτωση ο κίνδυνος είναι υψηλός

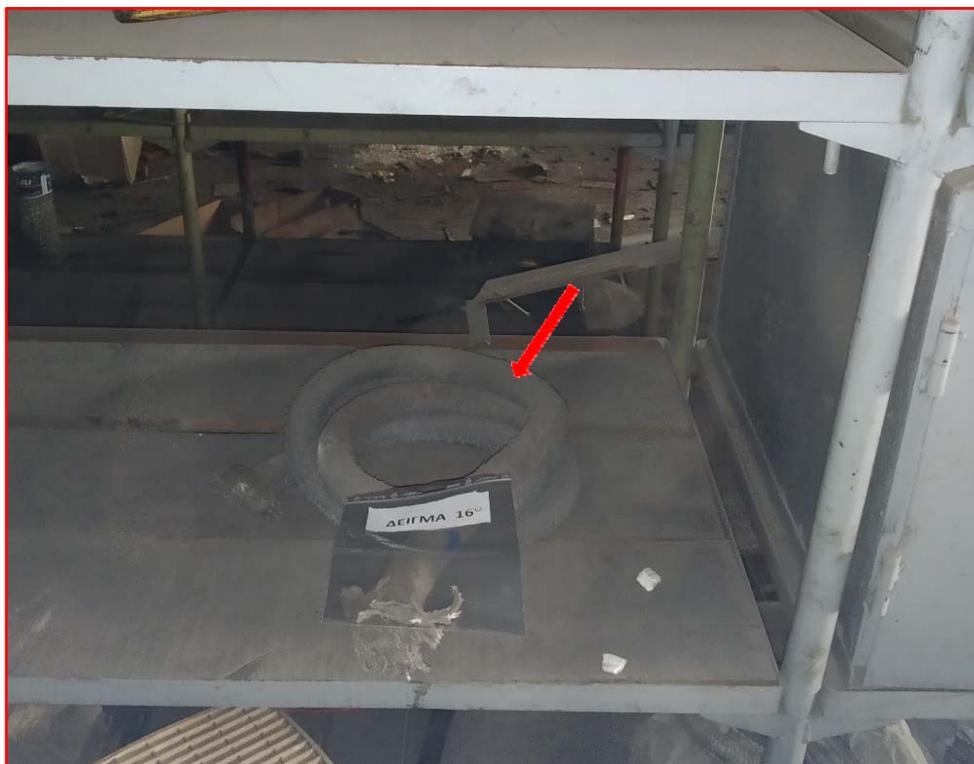
Ποσότητα:	Μη μετρήσιμη
Παρατηρήσεις:	Το συγκεκριμένο στεγανωτικό υλικό βρέθηκε χύδην σε πολλά σημεία του χώρου. Ο χώρος είναι αποθήκη υλικών και μέσα εντοπίστηκαν χύδην αμιαντούχα υλικά μαζί με μη επικίνδυνα υλικά και αστικά απόβλητα επικαλυμμένα με τέφρα. Συστήνεται να προηγηθεί η συλλογή και συσκευασία των αμιαντούχων υλικών και μετά ο καθαρισμός του χώρου από τα υπόλοιπα υλικά.
Κατάσταση υλικού:	Καλή. Το στεγανωτικό υλικό είναι σε καλή κατάσταση και ο αμίαντος δεν είναι εκτεθειμένος.
Εκτίμηση Επικινδυνότητας:	Όταν το υλικό δεν υφίστανται μηχανική διαταραχή, ο κίνδυνος είναι χαμηλός. Σε αντίθετη περίπτωση ο κίνδυνος είναι υψηλός

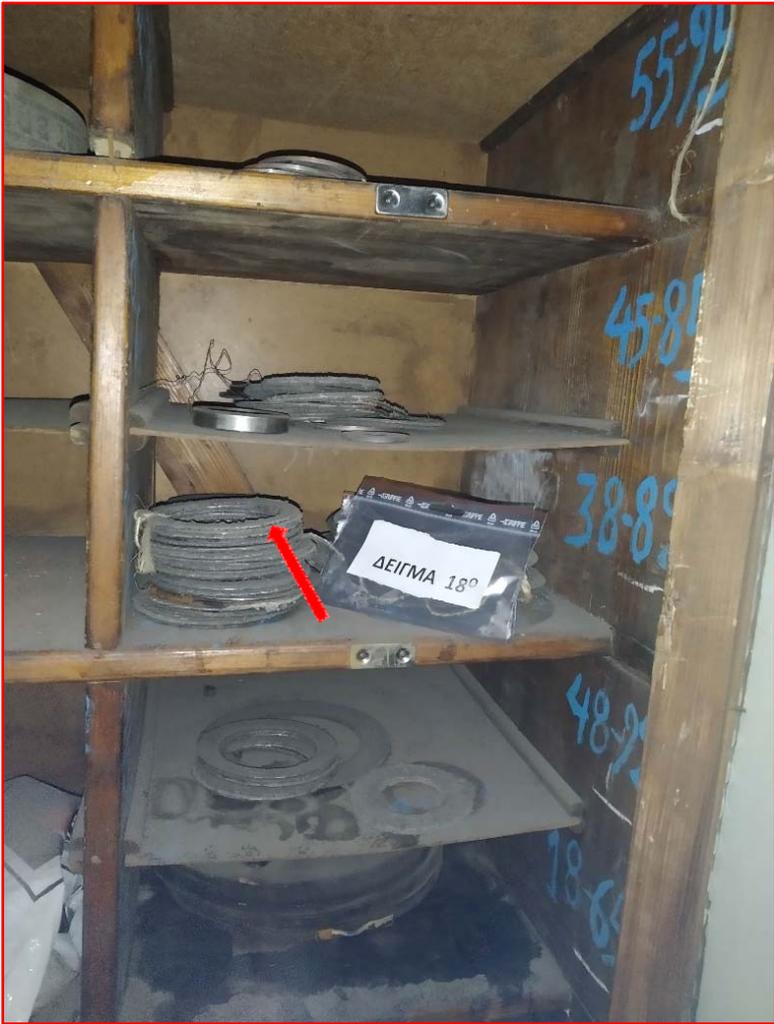
Ποσότητα:	Μη μετρήσιμη
Παρατηρήσεις:	Η φλάντζα είναι μαύρου χρώματος και έχει ενσωματωμένο κυκλικό μεταλλικό στοιχείο (πιθανόν λαμαρίνα). Εντοπίστηκε σε ράφι ντουλάπας αποθήκευσης υλικών. Ο χώρος είναι αποθήκη υλικών και μέσα εντοπίστηκαν χύδην αμιαντούχα υλικά μαζί με μη επικίνδυνα υλικά και αστικά απόβλητα επικαλυμμένα με τέφρα. Συστήνεται να προηγηθεί η συλλογή και συσκευασία των αμιαντούχων υλικών και μετά ο καθαρισμός του χώρου από τα υπόλοιπα υλικά.
Κατάσταση υλικού:	Καλή. Το στεγανωτικό υλικό είναι σε καλή κατάσταση και ο αμίαντος δεν είναι εκτεθειμένος.
Εκτίμηση Επικινδυνότητας:	Όταν το υλικό δεν υφίστανται μηχανική διαταραχή, ο κίνδυνος είναι χαμηλός. Σε αντίθετη περίπτωση ο κίνδυνος είναι υψηλός

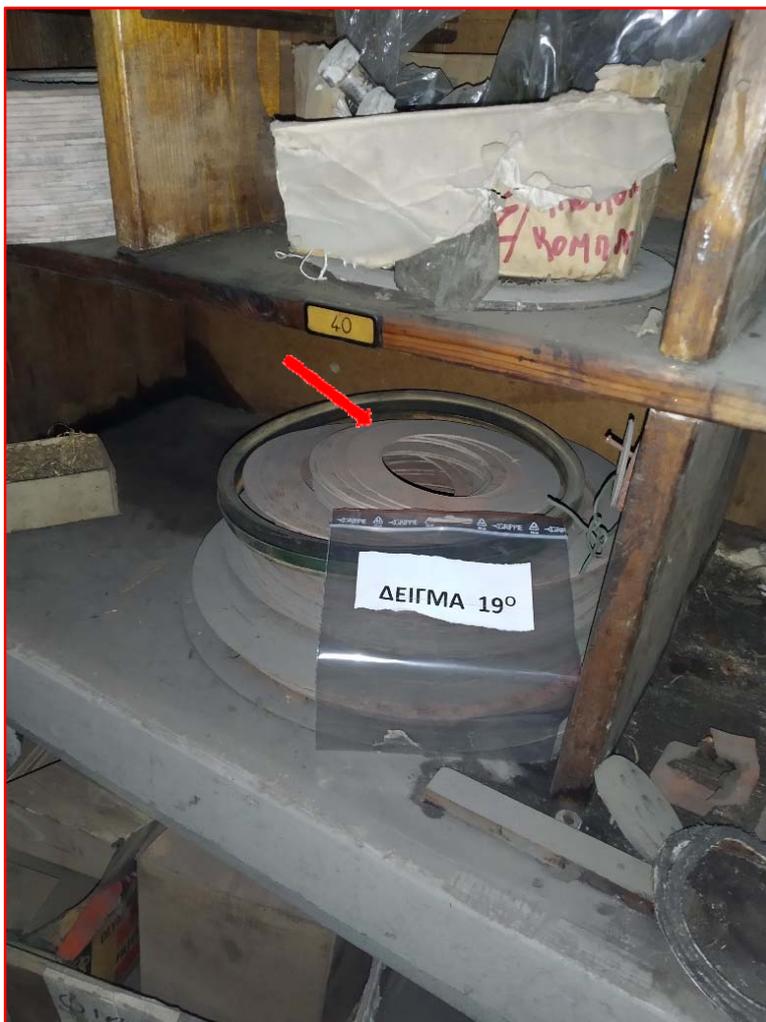
Ποσότητα:	Μη μετρήσιμη
Παρατηρήσεις:	Η φλάντζα είναι καφέ χρώματος. Εντοπίστηκε σε ράφι ντουλάπας αποθήκευσης υλικών. Ο χώρος είναι αποθήκη υλικών και μέσα εντοπίστηκαν χύδην αμιαντούχα υλικά μαζί με μη επικίνδυνα υλικά και αστικά απόβλητα επικαλυμμένα με τέφρα. Συστήνεται να προηγηθεί η συλλογή και συσκευασία των αμιαντούχων υλικών και μετά ο καθαρισμός του χώρου από τα υπόλοιπα υλικά.
Κατάσταση υλικού:	Καλή. Το στεγανωτικό υλικό είναι σε καλή κατάσταση και ο αμίαντος δεν είναι εκτεθειμένος.
Εκτίμηση Επικινδυνότητας:	Όταν το υλικό δεν υφίστανται μηχανική διαταραχή, ο κίνδυνος είναι χαμηλός. Σε αντίθετη περίπτωση ο κίνδυνος είναι υψηλός

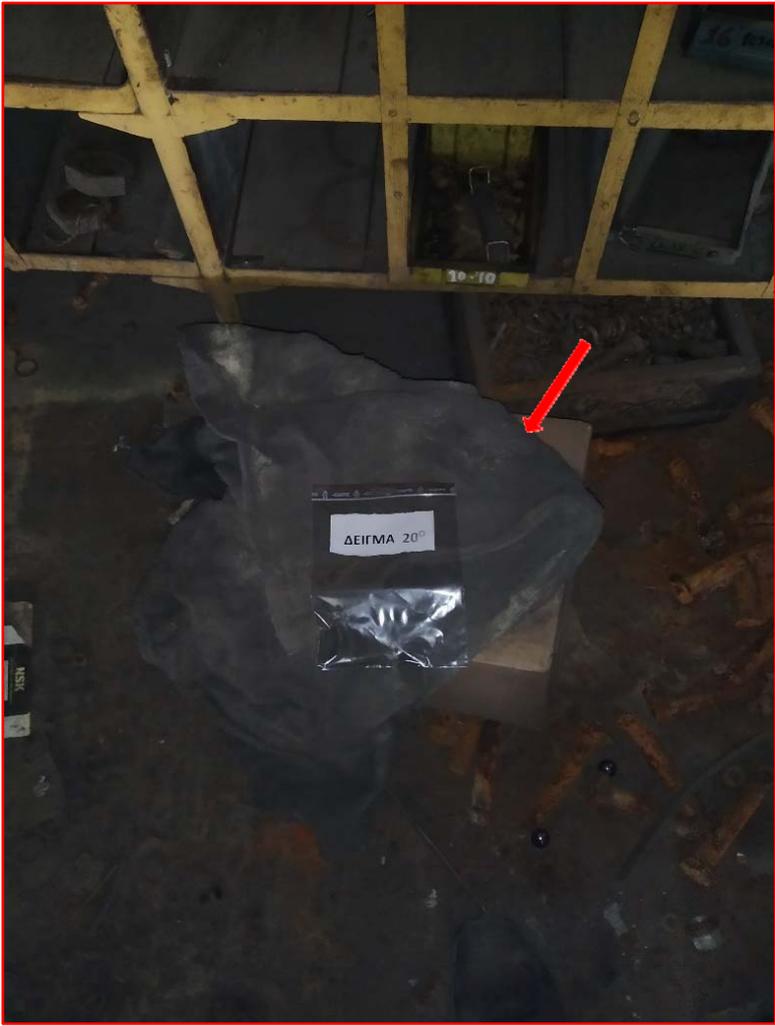
Ποσότητα:	Μη μετρήσιμη
Παρατηρήσεις:	Η μόνωση είναι τύπου κουβέρτας, καφέ χρώματος. Ο χώρος είναι αποθήκη υλικών και μέσα εντοπίστηκαν πολλά υλικά χύδην που είναι αμιαντούχα μαζί με μη επικίνδυνα υλικά και αστικά απόβλητα επικαλυμμένα με τέφρα. Συστήνεται η συλλογή και συσκευασία των αμιαντούχων υλικών και μετά ο καθαρισμός του χώρου από τα υπόλοιπα υλικά.
Κατάσταση υλικού:	Καλή.
Εκτίμηση Επικινδυνότητας:	Όταν το υλικό δεν υφίστανται μηχανική διαταραχή, ο κίνδυνος είναι χαμηλός. Σε αντίθετη περίπτωση ο κίνδυνος είναι υψηλός.

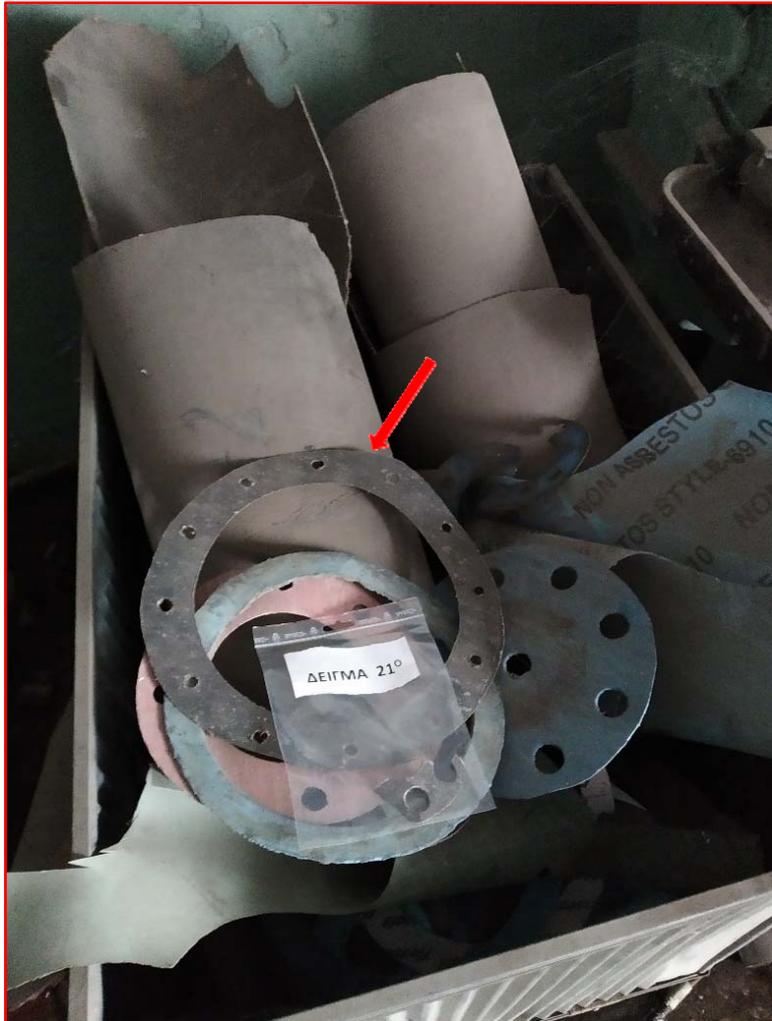
Ποσότητα:	Μη μετρήσιμη
Παρατηρήσεις:	Μέσα στο χώρο εντοπίστηκε μεταλλικός κάδος γεμάτος με στεγανωτικά υλικά διαφόρων διαστάσεων και χρωματισμών. Βρέθηκε στεγανωτικό υλικό χρώματος μπλε που αναγράφει την λέξη asbestos – αμιάντος. Ο δειγματοσμός έγινε σε δύο άλλα στεγανωτικά υλικά διαφορετικής υφής και χρώματος. Συστήνεται η διαχείριση όλων των υλικών που περιέχονται στον κάδο ως αμιαντούχα απόβλητα. Δείγμα από τον ίδιο χώρο είναι και το Ν° 71.
Κατάσταση υλικού:	Καλή. Το στεγανωτικό υλικό είναι σε καλή κατάσταση και ο αμιάντος δεν είναι εκτεθειμένος.
Εκτίμηση Επικινδυνότητας:	Όταν το υλικό δεν υφίστανται μηχανική διαταραχή, ο κίνδυνος είναι χαμηλός. Σε αντίθετη περίπτωση ο κίνδυνος είναι υψηλός.

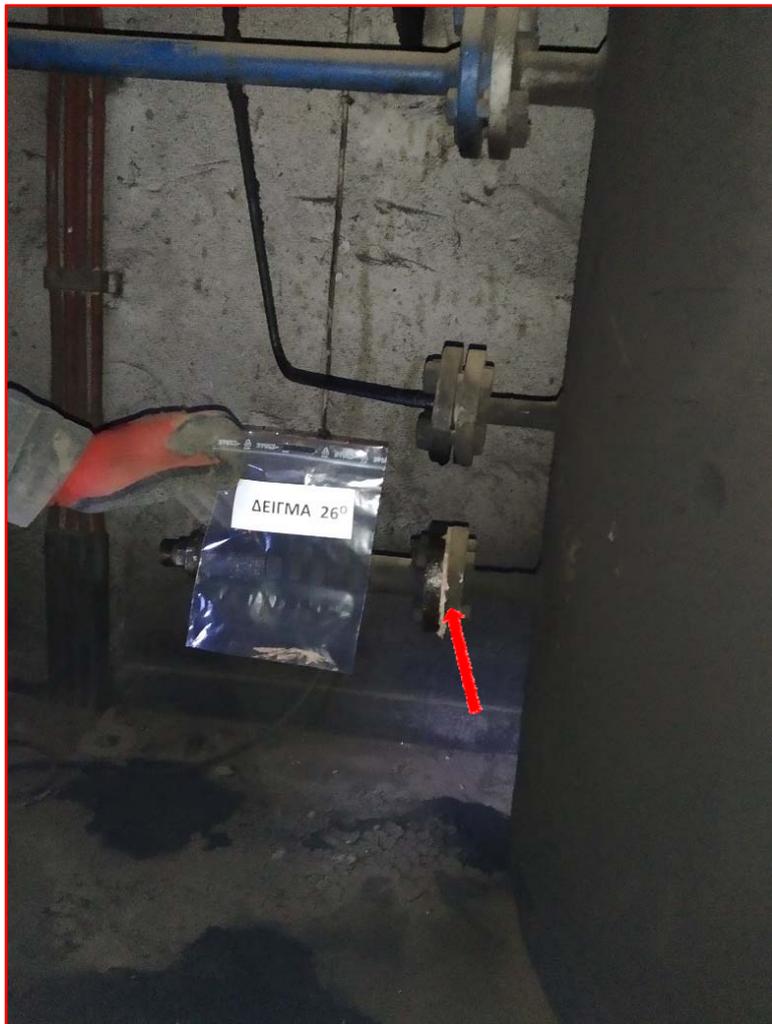
Αριθμός Δείγματος:	26
Περιοχή δειγματοληψίας:	Ισόγειο Μηχανοστασίου
Κτίριο – Επίπεδο:	2b / +0,00μ – Πόρτα Ν° 18
Περιγραφή δείγματος:	Στεγανωτικό υλικό (φλάντζα) μαύρου χρώματος σύνδεσης σωληνογραμμής αντλητικού συστήματος πυρόσβεσης μεταξύ των αεριοφυλακίων διαμέτρου Φ10.

Ποσότητα:	30 τεμ
Παρατηρήσεις:	---
Κατάσταση υλικού:	Καλή. Το στεγανωτικό υλικό είναι σε καλή κατάσταση και ο αμίαντος δεν είναι εκτεθειμένος.
Εκτίμηση Επικινδυνότητας:	Όταν το υλικό δεν υφίστανται μηχανική διαταραχή, ο κίνδυνος είναι χαμηλός. Σε αντίθετη περίπτωση ο κίνδυνος είναι υψηλός.

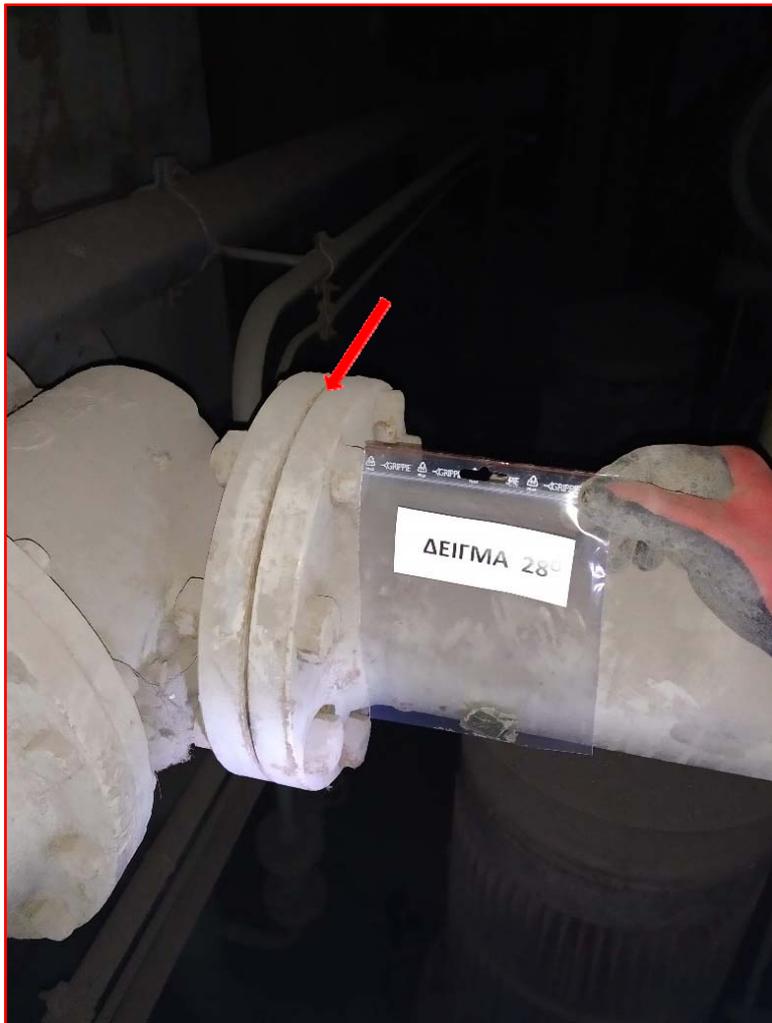
Ποσότητα:	30 τεμ
Παρατηρήσεις:	Οι φλάντζες βρίσκονται σε διάφορα σημεία στην σωληνογραμμή γύρω από το δοχείο ψύξης της στροβιλογεννήτριας II (Brown Boveri) και είναι διαφορών διαμέτρων.
Κατάσταση υλικού:	Καλή. Το στεγανωτικό υλικό είναι σε καλή κατάσταση και ο αμίαντος δεν είναι εκτεθειμένος.
Εκτίμηση Επικινδυνότητας:	Όταν το υλικό δεν υφίστανται μηχανική διαταραχή, ο κίνδυνος είναι χαμηλός. Σε αντίθετη περίπτωση ο κίνδυνος είναι υψηλός.

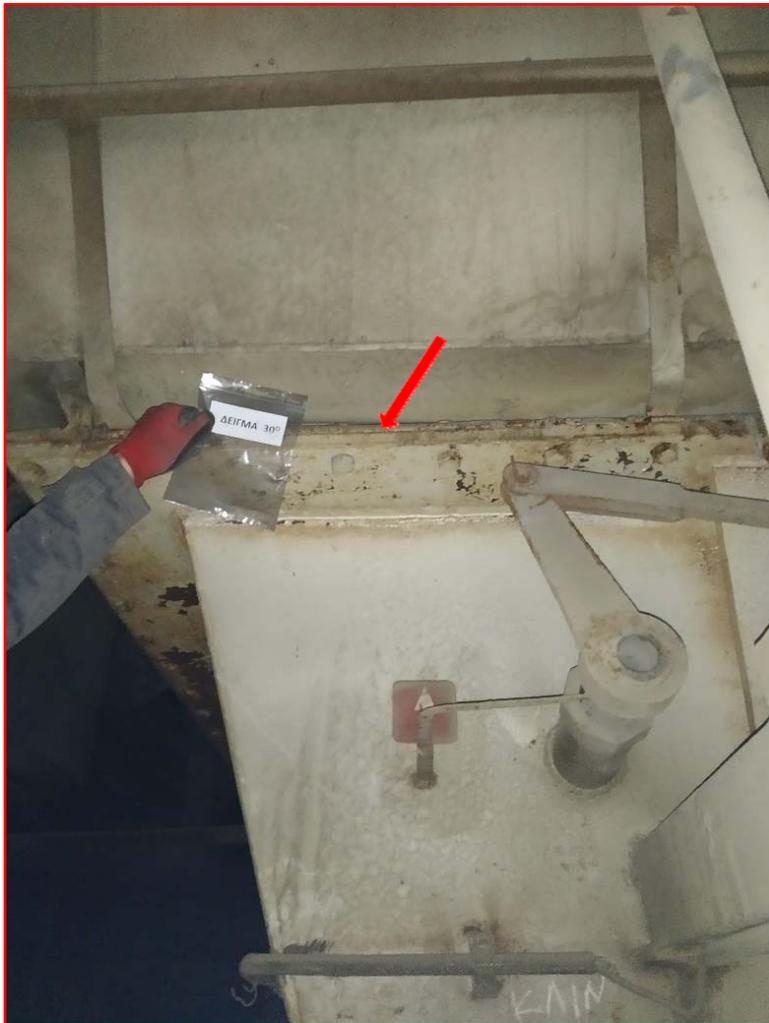
Ποσότητα:	2 τεμ
Παρατηρήσεις:	Το κορδόνι στεγανοποιεί την μεταλλική σύνδεση της χοάνης. Υπάρχουν 2 τεμ ανά μονάδα.
Κατάσταση υλικού:	Καλή. Το στεγανωτικό υλικό είναι σε καλή κατάσταση και ο αμίαντος δεν είναι εκτεθειμένος.
Εκτίμηση Επικινδυνότητας:	Όταν το υλικό δεν υφίστανται μηχανική διαταραχή, ο κίνδυνος είναι χαμηλός. Σε αντίθετη περίπτωση ο κίνδυνος είναι υψηλός.

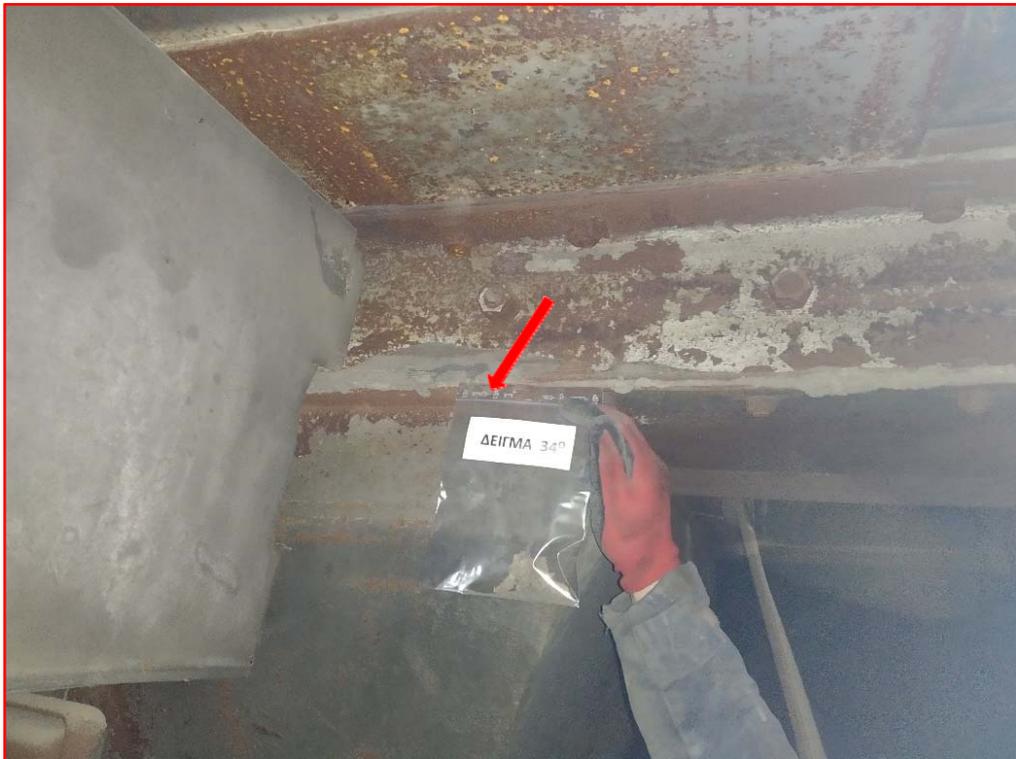
Ποσότητα:	6 τεμ
Παρατηρήσεις:	Ίδιο στεγανωτικό υλικό εντοπίστηκε να έχουν στον ίδιο εξοπλισμό: 2 τεμ κυκλικού αγωγού, 8 τεμ θυρίδες επιθεώρησης
Κατάσταση υλικού:	Καλή. Το στεγανωτικό υλικό είναι σε καλή κατάσταση και ο αμίαντος δεν είναι εκτεθειμένος.
Εκτίμηση Επικινδυνότητας:	Όταν το υλικό δεν υφίστανται μηχανική διαταραχή, ο κίνδυνος είναι χαμηλός. Σε αντίθετη περίπτωση ο κίνδυνος είναι υψηλός.

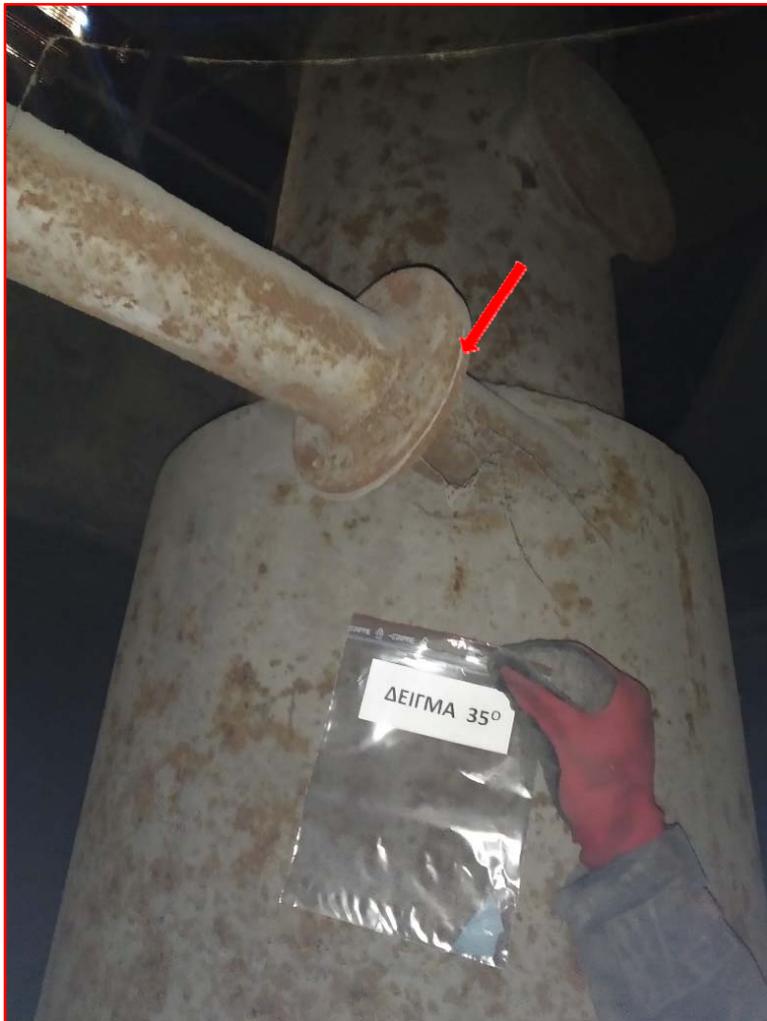
Ποσότητα:	3 τεμ
Παρατηρήσεις:	Ο εξοπλισμός βρίσκεται ανάμεσα στις δύο μονάδες.
Κατάσταση υλικού:	Καλή. Το στεγανωτικό υλικό είναι σε καλή κατάσταση και ο αμίαντος δεν είναι εκτεθειμένος.
Εκτίμηση Επικινδυνότητας:	Όταν το υλικό δεν υφίστανται μηχανική διαταραχή, ο κίνδυνος είναι χαμηλός. Σε αντίθετη περίπτωση ο κίνδυνος είναι υψηλός.

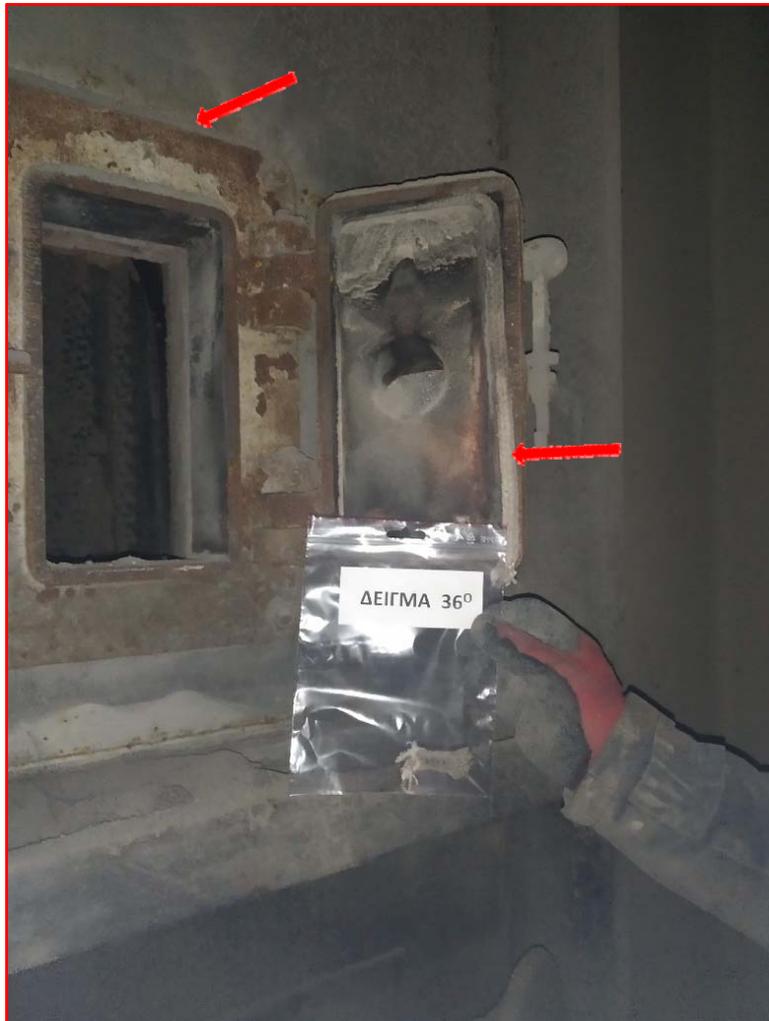
Ποσότητα:	9 τεμ
Παρατηρήσεις:	<p>Οι θυρίδες επιθεώρησης έχουν διαστάσεις 30x50. Οι 3 από τις 9 θυρίδες βρίσκονται στον οχετό καύσης. Το αμιαντούχο κορδόνι βρίσκεται σε δύο σημεία στον συγκεκριμένο εξοπλισμό: ένα κορδόνι βρίσκεται στο πορτάκι πάνω στην θυρίδα και ένα δεύτερο βρίσκεται στην σύνδεση που ενώνετε με τον λέβητα. Ίδιο στεγανωτικό υλικό παρατηρήθηκε και σε δύο 2 θυρίδες επίσκεψης διαστάσεων 45x50. Το ίδιο δείγμα στεγανωτικό κορδόνι παρατηρήθηκε στους παρακάτω εξοπλισμούς:</p> <ul style="list-style-type: none"> ▪ Επίπεδο +8,30μ – πόρτα Ν° 39 υπάρχουν 6 όμοιες θυρίδες επιθεώρησης. ▪ Επίπεδο +12,50μ – πόρτα Ν° 40 υπάρχουν στην πλευρά του Λυνο 2 θυρίδες επίσκεψης διαστάσεων 60x60 και 1 θυρίδα επιθεώρησης στον οχετό λιγνίτη. ▪ Επίπεδο +16,90μ – πόρτα Ν° 41 υπάρχουν στην πλευρά του Λυνο 1 θυρίδες επίσκεψης διαστάσεων 60x60 και 3 θυρίδες επιθεώρησης.

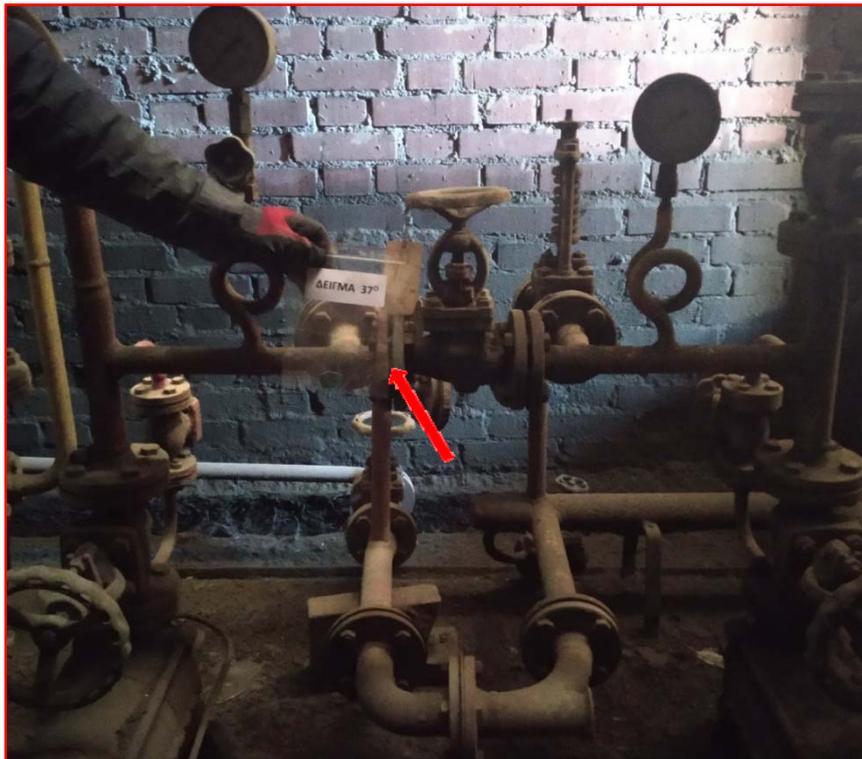
Ποσότητα:	30 τεμ
Παρατηρήσεις:	Το πυροσβεστικό σύστημα είναι για την δεξαμενή πετρελαίου που χρησιμοποιούνται για αποθήκευση μαζούτ και για τις δύο μονάδες.
Κατάσταση υλικού:	Καλή. Το στεγανωτικό υλικό είναι σε καλή κατάσταση και ο αμίαντος δεν είναι εκτεθειμένος.
Εκτίμηση Επικινδυνότητας:	Όταν το υλικό δεν υφίστανται μηχανική διαταραχή, ο κίνδυνος είναι χαμηλός. Σε αντίθετη περίπτωση ο κίνδυνος είναι υψηλός.

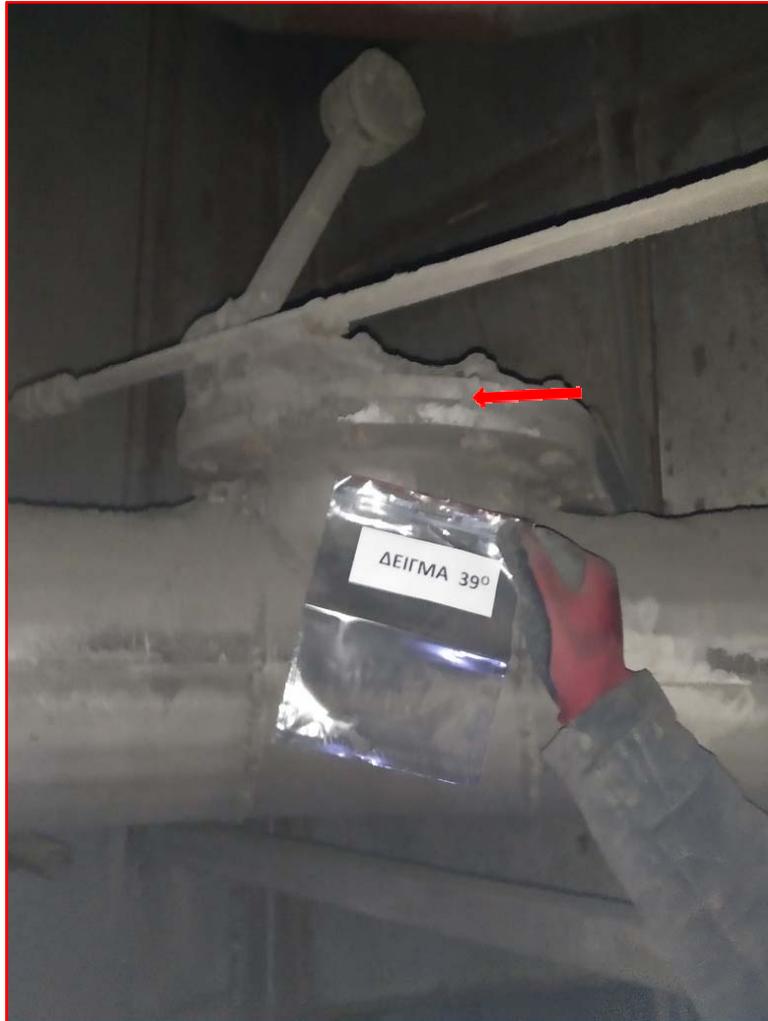
Αριθμός Δείγματος:	39
Περιοχή δειγματοληψίας:	Λεβητοστάσιο
Κτίριο – Επίπεδο:	2c / +5,50μ – Πόρτα Νο 23
Περιγραφή δείγματος:	Στεγανωτικό υλικό (φλάντζα) στρογγυλή Φ40 στο σύστημα καύσης της Μονάδας Ι.

Ποσότητα:	Μη μετρήσιμη
Παρατηρήσεις:	---
Κατάσταση υλικού:	Καλή. Το στεγανωτικό υλικό είναι σε καλή κατάσταση και ο αμίαντος δεν είναι εκτεθειμένος.
Εκτίμηση Επικινδυνότητας:	Όταν το υλικό δεν υφίστανται μηχανική διαταραχή, ο κίνδυνος είναι χαμηλός. Σε αντίθετη περίπτωση ο κίνδυνος είναι υψηλός.

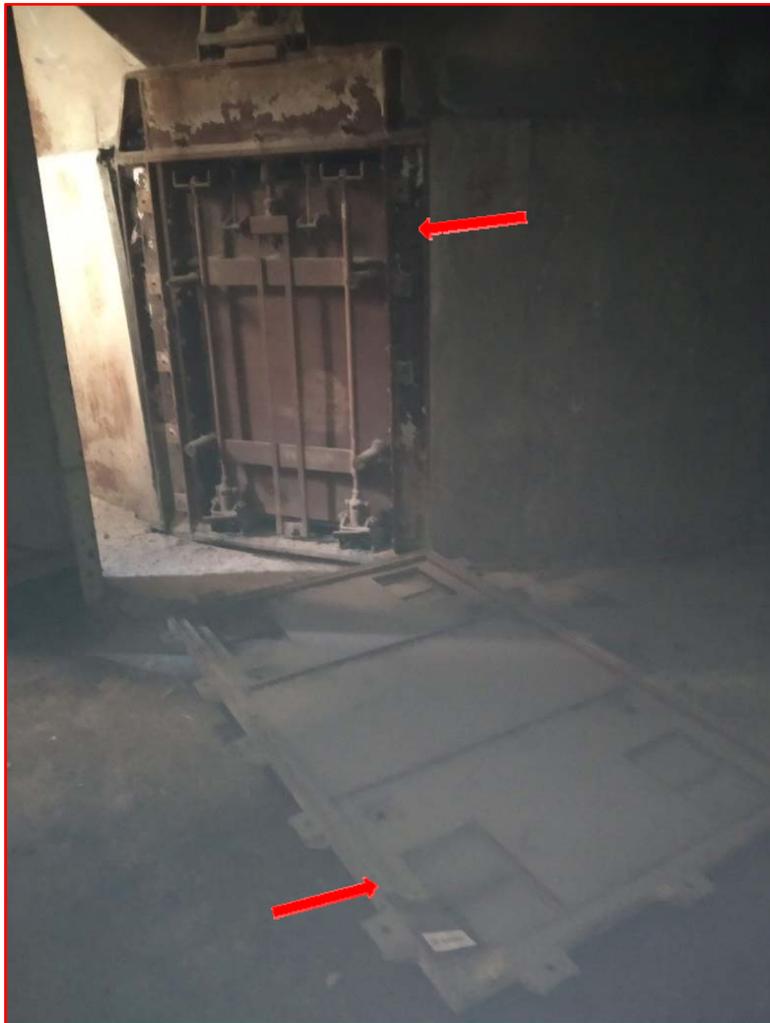
Ποσότητα:	2 τεμ
Παρατηρήσεις:	Το στεγανωτικό υλικό (κορδόνι) βρίσκεται σε δύο σημεία: πάνω στην πόρτα και πάνω στο αυλάκι που σφραγίζει η πόρτα.
Κατάσταση υλικού:	Καλή. Το στεγανωτικό υλικό είναι σε καλή κατάσταση και ο αμίαντος δεν είναι εκτεθειμένος.
Εκτίμηση Επικινδυνότητας:	Όταν το υλικό δεν υφίστανται μηχανική διαταραχή, ο κίνδυνος είναι χαμηλός. Σε αντίθετη περίπτωση ο κίνδυνος είναι υψηλός.

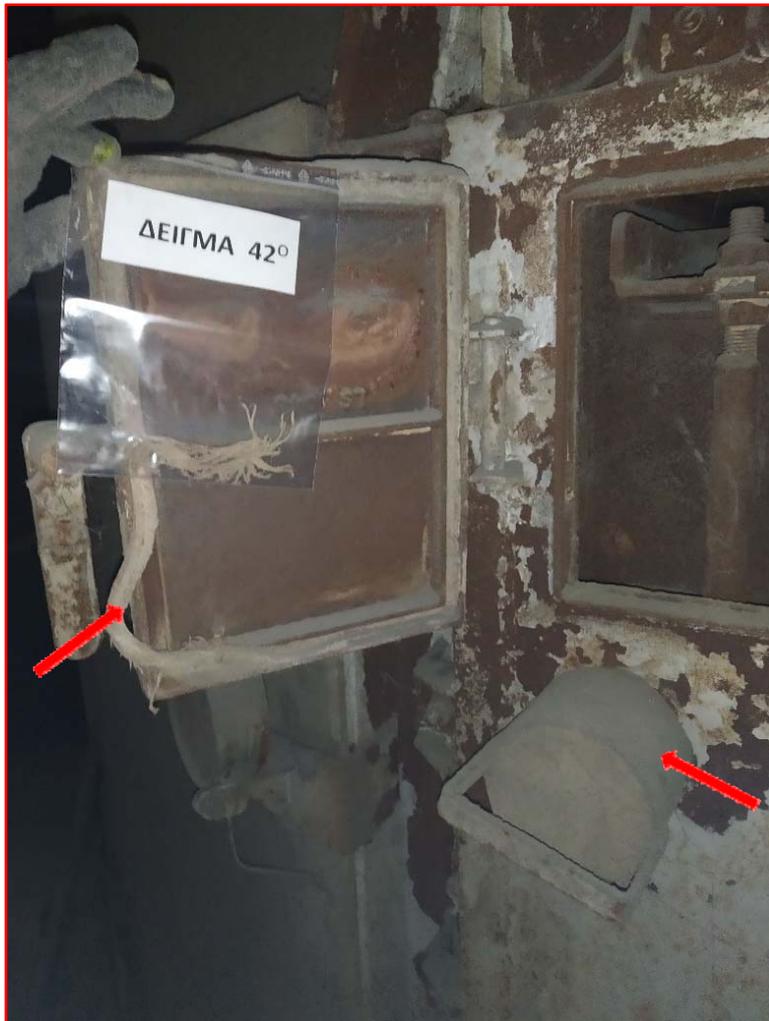
Ποσότητα:	4 τεμ
Παρατηρήσεις:	Το στεγανωτικό υλικό βρίσκεται πάνω στην θυρίδα αλλά και πάνω στο αυλάκι που σφραγίζει. Ίδιο υλικό παρατηρήθηκε μέσα σε 4 τάπες Φ10 που βρίσκονται γύρω από τις θυρίδες.
Κατάσταση υλικού:	Καλή. Το στεγανωτικό υλικό είναι σε καλή κατάσταση και ο αμίαντος δεν είναι εκτεθειμένος.
Εκτίμηση Επικινδυνότητας:	Όταν το υλικό δεν υφίστανται μηχανική διαταραχή, ο κίνδυνος είναι χαμηλός. Σε αντίθετη περίπτωση ο κίνδυνος είναι υψηλός.

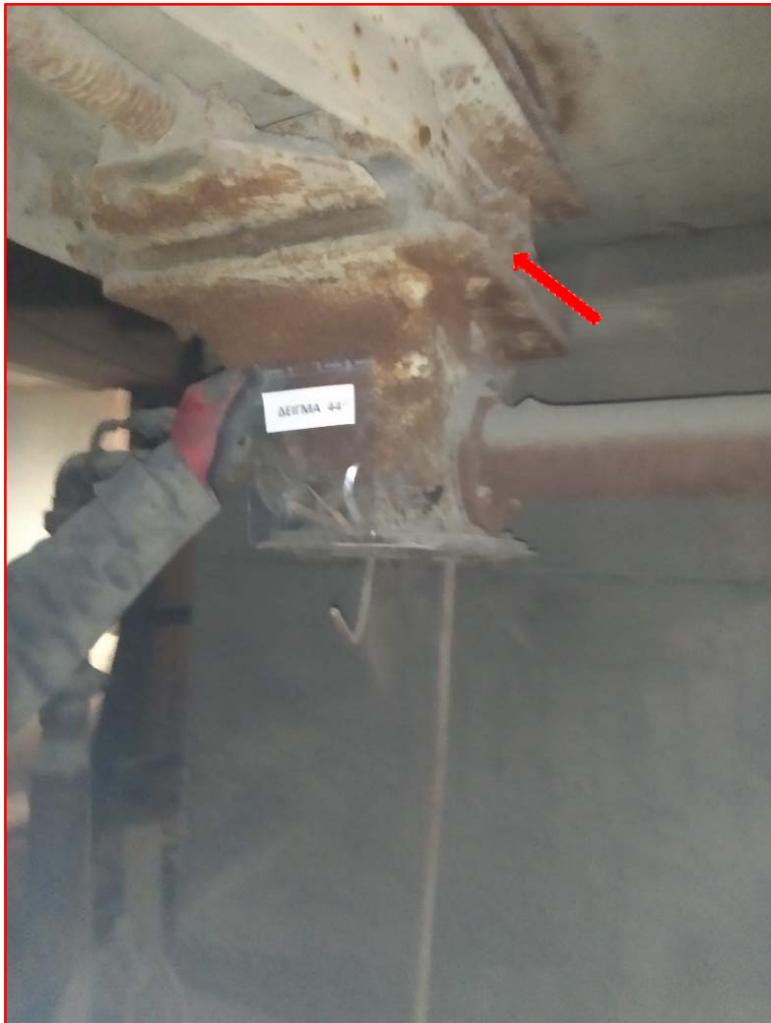
Αριθμός Δείγματος:	44
Περιοχή δειγματοληψίας:	Λεβητοστάσιο
Κτίριο – Επίπεδο:	2c / +5,50μ – Πόρτα Ν° 23
Περιγραφή δείγματος:	Στεγανωτικό υλικό (κορδόνι) σύνδεσης χοάνης μεταλλικών στοιχείων Λυνο Μονάδας Ι.

Ποσότητα:	Μη μετρήσιμη
Παρατηρήσεις:	---
Κατάσταση υλικού:	Καλή. Το στεγανωτικό υλικό είναι σε καλή κατάσταση και ο αμίαντος δεν είναι εκτεθειμένος.
Εκτίμηση Επικινδυνότητας:	Όταν το υλικό δεν υφίστανται μηχανική διαταραχή, ο κίνδυνος είναι χαμηλός. Σε αντίθετη περίπτωση ο κίνδυνος είναι υψηλός.

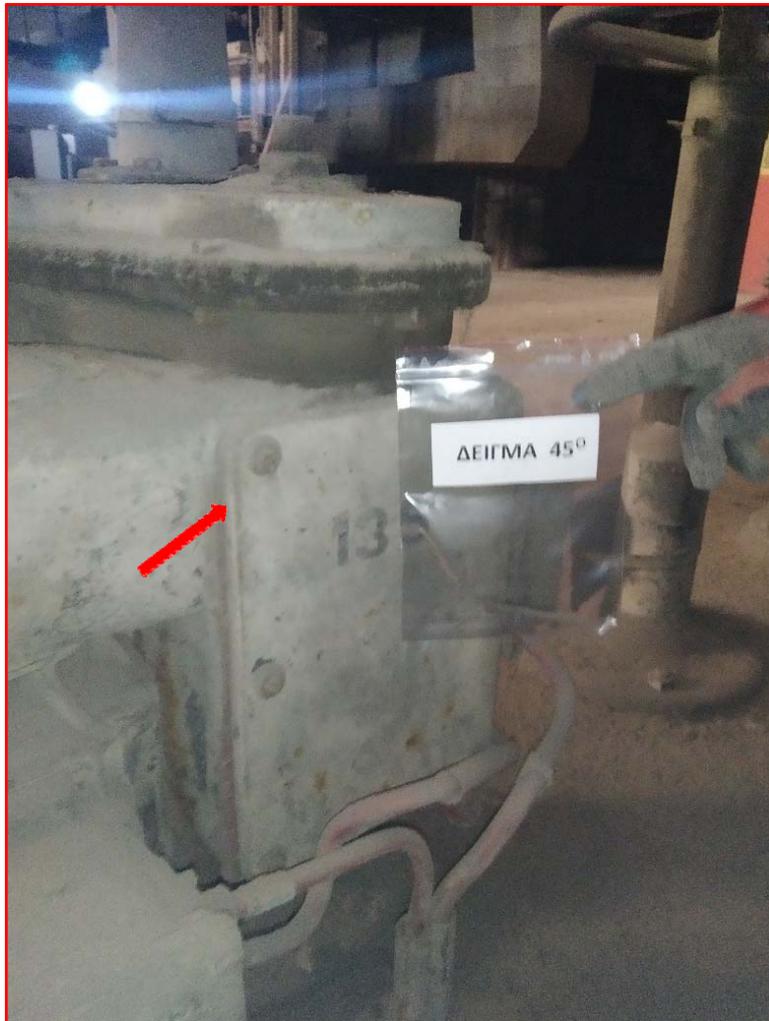
Αριθμός Δείγματος:	45
Περιοχή δειγματοληψίας:	Λεβητοστάσιο
Κτίριο – Επίπεδο:	2c / +5,50μ – Πόρτα Ν° 23
Περιγραφή δείγματος:	Στεγανωτικό υλικό (φλάντζα) πάνω στον μηχανισμό σε χειροκίνητα βολάν ελέγχου διακοπών της Μονάδας Ι.

Ποσότητα:	2 τεμ
Παρατηρήσεις:	---
Κατάσταση υλικού:	Καλή. Το στεγανωτικό υλικό είναι σε καλή κατάσταση και ο αμίαντος δεν είναι εκτεθειμένος.
Εκτίμηση Επικινδυνότητας:	Όταν το υλικό δεν υφίστανται μηχανική διαταραχή, ο κίνδυνος είναι χαμηλός. Σε αντίθετη περίπτωση ο κίνδυνος είναι υψηλός.
