Αντικείμενο: «Καθαίρεση του κύριου κτιρίου του ΑΗΣ ΛΙΠΤΟΛ, που περιλαμβάνει το λεβητοστάσιο, το μηχανοστάσιο, το κτίριο αφαλάτωσης και το Control Room, το Σύστημα Αποκομιδής τέφρας με την καμινάδα και τον Πύργο ψύξης»

ΣΥΜΠΛΗΡΩΜΑ Νο2

ΠΑΡΑΡΤΗΜΑ Ι

Πίνακας ΠΙ-1: Εξοπλισμός από τον οποίο πραγματοποιήθηκε δειγματοληψία πιθανών αμιαντούχων υλικών

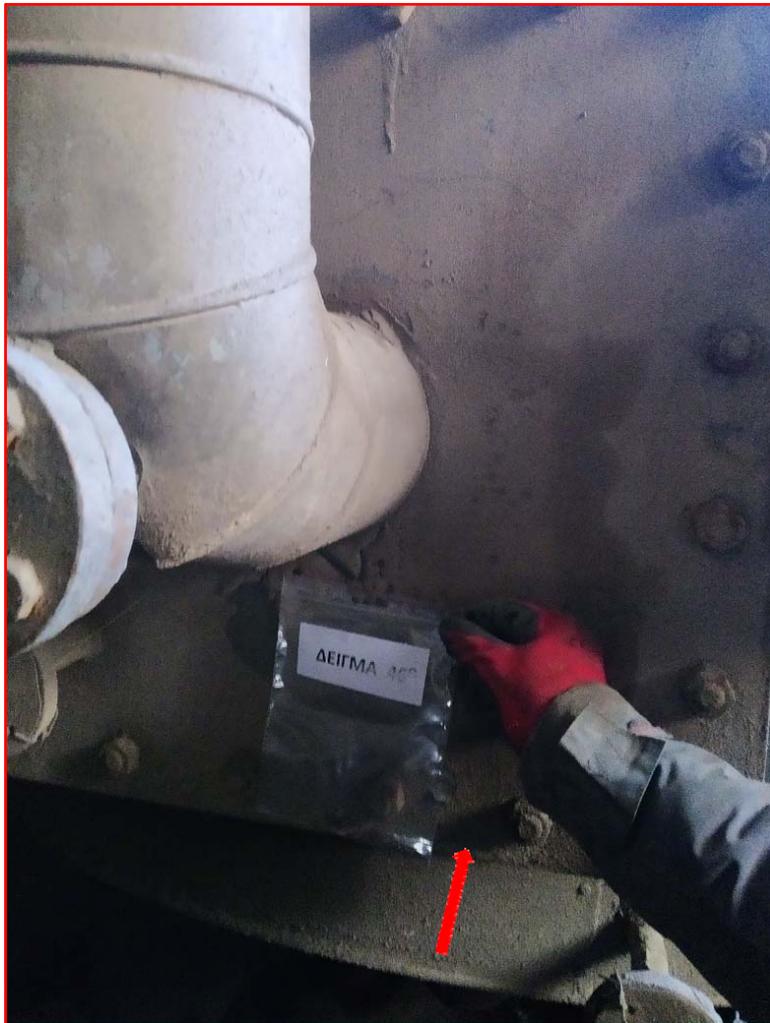
Αριθμός Δείγματος:	46
Περιοχή δειγματοληψίας:	Λεβητοστάσιο
Κτίριο – Επίπεδο:	2c / +5,50μ – Πόρτα Ν° 23
Περιγραφή δείγματος:	Στεγανωτικό υλικό (φλάντζα) τετράγωνη στην δεξαμενή πετρελαίου λειτουργίας των δύο μονάδων.

Ποσότητα:	1 τεμ
Παρατηρήσεις:	---
Κατάσταση υλικού:	Καλή. Το στεγανωτικό υλικό είναι σε καλή κατάσταση και ο αμίαντος δεν είναι εκτεθειμένος.
Εκτίμηση Επικινδυνότητας:	Όταν το υλικό δεν υφίστανται μηχανική διαταραχή, ο κίνδυνος είναι χαμηλός. Σε αντίθετη περίπτωση ο κίνδυνος είναι υψηλός.

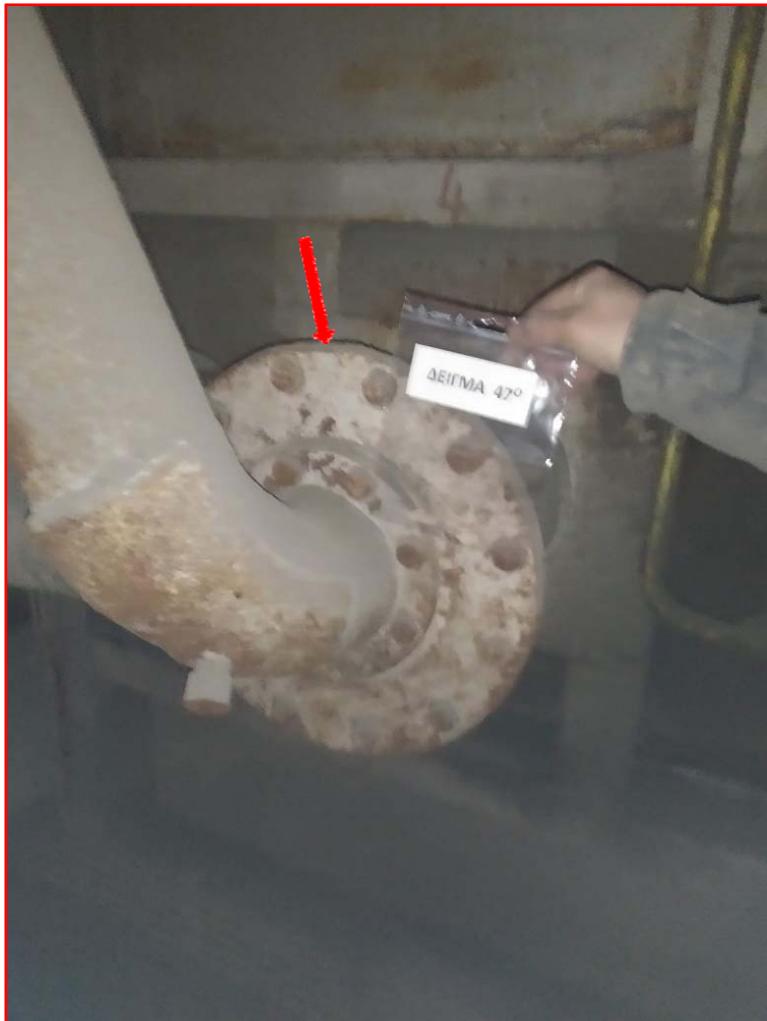
Ποσότητα:	2 τεμ
Παρατηρήσεις:	Ίδιο στεγανωτικό υλικό υπάρχει σε φλάντζα και στην διάταξη ψεκασμού πετρελαίου που βρίσκεται ακριβώς δίπλα στον εξοπλισμό. Επιπρόσθετα η ίδια διάταξη υπάρχει στο ίδιο κτίριο (2c) επίπεδο +8,30μ (πόρτα 39).
Κατάσταση υλικού:	Καλή. Το στεγανωτικό υλικό είναι σε καλή κατάσταση και ο αμίαντος δεν είναι εκτεθειμένος.
Εκτίμηση Επικινδυνότητας:	Όταν το υλικό δεν υφίστανται μηχανική διαταραχή, ο κίνδυνος είναι χαμηλός. Σε αντίθετη περίπτωση ο κίνδυνος είναι υψηλός.

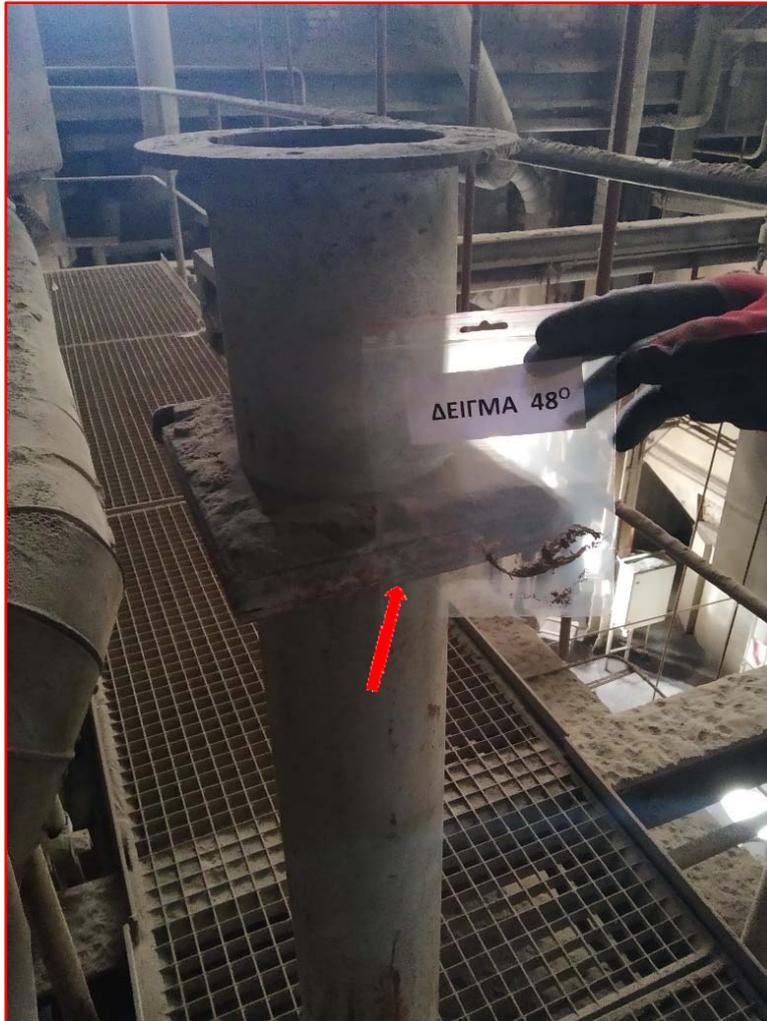
Αριθμός Δείγματος:	48
Περιοχή δειγματοληψίας:	Λεβητοστάσιο
Κτίριο – Επίπεδο:	2c / +12,50μ – Πόρτα Ν° 40
Περιγραφή δείγματος:	Στεγανωτικό υλικό (φλάντζα) τετράγωνη διαστάσεων 20*20 σε αγωγό της μονάδας Ι.

Ποσότητα:	1 τεμ
Παρατηρήσεις:	---
Κατάσταση υλικού:	Καλή. Το στεγανωτικό υλικό είναι σε καλή κατάσταση και ο αμίαντος δεν είναι εκτεθειμένος.
Εκτίμηση Επικινδυνότητας:	Όταν το υλικό δεν υφίστανται μηχανική διαταραχή, ο κίνδυνος είναι χαμηλός. Σε αντίθετη περίπτωση ο κίνδυνος είναι υψηλός.

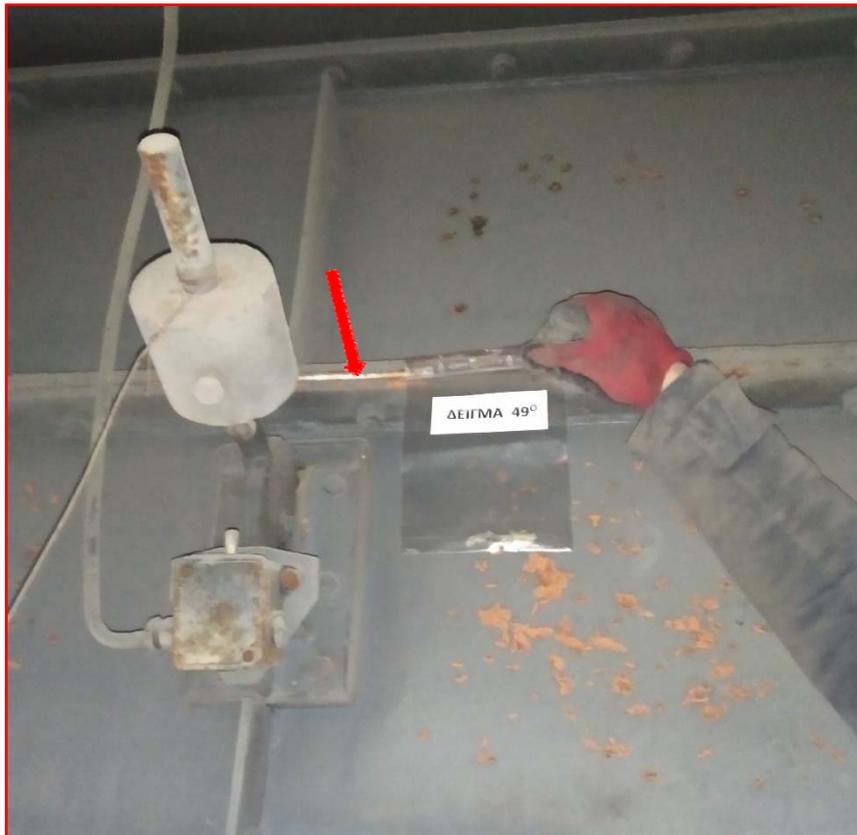
Ποσότητα:	Μη μετρήσιμη
Παρατηρήσεις:	Το στεγανωτικό κορδόνι βρίσκεται σε όλες τις συνδέσεις μεταλλικών στοιχείων με κοχλίες που υπάρχουν στους τροφοδότες λιγνίτη. Οι τροφοδότες είναι δύο για κάθε μονάδα.
Κατάσταση υλικού:	Καλή. Το στεγανωτικό υλικό είναι σε καλή κατάσταση και ο αμίαντος δεν είναι εκτεθειμένος.
Εκτίμηση Επικινδυνότητας:	Όταν το υλικό δεν υφίσταται μηχανική διαταραχή, ο κίνδυνος είναι χαμηλός. Σε αντίθετη περίπτωση ο κίνδυνος είναι υψηλός.

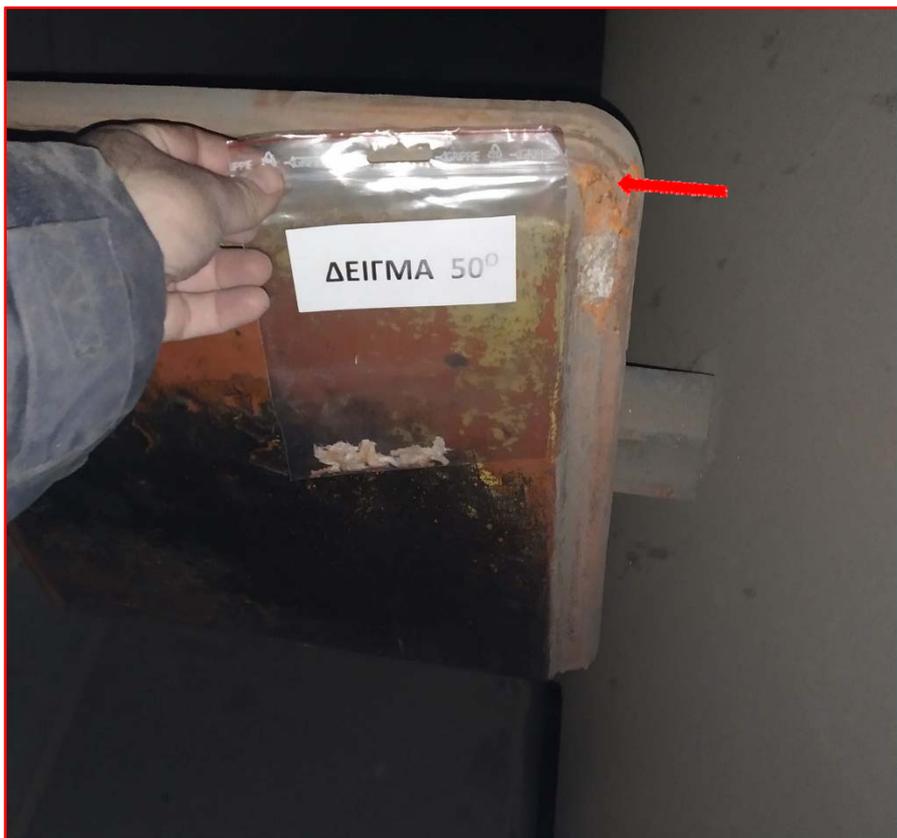
Ποσότητα:	4 τεμ
Παρατηρήσεις:	Κάθε μονάδα έχει δύο τροφοδότες λιγνίτη.
Κατάσταση υλικού:	Καλή. Το στεγανωτικό υλικό είναι σε καλή κατάσταση και ο αμίαντος δεν είναι εκτεθειμένος.
Εκτίμηση Επικινδυνότητας:	Όταν το υλικό δεν υφίσταται μηχανική διαταραχή, ο κίνδυνος είναι χαμηλός. Σε αντίθετη περίπτωση ο κίνδυνος είναι υψηλός.

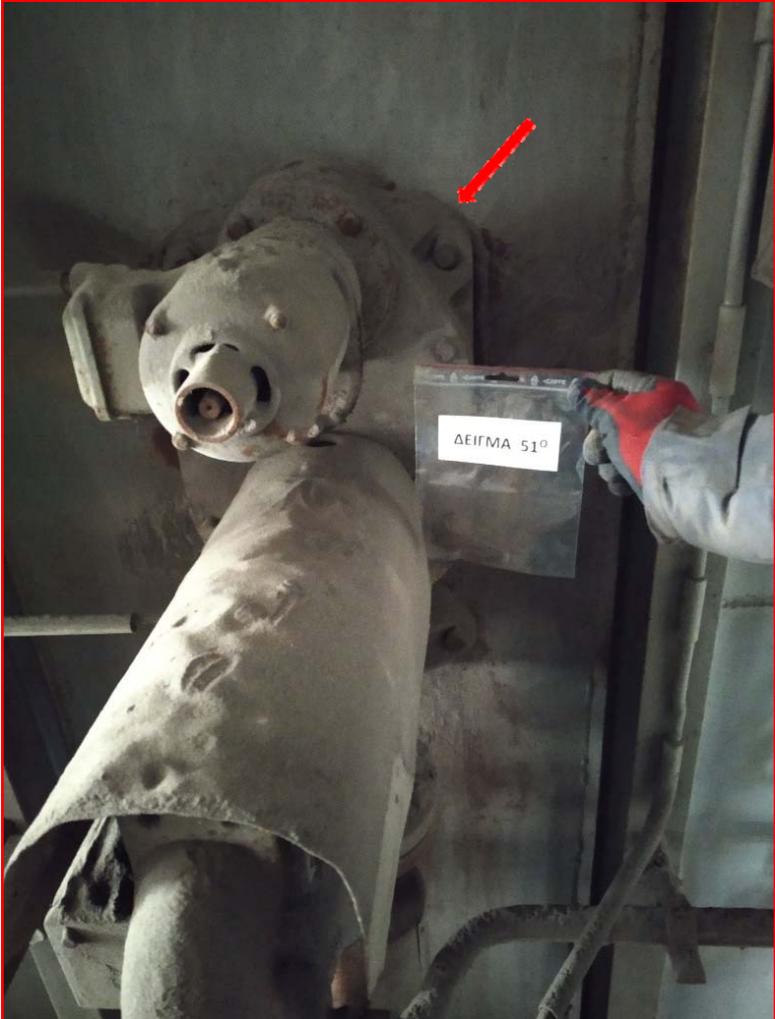
Ποσότητα:	Μη μετρήσιμη
Παρατηρήσεις:	<p>Το στεγανωτικό υλικό βρίσκεται πάνω στην σύνδεση με τον λέβητα. Ίδιο υλικό παρατηρήθηκε στο εξωτερικό της στρογγυλής διάταξης δίπλα στον καυστήρα πετρελαίου.</p> <ul style="list-style-type: none"> ▪ Επίπεδο +16,90μ – πόρτα Νο 41 έχει αντίστοιχα 4 ίδιες διατάξεις. ▪ Επίπεδο +19,50μ – πόρτα Νο 42 έχει αντίστοιχα 4 ίδιες διατάξεις.
Κατάσταση υλικού:	Καλή. Το στεγανωτικό υλικό είναι σε καλή κατάσταση και ο αμιάντος δεν είναι εκτεθειμένος.
Εκτίμηση Επικινδυνότητας:	Όταν το υλικό δεν υφίστανται μηχανική διαταραχή, ο κίνδυνος είναι χαμηλός. Σε αντίθετη περίπτωση ο κίνδυνος είναι υψηλός.

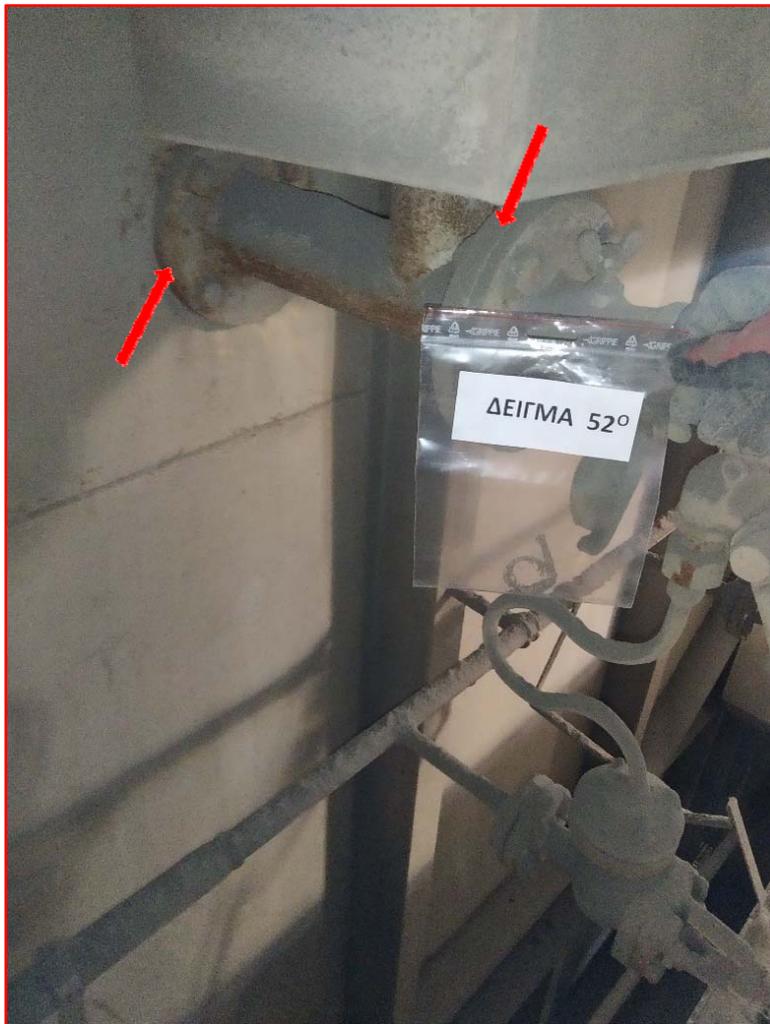
Αριθμός Δείγματος:	52
Περιοχή δειγματοληψίας:	Λεβητοστάσιο
Κτίριο – Επίπεδο:	2c / +12,50μ – Πόρτα Ν° 40
Περιγραφή δείγματος:	Στεγανωτικό υλικό (φλάντζα) σε κυκλικό αγωγό πάνω στην διάταξη ψεκασμού νερού – συστήματος εξανθράκωσης διαμέτρου Φ10 & Φ20

Ποσότητα:	Μη μετρήσιμη
Παρατηρήσεις:	---
Κατάσταση υλικού:	Καλή. Το στεγανωτικό υλικό είναι σε καλή κατάσταση και ο αμίαντος δεν είναι εκτεθειμένος.
Εκτίμηση Επικινδυνότητας:	Όταν το υλικό δεν υφίστανται μηχανική διαταραχή, ο κίνδυνος είναι χαμηλός. Σε αντίθετη περίπτωση ο κίνδυνος είναι υψηλός.

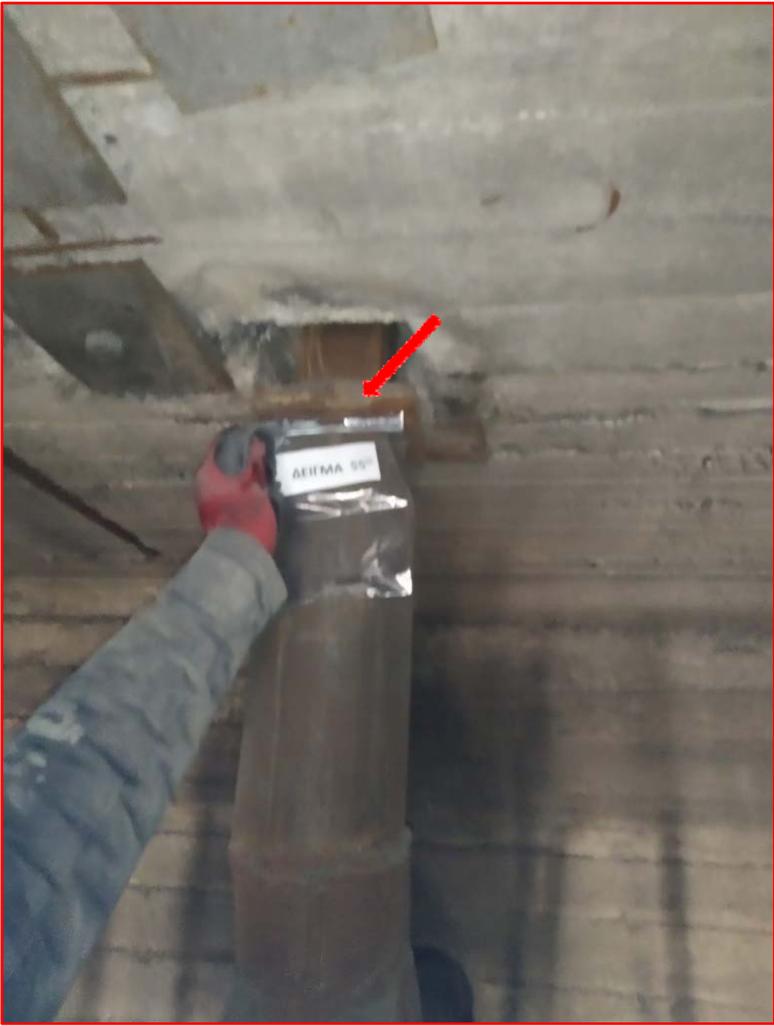
Αριθμός Δείγματος:	55
Περιοχή δειγματοληψίας:	Λεβητοστάσιο
Κτίριο – Επίπεδο:	2c / +27,50μ – Πόρτα Ν° 45
Περιγραφή δείγματος:	Στεγανωτικό υλικό (φλάντζα) μεταλλικού σωλήνα

Ποσότητα:	2 τεμ
Παρατηρήσεις:	---
Κατάσταση υλικού:	Καλή. Το στεγανωτικό υλικό είναι σε καλή κατάσταση και ο αμίαντος δεν είναι εκτεθειμένος.
Εκτίμηση Επικινδυνότητας:	Όταν το υλικό δεν υφίστανται μηχανική διαταραχή, ο κίνδυνος είναι χαμηλός. Σε αντίθετη περίπτωση ο κίνδυνος είναι υψηλός.

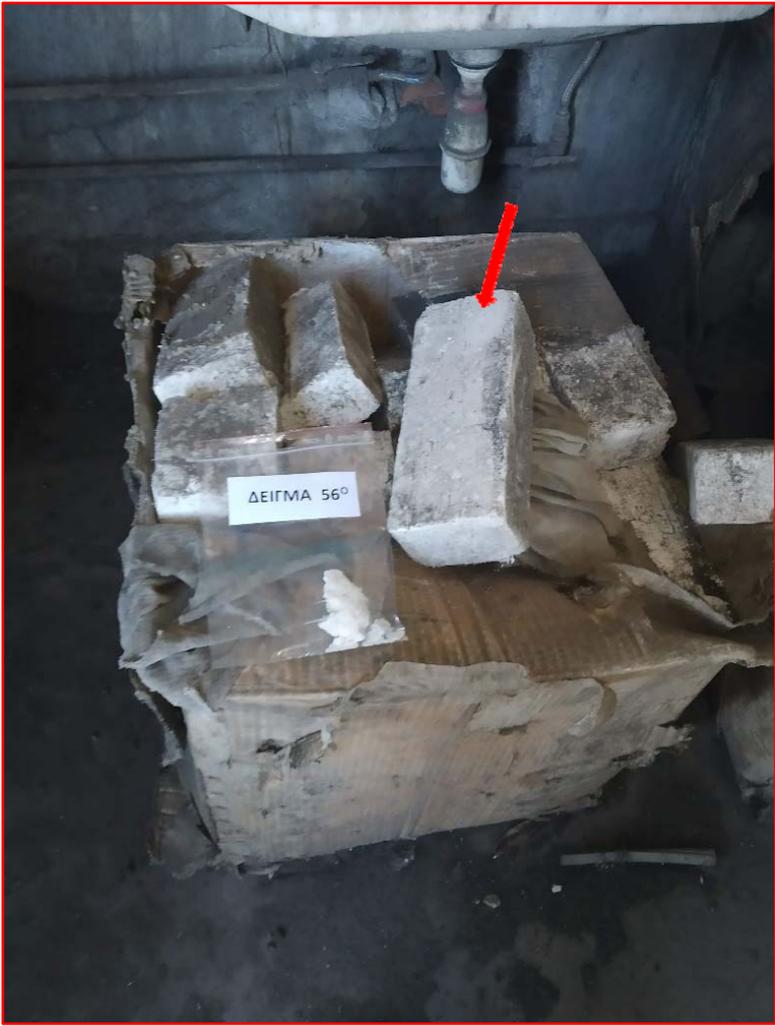
Ποσότητα:	0,5 m ³
Παρατηρήσεις:	---
Κατάσταση υλικού:	Καλή. Η μόνωση είναι σε δεμένη με κάποιο συγκολλητικό προϊόν σε σχήμα ορθογώνιο.
Εκτίμηση Επικινδυνότητας:	Όταν το υλικό δεν υφίστανται μηχανική διαταραχή, ο κίνδυνος είναι χαμηλός. Σε αντίθετη περίπτωση ο κίνδυνος είναι υψηλός

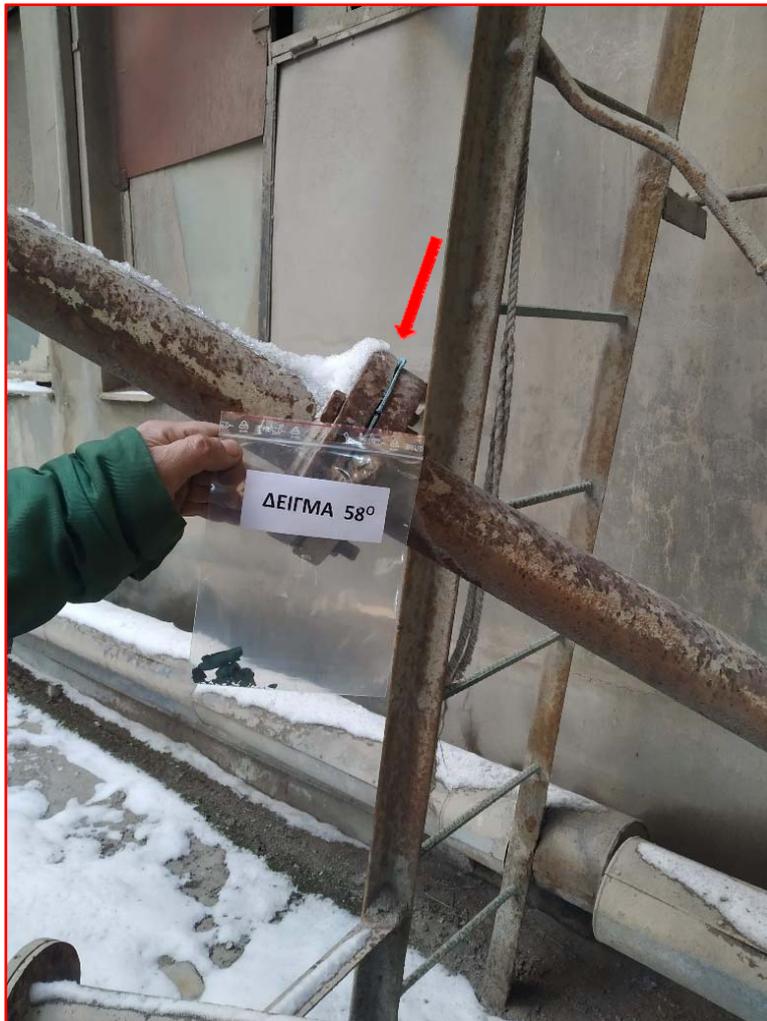
Αριθμός Δείγματος:	58
Περιοχή δειγματοληψίας:	Σύστημα αποκομιδής τέφρας
Κτίριο – Επίπεδο:	3d – c / +0,00μ
Περιγραφή δείγματος:	Στεγανωτικό υλικό (φλάντζα) σε σωληνογραμμή των μηχανικών φίλτρων διαμέτρου Φ15

Ποσότητα:	Μη μετρήσιμη
Παρατηρήσεις:	---
Κατάσταση υλικού:	Καλή. Το στεγανωτικό υλικό είναι σε καλή κατάσταση και ο αμίαντος δεν είναι εκτεθειμένος.
Εκτίμηση Επικινδυνότητας:	Όταν το υλικό δεν υφίστανται μηχανική διαταραχή, ο κίνδυνος είναι χαμηλός. Σε αντίθετη περίπτωση ο κίνδυνος είναι υψηλός

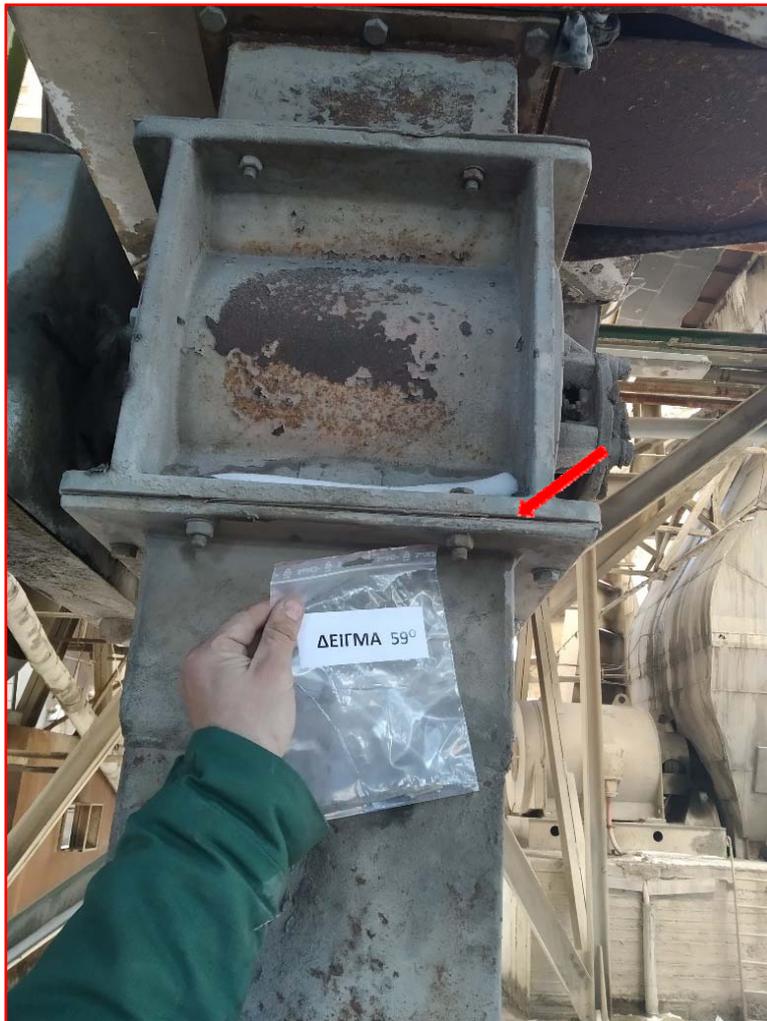
Αριθμός Δείγματος:	59
Περιοχή δειγματοληψίας:	Σύστημα αποκομιδής τέφρας
Κτίριο – Επίπεδο:	3d – c / +0,00μ
Περιγραφή δείγματος:	Στεγανωτικό υλικό (κορδόνι) τετράγωνης σύνδεσης ηλεκτροστατικών φίλτρων

Ποσότητα:	Μη μετρήσιμη
Παρατηρήσεις:	---
Κατάσταση υλικού:	Καλή. Το στεγανωτικό υλικό είναι σε καλή κατάσταση και ο αμίαντος δεν είναι εκτεθειμένος.
Εκτίμηση Επικινδυνότητας:	Όταν το υλικό δεν υφίστανται μηχανική διαταραχή, ο κίνδυνος είναι χαμηλός. Σε αντίθετη περίπτωση ο κίνδυνος είναι υψηλός

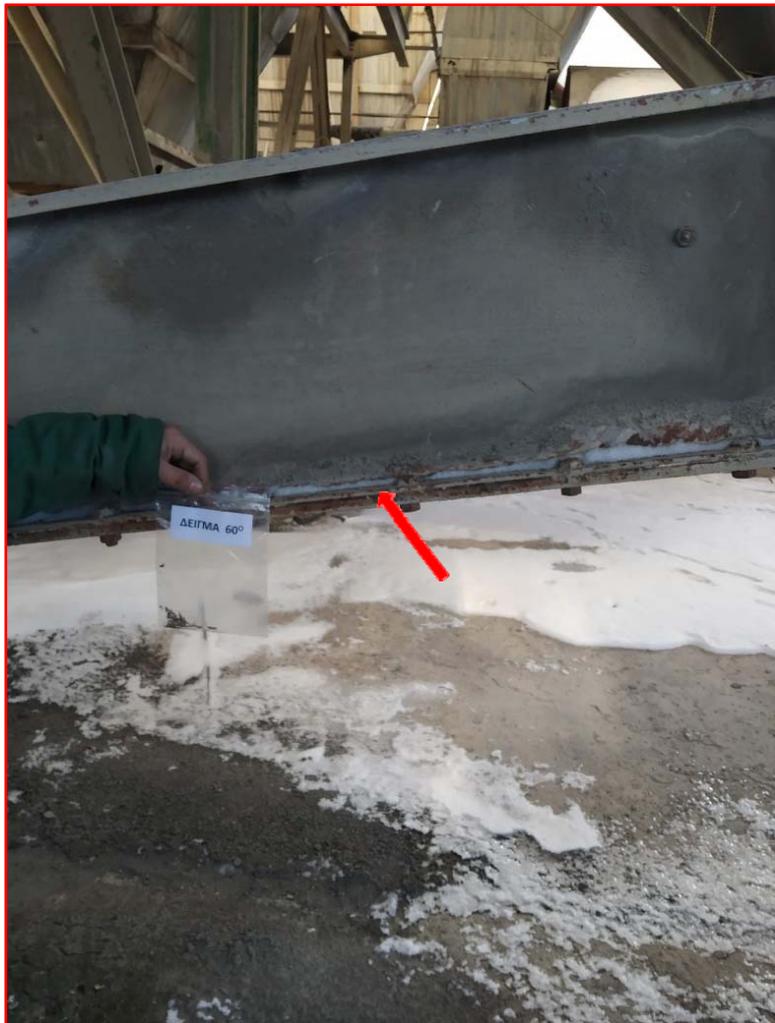
Ποσότητα:	Μη μετρήσιμη
Παρατηρήσεις:	Το ίδιο υλικό παρατηρήθηκε και σε μικρές θυρίδες πάνω στην χοάνη των ηλεκτροστατικών φίλτρων.
Κατάσταση υλικού:	Καλή. Το στεγανωτικό υλικό είναι σε καλή κατάσταση και ο αμίαντος δεν είναι εκτεθειμένος.
Εκτίμηση Επικινδυνότητας:	Όταν το υλικό δεν υφίστανται μηχανική διαταραχή, ο κίνδυνος είναι χαμηλός. Σε αντίθετη περίπτωση ο κίνδυνος είναι υψηλός

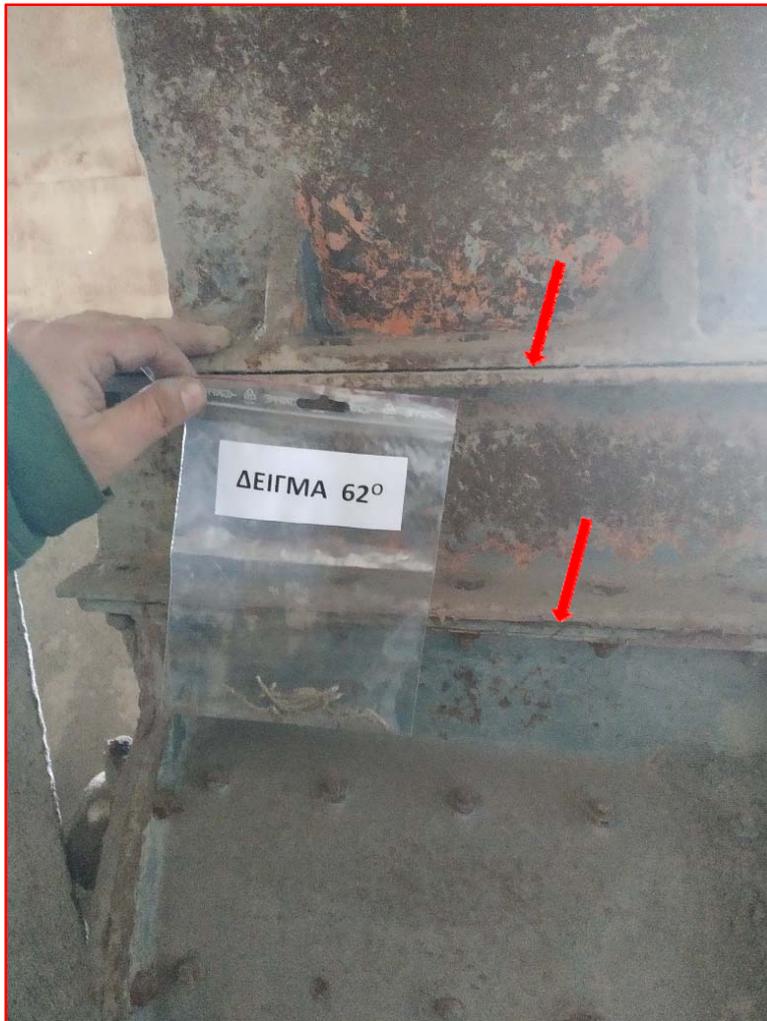
Αριθμός Δείγματος:	62
Περιοχή δειγματοληψίας:	Σύστημα αποκομιδής τέφρας – Σιλό τέφρας
Κτίριο – Επίπεδο:	3f / +5,80μ
Περιγραφή δείγματος:	Στεγανωτικό υλικό (κορδόνι) φλάντζας σύνδεσης μεταλλικών στοιχείων χοάνης

Ποσότητα:	Μη μετρήσιμη
Παρατηρήσεις:	---
Κατάσταση υλικού:	Καλή. Το στεγανωτικό υλικό είναι σε καλή κατάσταση και ο αμίαντος δεν είναι εκτεθειμένος.
Εκτίμηση Επικινδυνότητας:	Όταν το υλικό δεν υφίστανται μηχανική διαταραχή, ο κίνδυνος είναι χαμηλός. Σε αντίθετη περίπτωση ο κίνδυνος είναι υψηλός

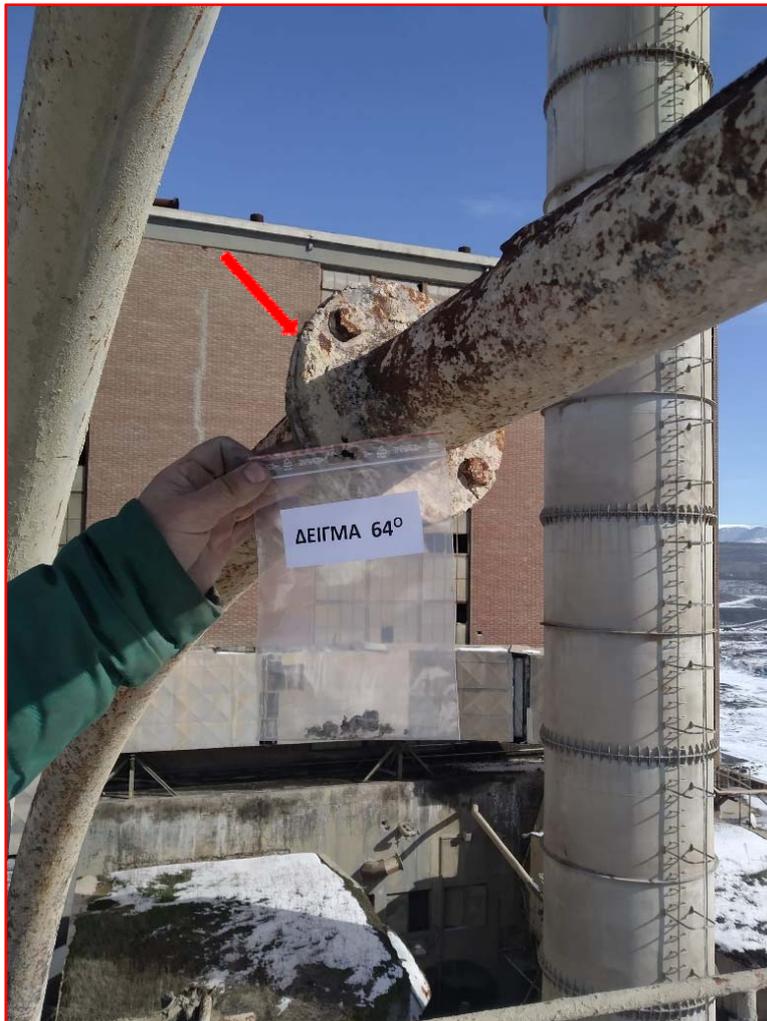
Αριθμός Δείγματος:	64
Περιοχή δειγματοληψίας:	Σύστημα αποκομιδής τέφρας – Σιλό τέφρας
Κτίριο – Επίπεδο:	3f / +18,00μ
Περιγραφή δείγματος:	Στεγανωτικό υλικό (φλάντζα) σωληνογραμμών που έρχονται από τα φίλτρα διαμέτρου Φ15

Ποσότητα:	Μη μετρήσιμη
Παρατηρήσεις:	---
Κατάσταση υλικού:	Καλή. Το στεγανωτικό υλικό είναι σε καλή κατάσταση και ο αμίαντος δεν είναι εκτεθειμένος.
Εκτίμηση Επικινδυνότητας:	Όταν το υλικό δεν υφίστανται μηχανική διαταραχή, ο κίνδυνος είναι χαμηλός. Σε αντίθετη περίπτωση ο κίνδυνος είναι υψηλός

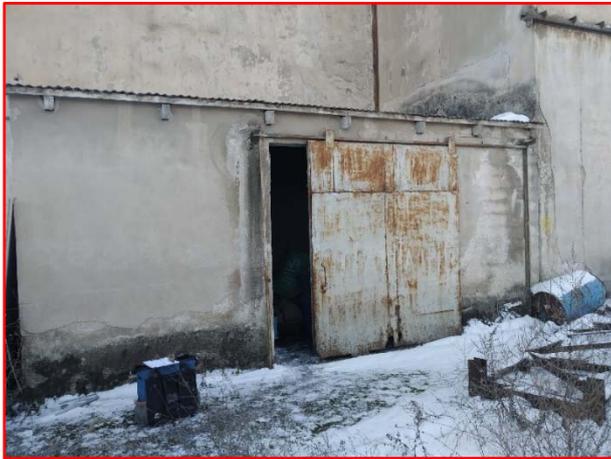
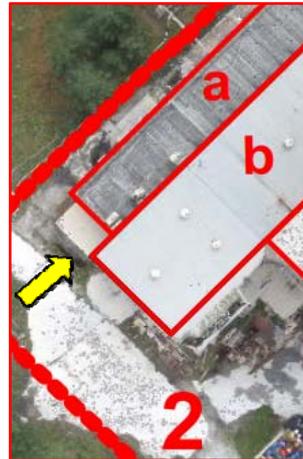
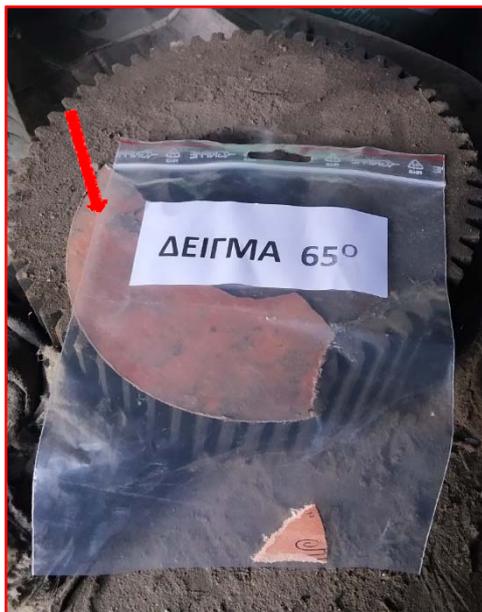
Αριθμός Δείγματος:	65
Περιοχή δειγματοληψίας:	Αποθήκη υλικών εντός ΑΗΣ (εξωτερική πόρτα)
Κτίριο – Επίπεδο:	Μεταξύ 2a – 2b εξωτερικά / +0,00μ
Περιγραφή δείγματος:	Χύδην στεγανωτικό υλικό φλάντζα στρόγγυλη – κόκκινου χρώματος

Ποσότητα:	Μη μετρήσιμη
Παρατηρήσεις:	Ο χώρος είναι αποθήκη υλικών και μέσα εντοπίστηκαν χύδην αμιαντούχα υλικά μαζί με μη επικίνδυνα υλικά επικαλυμμένα με τέφρα. Συστήνεται να προηγηθεί η συλλογή και συσκευασία των αμιαντούχων υλικών και μετά ο καθαρισμός του χώρου από τα υπόλοιπα υλικά.
Κατάσταση υλικού:	Καλή. Το στεγανωτικό υλικό είναι σε καλή κατάσταση και ο αμίαντος δεν είναι εκτεθειμένος.
Εκτίμηση Επικινδυνότητας:	Όταν το υλικό δεν υφίστανται μηχανική διαταραχή, ο κίνδυνος είναι χαμηλός. Σε αντίθετη περίπτωση ο κίνδυνος είναι υψηλός

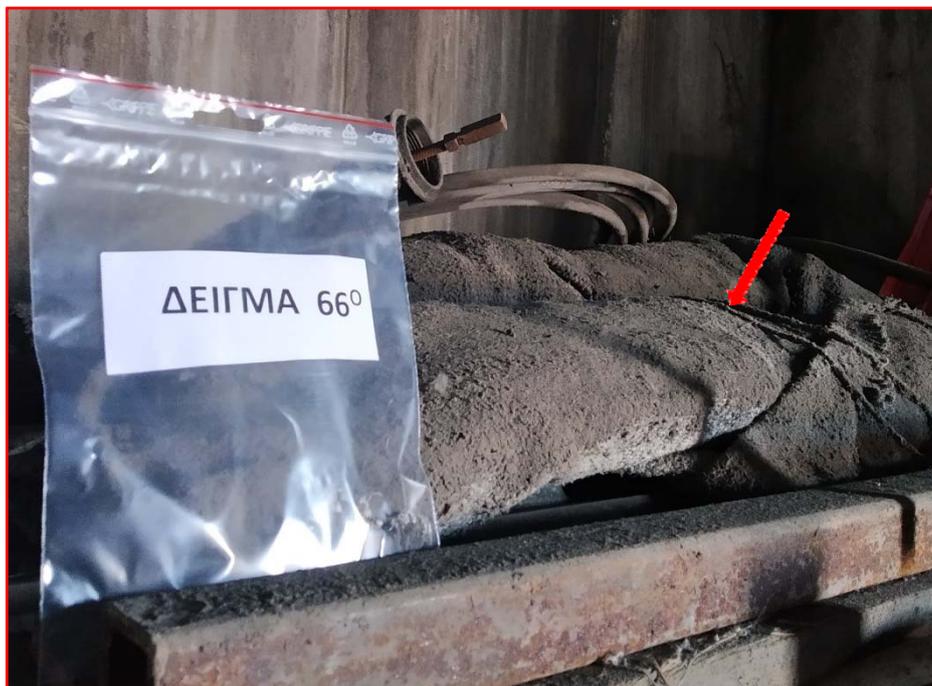
Ποσότητα:	Μη μετρήσιμη
Παρατηρήσεις:	Ο χώρος είναι αποθήκη υλικών και μέσα εντοπίστηκαν χύδην αμιαντούχα υλικά μαζί με μη επικίνδυνα υλικά επικαλυμμένα με τέφρα. Συστήνεται να προηγηθεί η συλλογή και συσκευασία των αμιαντούχων υλικών και μετά ο καθαρισμός του χώρου από τα υπόλοιπα υλικά.
Κατάσταση υλικού:	Καλή. Το στεγανωτικό υλικό είναι σε καλή κατάσταση και ο αμίαντος δεν είναι εκτεθειμένος.
Εκτίμηση Επικινδυνότητας:	Όταν το υλικό δεν υφίστανται μηχανική διαταραχή, ο κίνδυνος είναι χαμηλός. Σε αντίθετη περίπτωση ο κίνδυνος είναι υψηλός

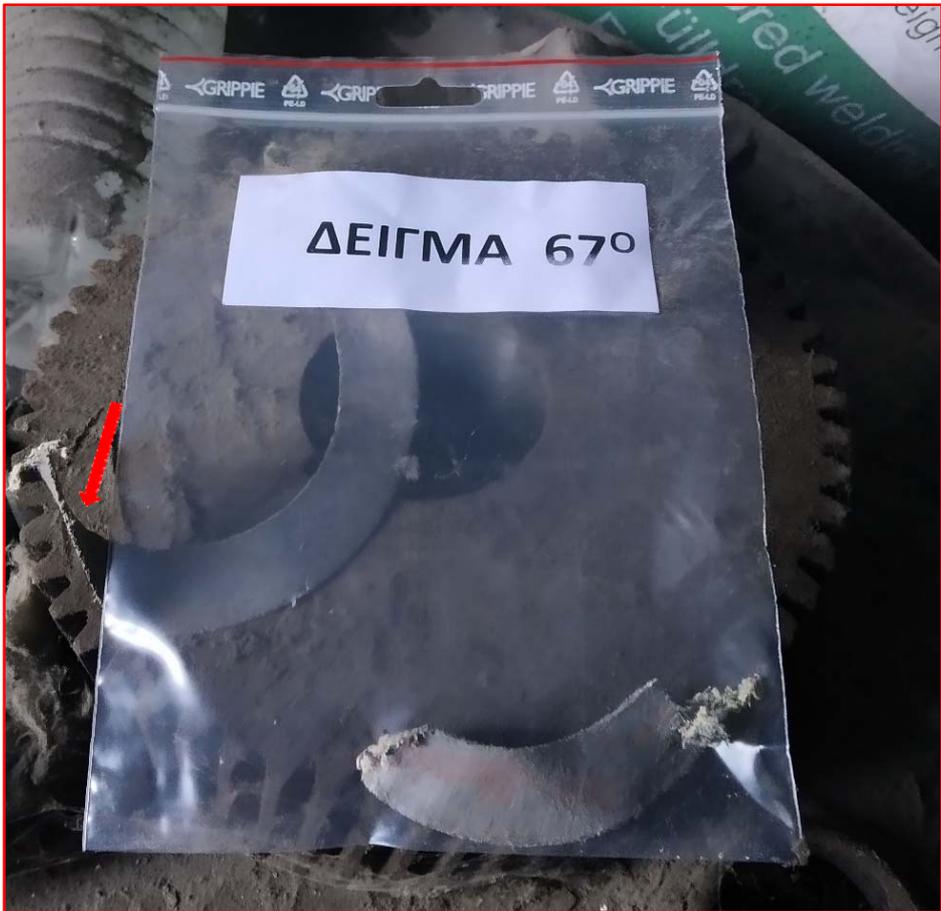
Ποσότητα:	Μη μετρήσιμη
Παρατηρήσεις:	Ο χώρος είναι αποθήκη υλικών και μέσα εντοπίστηκαν χύδην αμιαντούχα υλικά μαζί με μη επικίνδυνα υλικά επικαλυμμένα με τέφρα. Συστήνεται να προηγηθεί η συλλογή και συσκευασία των αμιαντούχων υλικών και μετά ο καθαρισμός του χώρου από τα υπόλοιπα υλικά.
Κατάσταση υλικού:	Καλή. Το στεγανωτικό υλικό είναι σε καλή κατάσταση και ο αμίαντος δεν είναι εκτεθειμένος.
Εκτίμηση Επικινδυνότητας:	Όταν το υλικό δεν υφίστανται μηχανική διαταραχή, ο κίνδυνος είναι χαμηλός. Σε αντίθετη περίπτωση ο κίνδυνος είναι υψηλός

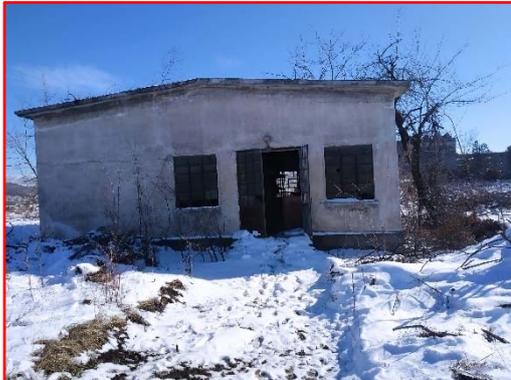
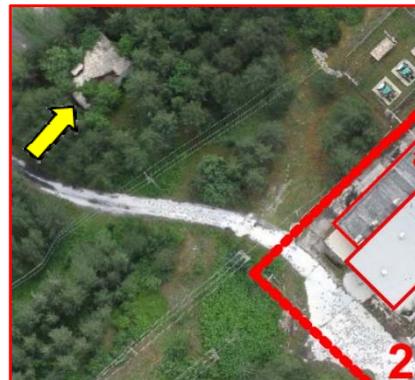
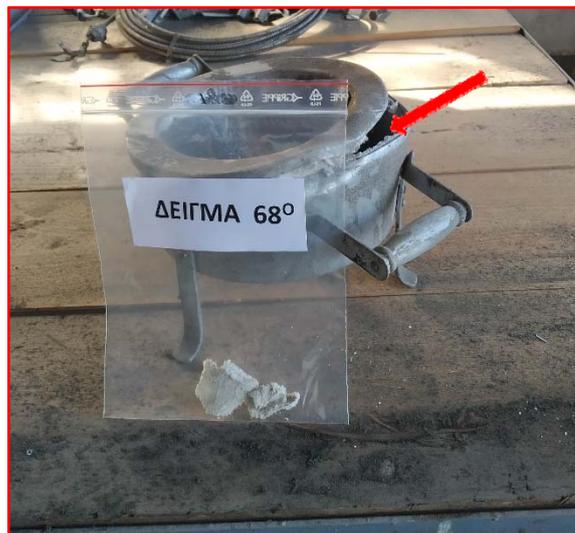
Αριθμός Δείγματος:	68
Περιοχή δειγματοληψίας:	Κτίριο αποθήκης υλικών εκτός ΑΗΣ
Κτίριο – Επίπεδο:	--- / +0,00μ
Περιγραφή δείγματος:	Μονωτικό υλικό σε διάταξη για ζέσταμα

Ποσότητα:	Μη μετρήσιμη
Παρατηρήσεις:	Είναι κτίριο αποθήκης υλικών και εντοπίστηκαν χύδην αμιαντούχα υλικά μαζί με μη επικίνδυνα υλικά. Συστήνεται να προηγηθεί η συλλογή και συσκευασία των αμιαντούχων υλικών και μετά ο καθαρισμός του χώρου από τα υπόλοιπα υλικά.
Κατάσταση υλικού:	Καλή. Το στεγανωτικό υλικό είναι σε καλή κατάσταση και ο αμίαντος δεν είναι εκτεθειμένος.
Εκτίμηση Επικινδυνότητας:	Όταν το υλικό δεν υφίστανται μηχανική διαταραχή, ο κίνδυνος είναι χαμηλός. Σε αντίθετη περίπτωση ο κίνδυνος είναι υψηλός

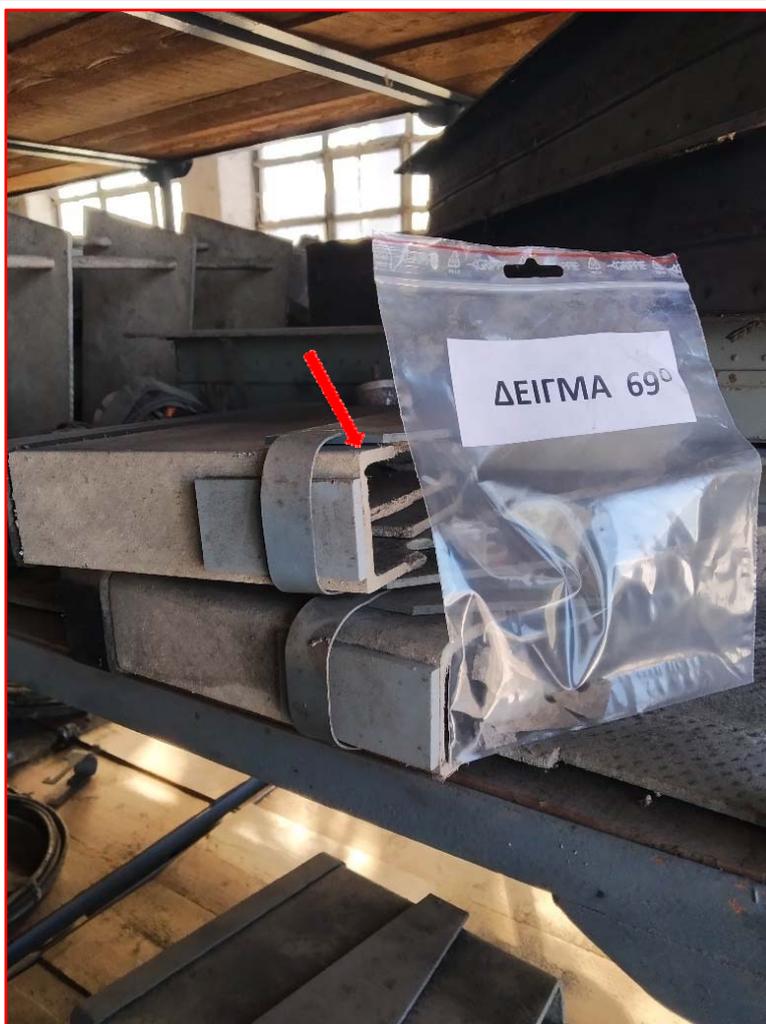
Ποσότητα:	Μη μετρήσιμη
Παρατηρήσεις:	Είναι κτίριο αποθήκης υλικών και εντοπίστηκαν χύδην αμιαντούχα υλικά μαζί με μη επικίνδυνα υλικά. Συστήνεται να προηγηθεί η συλλογή και συσκευασία των αμιαντούχων υλικών και μετά ο καθαρισμός του χώρου από τα υπόλοιπα υλικά.
Κατάσταση υλικού:	Καλή.
Εκτίμηση Επικινδυνότητας:	Όταν το υλικό δεν υφίστανται μηχανική διαταραχή, ο κίνδυνος είναι χαμηλός. Σε αντίθετη περίπτωση ο κίνδυνος είναι υψηλός

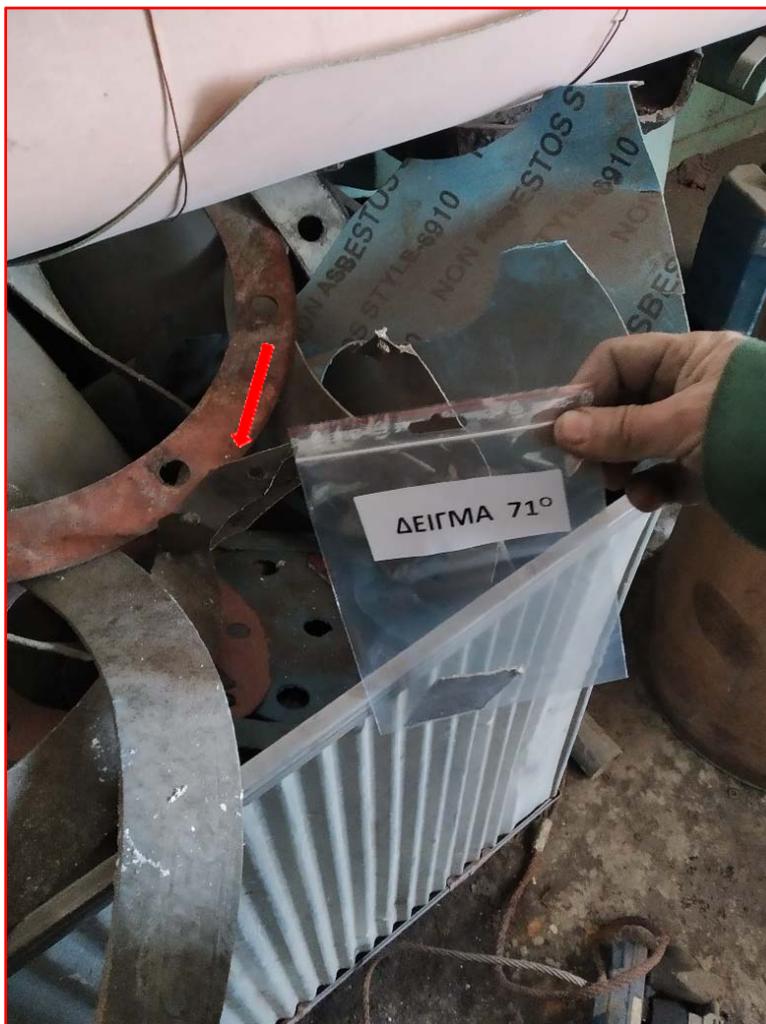
Ποσότητα:	Μη μετρήσιμη
Παρατηρήσεις:	Μέσα στο χώρο εντοπίστηκε μεταλλικός κάδος γεμάτος με στεγανωτικά υλικά διαφόρων διαστάσεων και χρωματισμών. Βρέθηκε στεγανωτικό υλικό χρώματος μπλε που αναγράφει την λέξη asbestos – αμίαντος. Ο δειγματοπισμός έγινε σε δύο άλλα στεγανωτικά υλικά διαφορετικής υφής και χρώματος. Συστήνεται η διαχείριση όλων των υλικών του κάδου ως αμιαντούχα. Δείγμα από τον ίδιο χώρο είναι και το Ν° 21.
Κατάσταση υλικού:	Καλή. Το στεγανωτικό υλικό είναι σε καλή κατάσταση και ο αμίαντος δεν είναι εκτεθειμένος.
Εκτίμηση Επικινδυνότητας:	Όταν το υλικό δεν υφίστανται μηχανική διαταραχή, ο κίνδυνος είναι χαμηλός. Σε αντίθετη περίπτωση ο κίνδυνος είναι υψηλός.

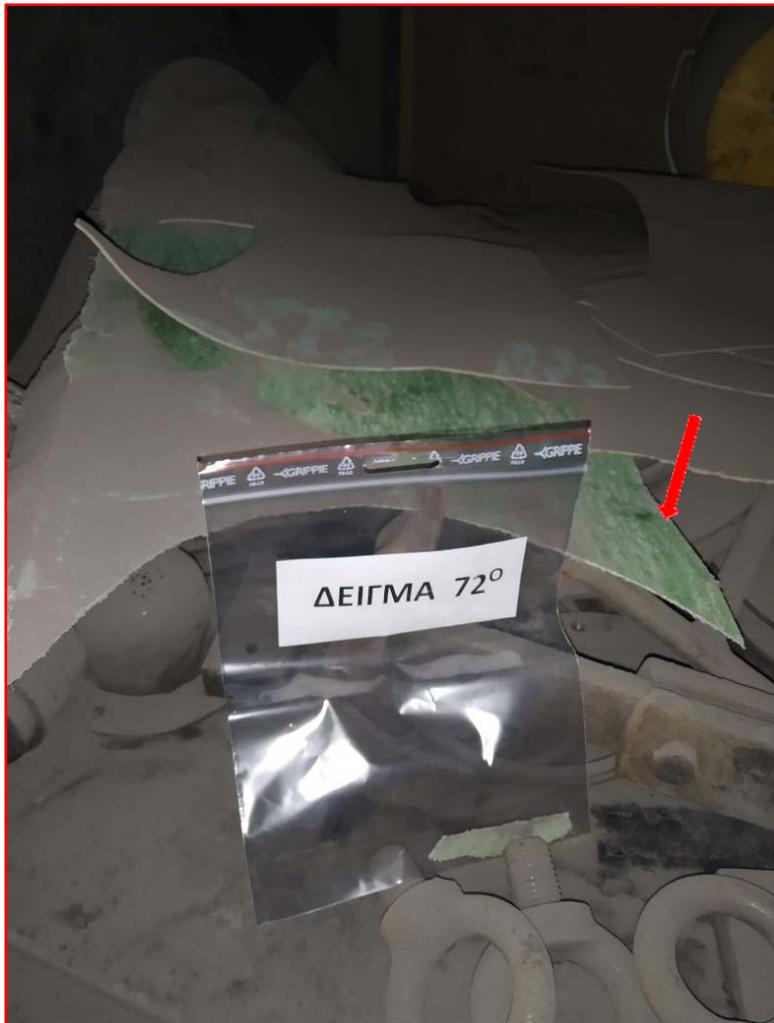
Ποσότητα:	Μη μετρήσιμη
Παρατηρήσεις:	Στο χώρο εντοπίστηκαν χύδην στεγανωτικά υλικά (φλάντζες), που ενδέχεται να περιέχουν ίνες αμιάντου. Η τέφρα που έχει επικαλύψει τα υλικά δημιούργησε προβλήματα στον διαχωρισμό με βάση το χρώμα. Δείγμα από τον ίδιο χώρο είναι και το Ν° 14. Συστήνεται η διαχείριση όλων των στεγανωτικών υλικών του χώρου ως αμιαντούχα.
Κατάσταση υλικού:	Καλή. Το στεγανωτικό υλικό είναι σε καλή κατάσταση και ο αμιάντος δεν είναι εκτεθειμένος.
Εκτίμηση Επικινδυνότητας:	Όταν το υλικό δεν υφίστανται μηχανική διαταραχή, ο κίνδυνος είναι χαμηλός. Σε αντίθετη περίπτωση ο κίνδυνος είναι υψηλός

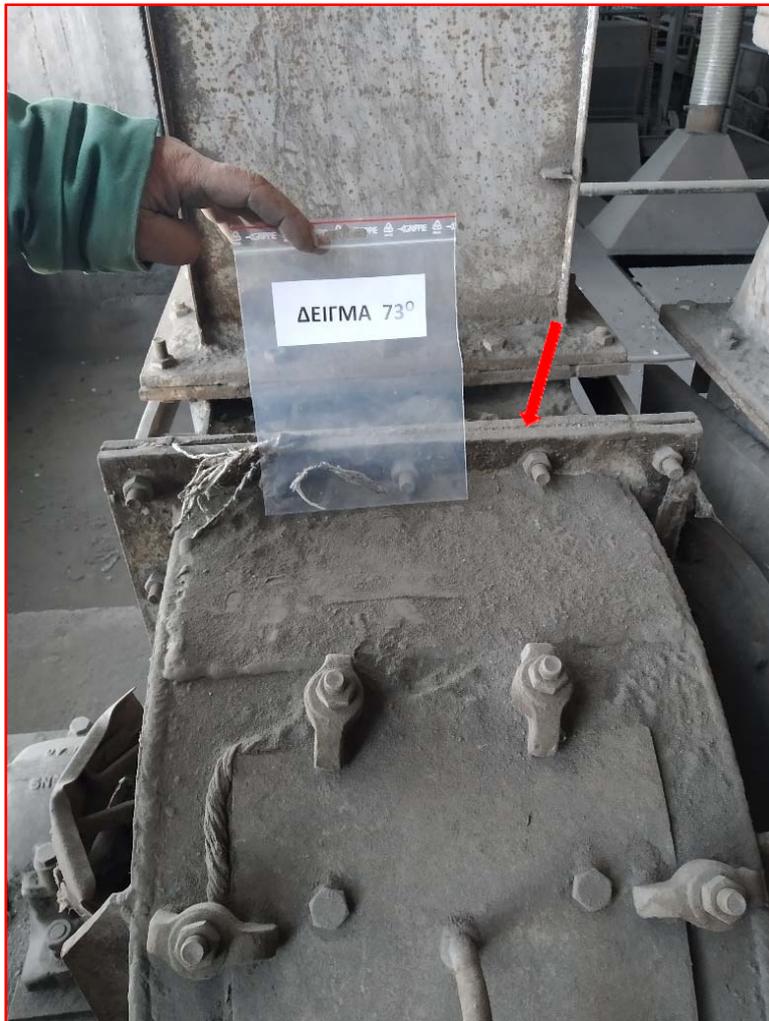
Αριθμός Δείγματος:	73
Περιοχή δειγματοληψίας:	Λεβητοστάσιο
Κτίριο – Επίπεδο:	2c / +31,50μ – Πόρτα Ν° 46
Περιγραφή δείγματος:	Στεγανωτικό υλικό (κορδόνι) σύνδεσης μεταλλικών στοιχείων ταινιόδρομου

Ποσότητα:	Μη μετρήσιμη
Παρατηρήσεις:	---
Κατάσταση υλικού:	Καλή. Το στεγανωτικό υλικό είναι σε καλή κατάσταση και ο αμίαντος δεν είναι εκτεθειμένος.
Εκτίμηση Επικινδυνότητας:	Όταν το υλικό δεν υφίστανται μηχανική διαταραχή, ο κίνδυνος είναι χαμηλός. Σε αντίθετη περίπτωση ο κίνδυνος είναι υψηλός.

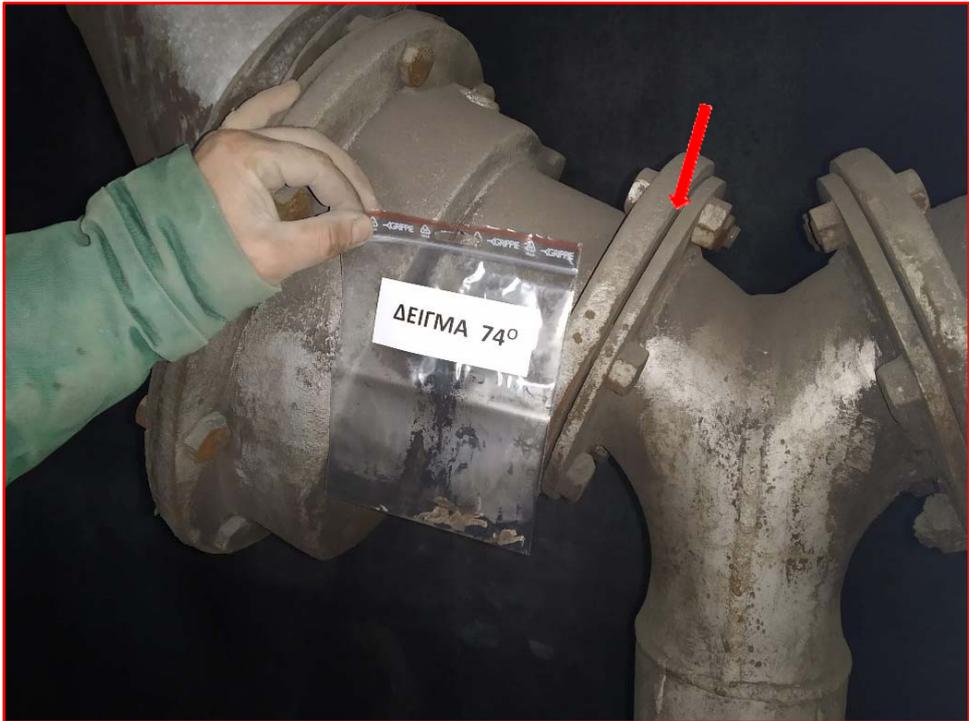
Αριθμός Δείγματος:	74
Περιοχή δειγματοληψίας:	Λεβητοστάσιο
Κτίριο – Επίπεδο:	2c / +31,50μ – Πόρτα Ν° 46
Περιγραφή δείγματος:	Στεγανωτικό υλικό (φλάντζα) σύνδεσης σωληνογραμμής

Ποσότητα:	Μη μετρήσιμη
Παρατηρήσεις:	---
Κατάσταση υλικού:	Καλή. Το στεγανωτικό υλικό είναι σε καλή κατάσταση και ο αμίαντος δεν είναι εκτεθειμένος.
Εκτίμηση Επικινδυνότητας:	Όταν το υλικό δεν υφίστανται μηχανική διαταραχή, ο κίνδυνος είναι χαμηλός. Σε αντίθετη περίπτωση ο κίνδυνος είναι υψηλός.

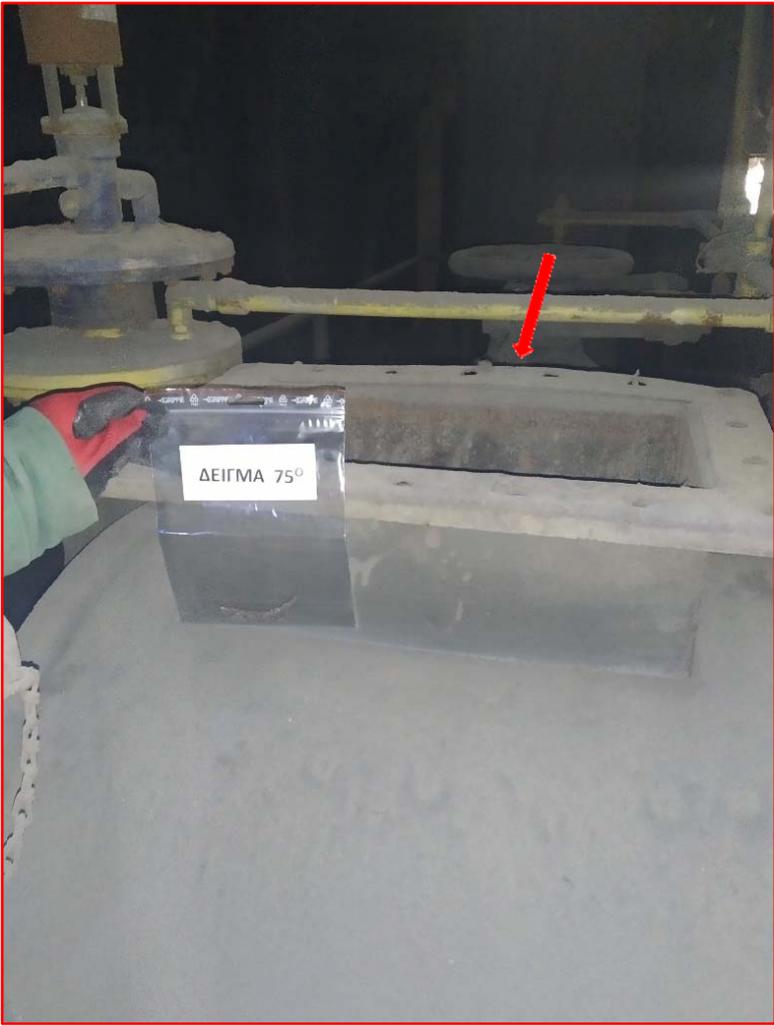
Αριθμός Δείγματος:	75
Περιοχή δειγματοληψίας:	Λεβητοστάσιο
Κτίριο – Επίπεδο:	2c / +8,50μ – Πόρτα Ν° 39
Περιγραφή δείγματος:	Στεγανωτικό υλικό (φλάντζα) ορθογωνικής διατομής

Ποσότητα:	Μη μετρήσιμη
Παρατηρήσεις:	---
Κατάσταση υλικού:	Καλή. Το στεγανωτικό υλικό είναι σε καλή κατάσταση και ο αμίαντος δεν είναι εκτεθειμένος.
Εκτίμηση Επικινδυνότητας:	Όταν το υλικό δεν υφίστανται μηχανική διαταραχή, ο κίνδυνος είναι χαμηλός. Σε αντίθετη περίπτωση ο κίνδυνος είναι υψηλός.

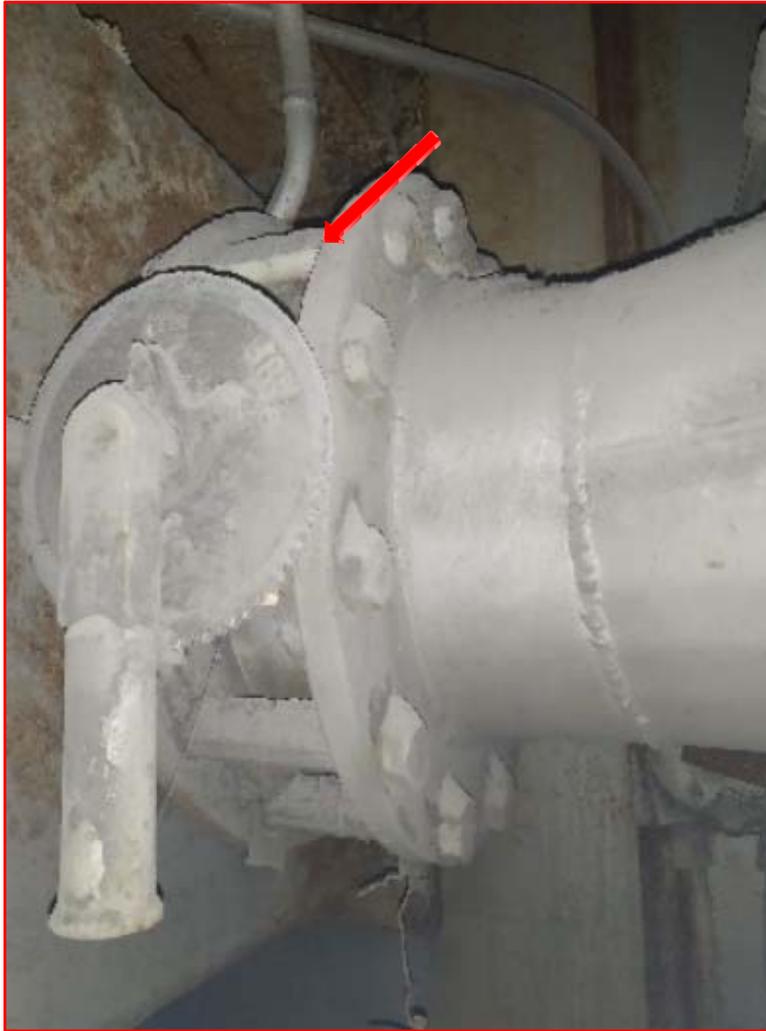
Εικόνα 1: (Λεβητοστάσιο – κτίριο 2c – επίπεδο +8,50μ – Πόρτα Ν° 39.) – Κυκλικά διαφράγματα ρύθμισης παροχής αέρα (damper) διαμέτρου Φ40. Ο εξοπλισμός περιέχει στεγανωτικό κορδόνι στις δύο πλευρές της μεταλλικής σύνδεσης που αναμένεται να είναι αμιαντούχο. Ο συγκεκριμένος εξοπλισμός εντοπίστηκε σε πολλά σημεία κατά μήκος της γραμμής αέρος στο σύστημα καύσης.
