Αντικείμενο: «Καθαίρεση του κύριου κτιρίου του ΑΗΣ ΛΙΠΤΟΛ, που περιλαμβάνει το λεβητοστάσιο, το μηχανοστάσιο, το κτίριο αφαλάτωσης και το Control Room, το Σύστημα Αποκομιδής τέφρας με την καμινάδα και τον Πύργο ψύξης»

ΣΥΜΠΛΗΡΩΜΑ Νο2

ΠΑΡΑΡΤΗΜΑ Ι

Πίνακας ΠΙ-1: Εξοπλισμός από τον οποίο πραγματοποιήθηκε δειγματοληψία πιθανών αμιαντούχων υλικών

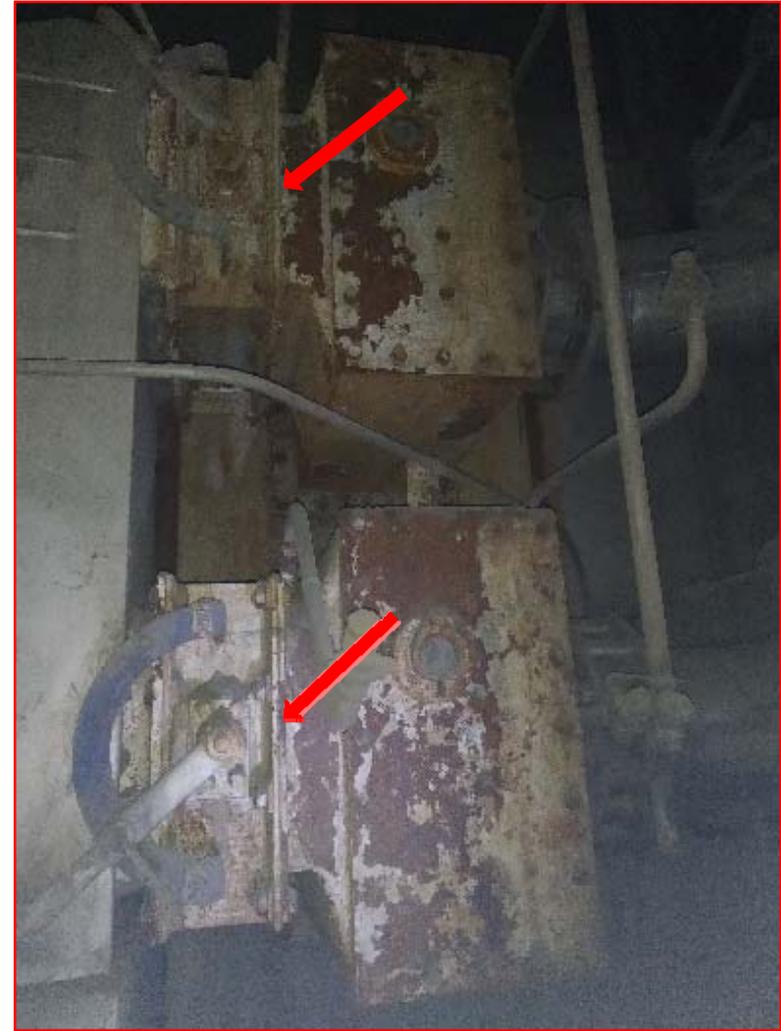
Εικόνα 2: (Λεβητοστάσιο – κτίριο 2c – επίπεδο +8,50μ – Πόρτα Ν° 39.) - Τετράγωνα διαφράγματα ρύθμισης παροχής αέρα (damper) με διαστάσεις 40x50. Στους στυπιοθαλάμους του εξοπλισμού αναμένεται ότι υπάρχει στεγανωτικό κορδόνι, το οποίο είναι πιθανό ότι είναι αμιαντούχο.

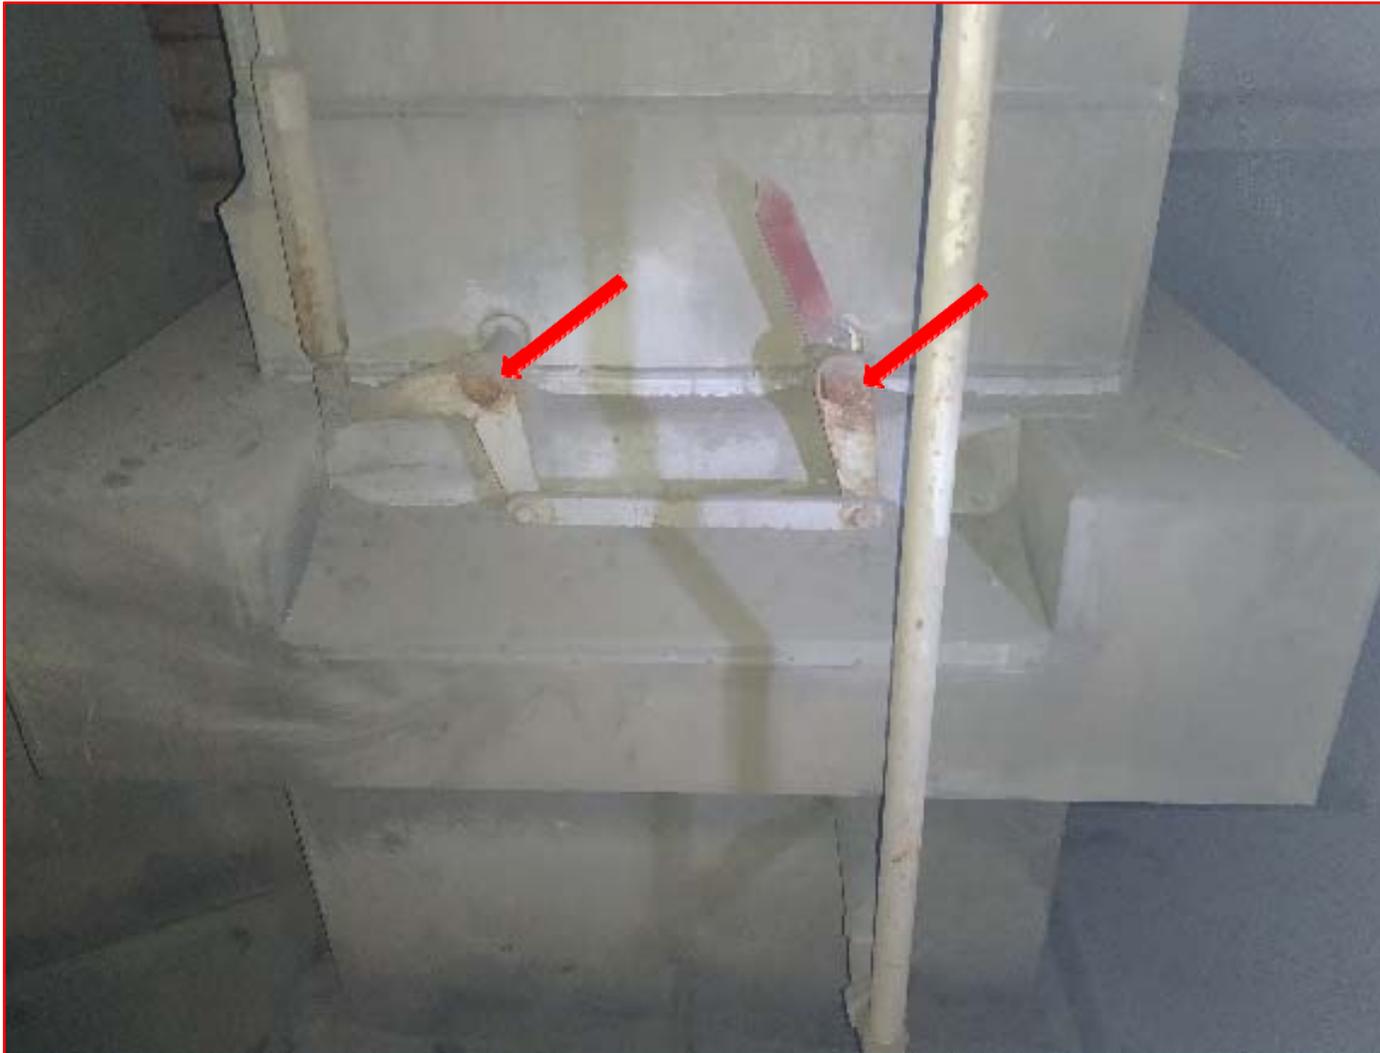
Εικόνα 3: (Λεβητοστάσιο – κτίριο 2c – επίπεδο +8,50μ – Πόρτα Ν° 39.) – Τετράγωνα διαφράγματα ρύθμισης παροχής αέρα (damper) με διαστάσεις 120x90. Στους συτιοθαλάμους του εξοπλισμού αναμένεται ότι υπάρχει κάποιο στεγανωτικό κορδόνι, το οποίο είναι πιθανό ότι είναι αμιαντούχο.

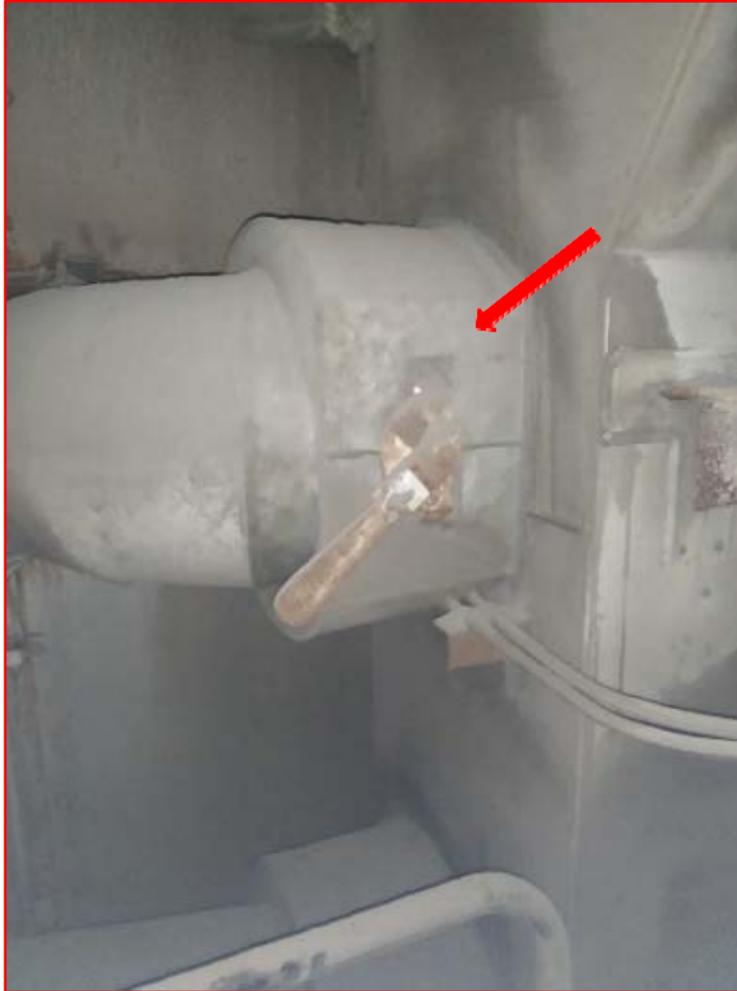
Εικόνα 4: (Λεβητοστάσιο – κτίριο 2c – επίπεδο +8,50μ – Πόρτα Ν° 39.) – Κυκλικά διαφράγματα ρύθμισης παροχής αέρα (damper) διαμέτρου Φ40. Ο εξοπλισμός περιέχει στεγανωτικό κορδόνι στις δύο πλευρές της μεταλλικής σύνδεσης που αναμένεται να είναι αμιαντούχο. Ο συγκεκριμένος εξοπλισμός εντοπίστηκε σε κάθε επίπεδο από το +5,50μ μέχρι το +22,00μ.

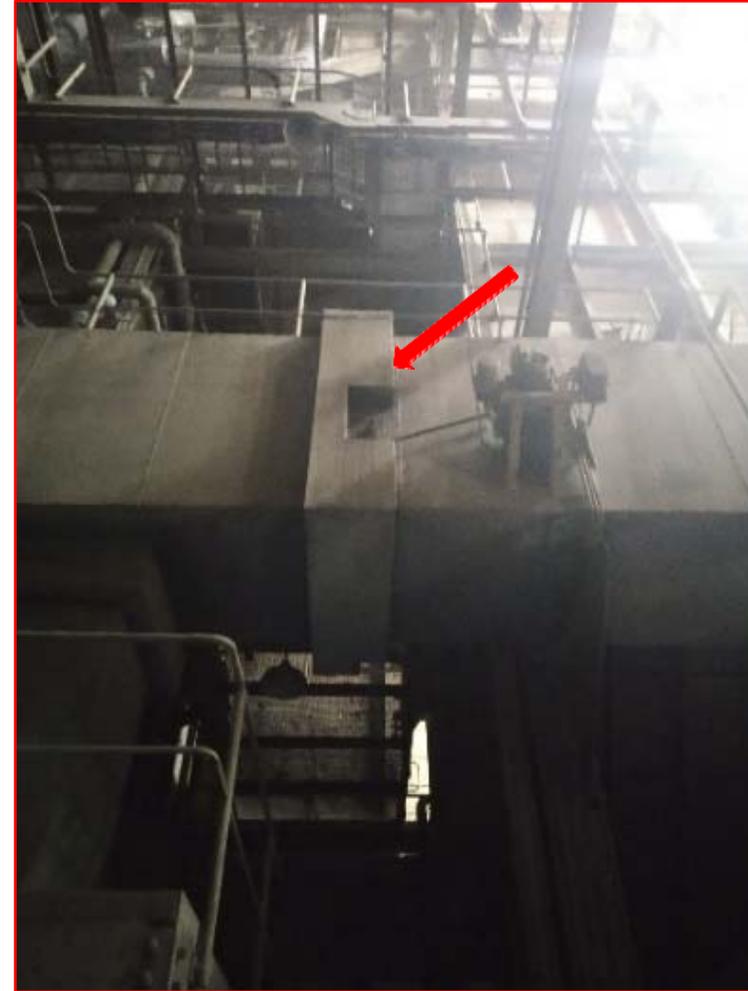
Εικόνα 5: (Λεβητοστάσιο – κτίριο 2c – επίπεδο +8,50μ – Πόρτα Ν° 39.) – Τετράγωνα διαφράγματα ρύθμισης παροχής αέρα (damper) με διαστάσεις 160x160. Στους στυπιοθαλάμους του εξοπλισμού αναμένεται ότι υπάρχει κάποιο στεγανωτικό κορδόνι, το οποίο είναι πιθανό ότι είναι αμιαντούχο.

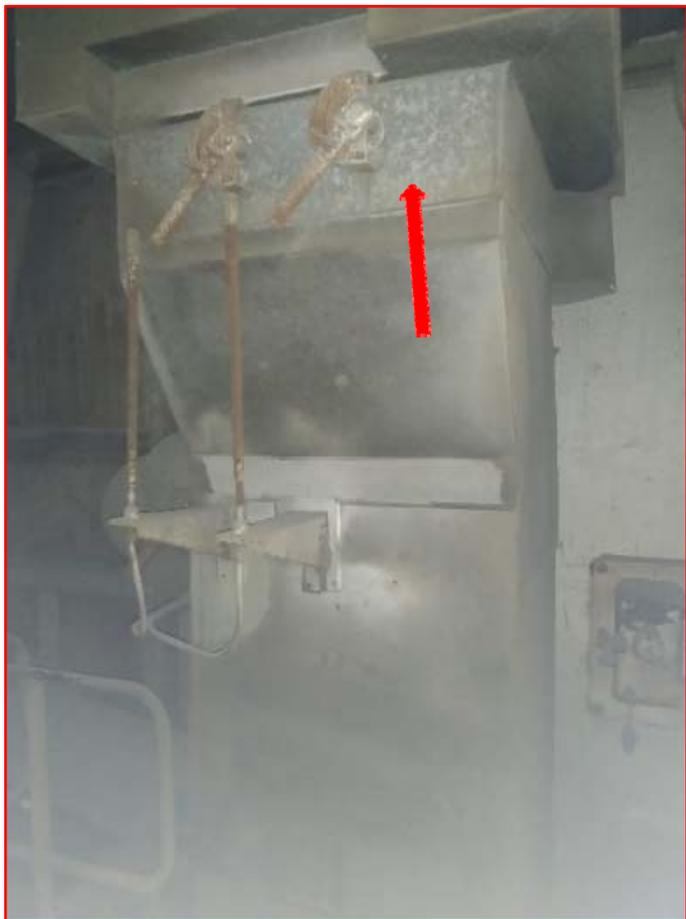
Εικόνα 6: (Λεβητοστάσιο – κτίριο 2c – επίπεδο +8,50μ – Πόρτα Ν° 39.) – Τετράγωνα διαφράγματα ρύθμισης παροχής αέρα (damper) με διαστάσεις 60x80. Στους στυπιοθαλάμους του εξοπλισμού αναμένεται ότι υπάρχει κάποιο στεγανωτικό κορδόνι, το οποίο είναι πιθανό ότι είναι αμιαντούχο.

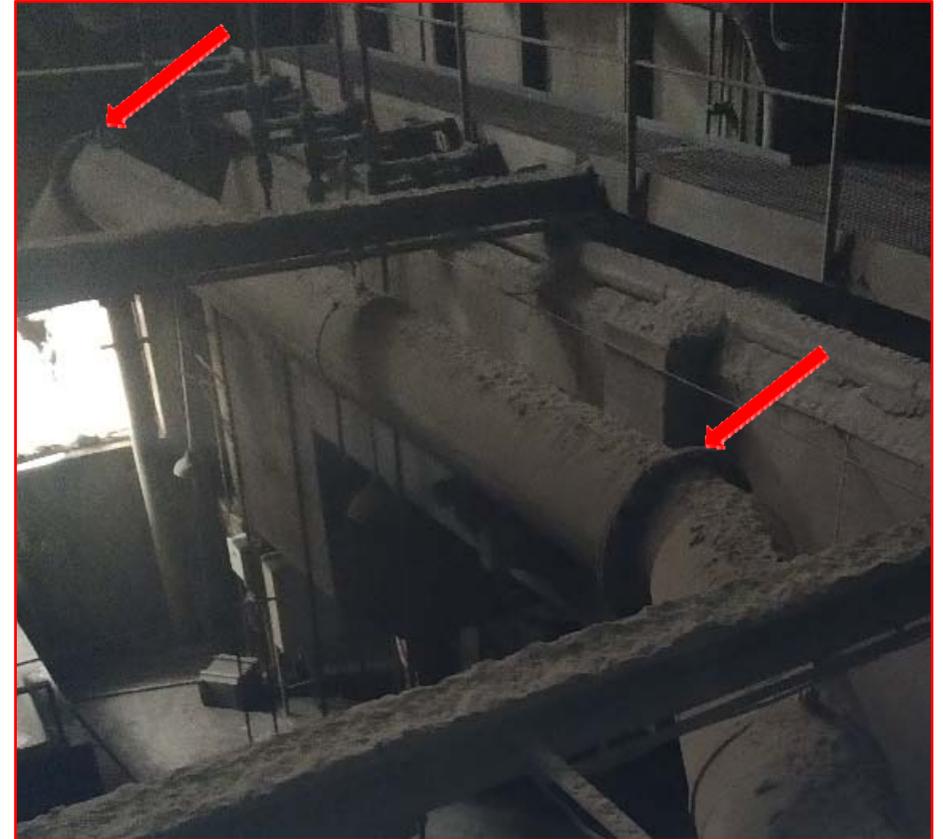
Εικόνα 9: (Λεβητοστάσιο – κτίριο 2c – επίπεδο +12,50μ – Πόρτα Ν° 40) Κυκλικές συνδέσεις αγωγών με κοχλίες. Στο χώρο του λεβητοστασίου παρατηρήθηκαν πολλές παρόμοιες συνδέσεις μεταξύ αγωγών. Το στεγανωτικό υλικό (φλάντζα) μεταξύ των συνδέσεων ενδέχεται να είναι αμιαντούχο.

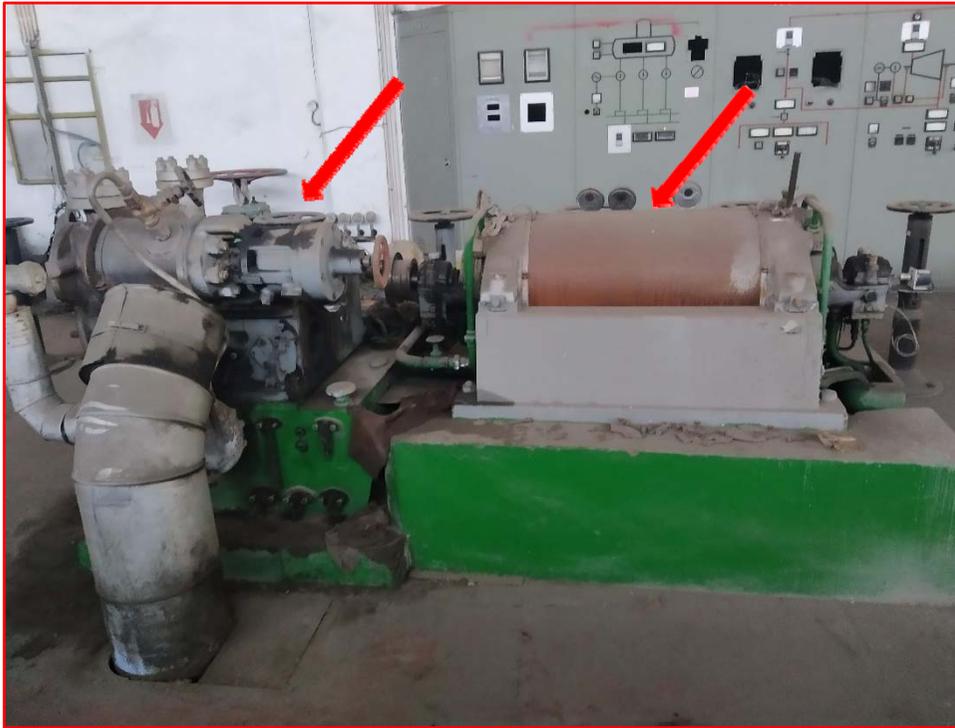
Εικόνα 10 – 11: (Μηχανοστάσιο – κτίριο 2b – επίπεδο +5,50μ.) – Τροφοδοτική αντλία λέβητα (2 τεμ). Υπάρχουν δύο αντλίες στο χώρο του μηχανοστασίου οι οποίες έχουν αμιαντούχα υλικά. Η μελέτη και δειγματισμός των υλικών πραγματοποιήθηκε στην τρίτη αντλία που υπάρχει στο χώρο και καταγράφηκαν στην μελέτη «ΕΝΤΟΠΙΣΜΟΣ ΚΑΙ ΚΑΤΑΓΡΑΦΗ ΑΜΙΑΝΤΟΥ ΚΑΙ ΑΜΙΑΝΤΟΥΧΩΝ ΥΛΙΚΩΝ ΣΕ ΗΛΕΚΤΡΟΜΗΧΑΝΟΛΟΓΙΚΟ ΕΞΟΠΛΙΣΜΟ ΠΡΩΗΝ ΕΝΕΡΓΕΙΑΚΟΥ ΣΥΓΚΡΟΤΗΜΑΤΟΣ ΛΙΠΤΟΛ. & ΣΥΝΤΑΞΗ ΤΕΥΧΟΥΣ ΤΕΧΝΙΚΗΣ ΠΡΟΔΙΑΓΡΑΦΗΣ ΑΠΟΡΡΥΠΑΝΣΗΣ ΕΞΟΠΛΙΣΜΟΥ» με συντάκτη τον Χρήστο Δ. Γανδά.

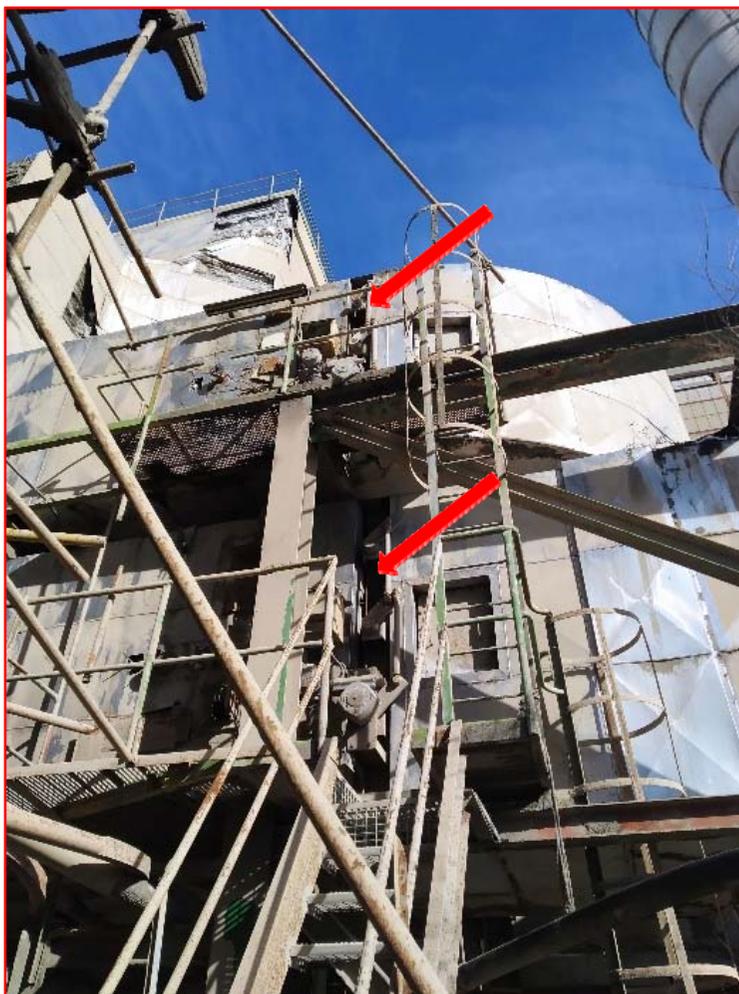
Εικόνα 12: (Σύστημα αποκομιδής τέφρας / Σιλό τέφρας – κτίριο 3c – επίπεδο +2,00μ) – Τετράγωνα διαφράγματα ρύθμισης παροχής αέρα (damper). Στους στυπιοθαλάμους του εξοπλισμού αναμένεται ότι υπάρχει κάποιο στεγανωτικό κορδόνι, το οποίο είναι πιθανό ότι είναι αμιαντούχο.

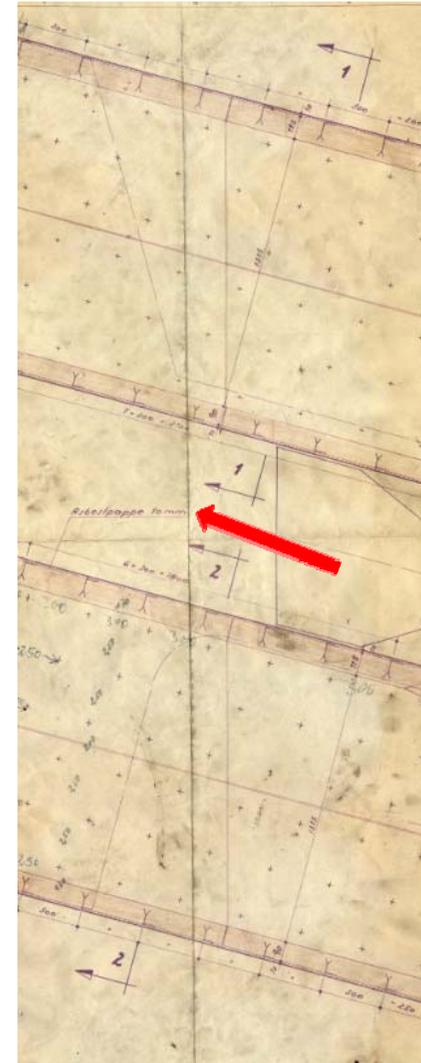
Αριθμός Σχεδίου:	Φ48/6 – Λέβητας
Περιγραφή (εξοπλισμός – υλικό):	Ένα δεύτερο σημείο στους δύο αγωγούς αέρα καύσεως λιγνίτη στο κομμάτι που συνδέεται με τον λέβητα περιέχεται γύρω από τους αγωγούς αμιαντούχο χαρτόνι (asbestpappe) πάχους 10mm. (Τομή 4 – 4)
